ORNL-2832

CORROSION ASSOCIATED WITH FLUORINATION  
IN THE OAK RIDGE NATIONAL LABORATORY  
FLUORIDE VOLATILITY PROCESS

CORROSION ASSOCIATED WITH FLUORINATION IN THE  
OAK RIDGE NATIONAL LABORATORY FLUORIDE VOLATILITY PROCESS

A. P. Litman and A. E. Goldman

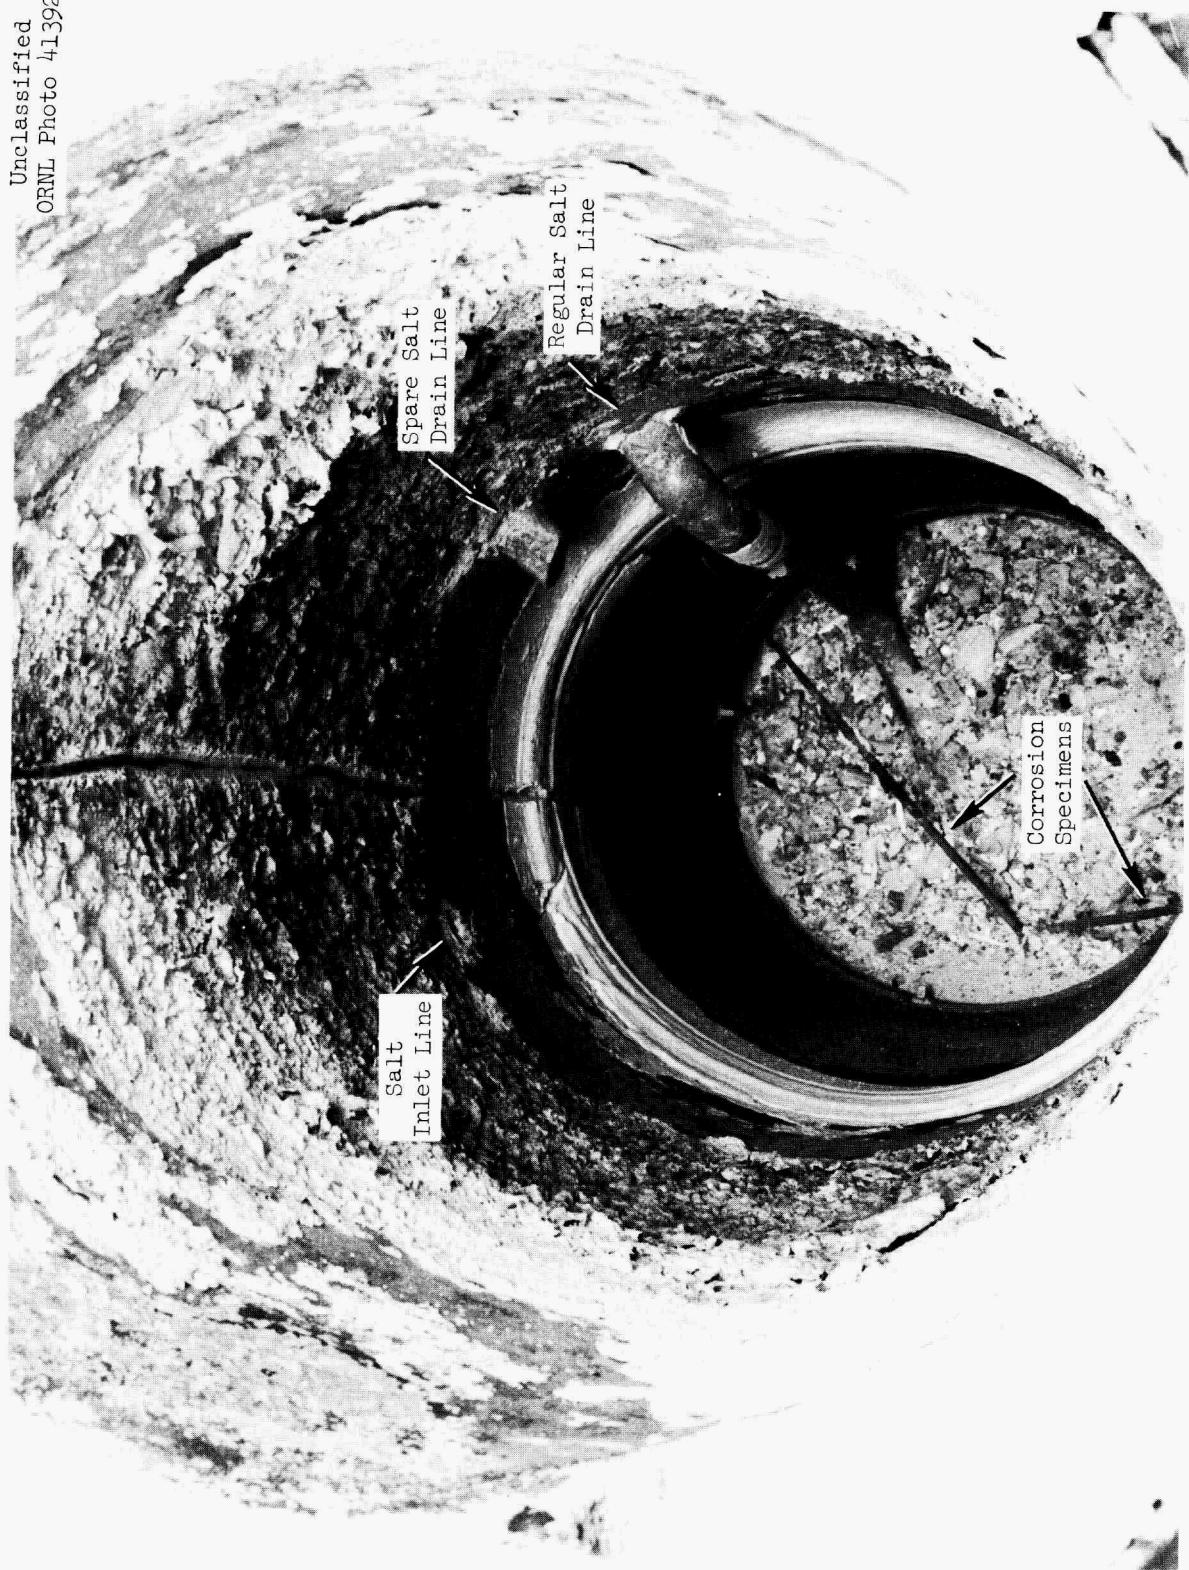
Fig. 5. Interior of the Mark I Volatility Pilot Plant Fluorinator After Run C-15.

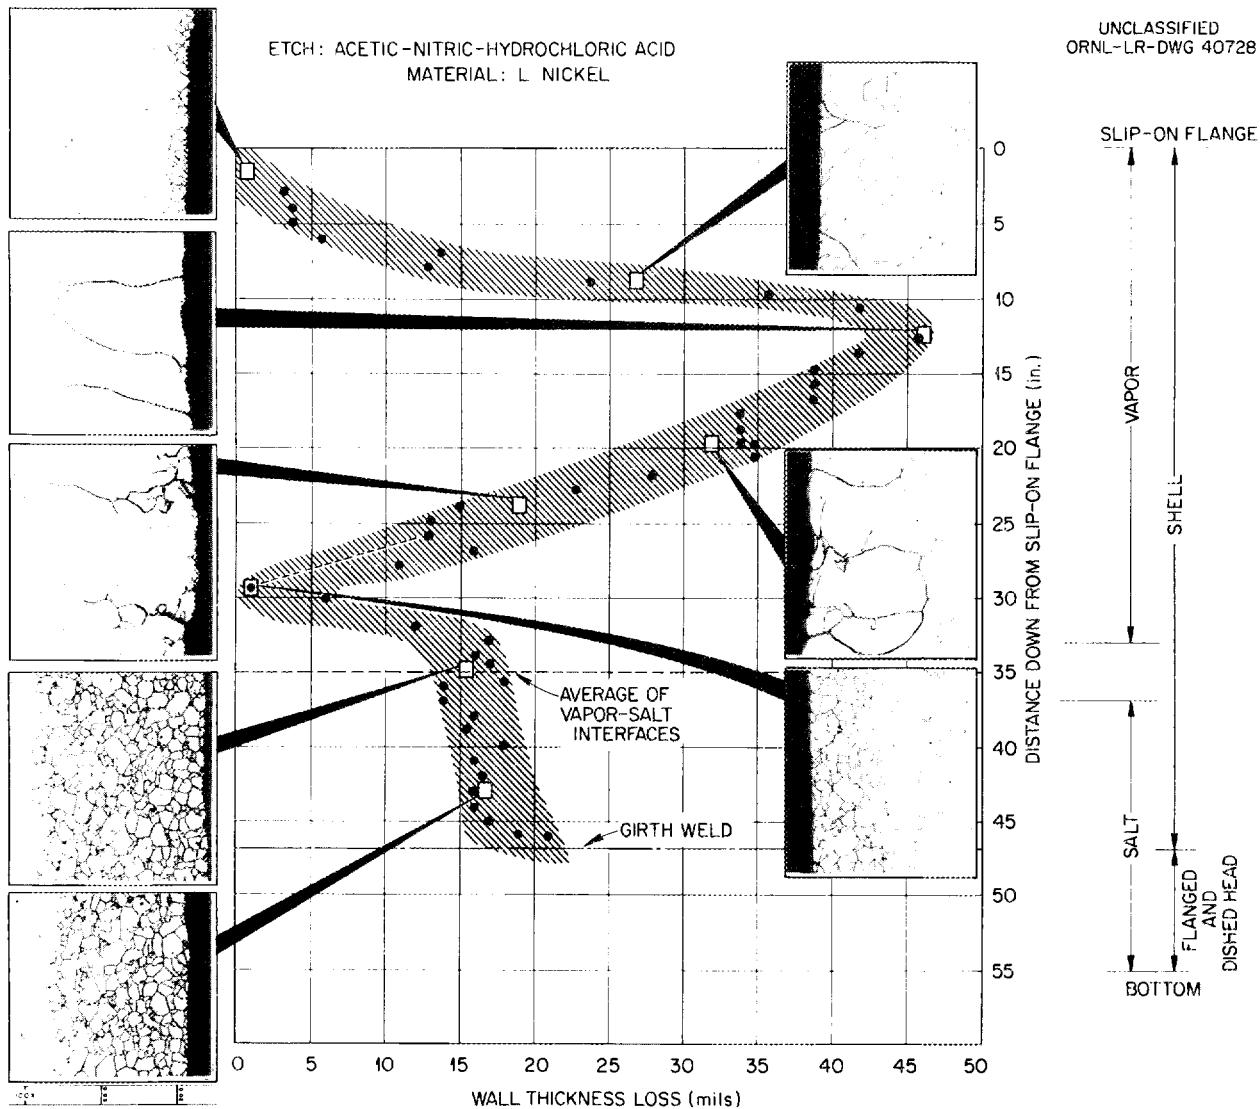
Fig. 8. Corrosion Profile and Typical Microstructures from the Mark I VPP Fluorinator. (Profile based on micrometer measurements from northeast quadrant full-length shell section.)

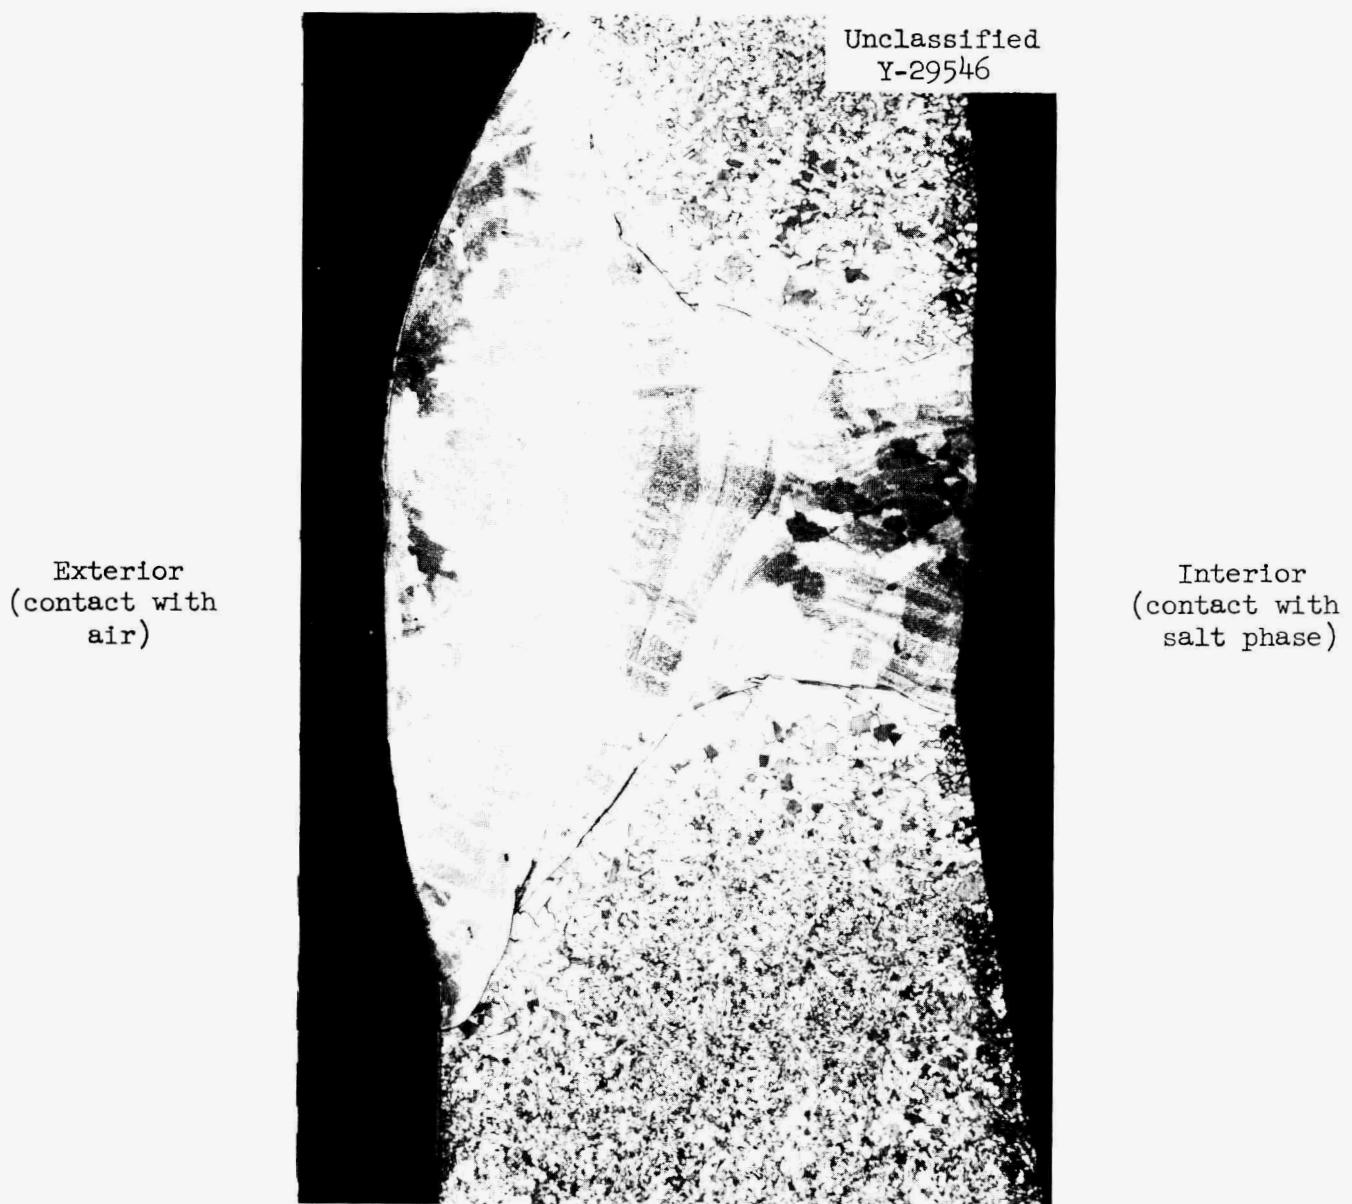
Fig. 9. Macrostructure of Section Through Girth Weld 47 in. Below Top Flange of Mark I VPP Fluorinator. Etchant: Acetic, nitric, hydrochloric acid. 10 X.

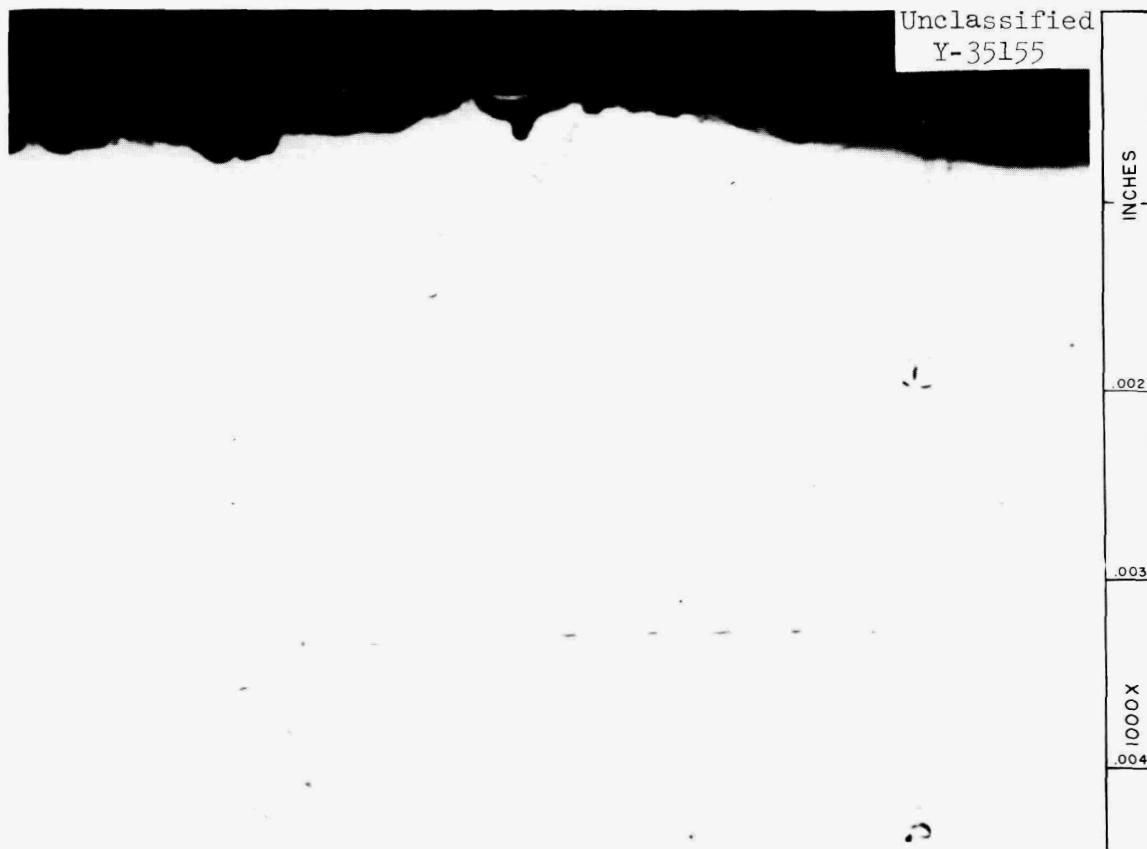
Fig. 10. Photomicrograph of Sample from Interior Surface of Mark I VPP L Nickel Fluorinator 12 in. Below Slip-on Flange (Vapor Phase) Showing Grain Boundary Deposit. Deposit was pale yellow under nonpolarized illumination and black under polarized light in accordance with Hall's method for identifying nickel sulfide deposits. Etchant: Potassium cyanide-ammonium persulfate, partially repolished. 1000X. Reference: A. M. Hall, "Sulfides in Nickel and Nickel Alloys," Trans. Met. Soc. AIME 152, 283, 1943.

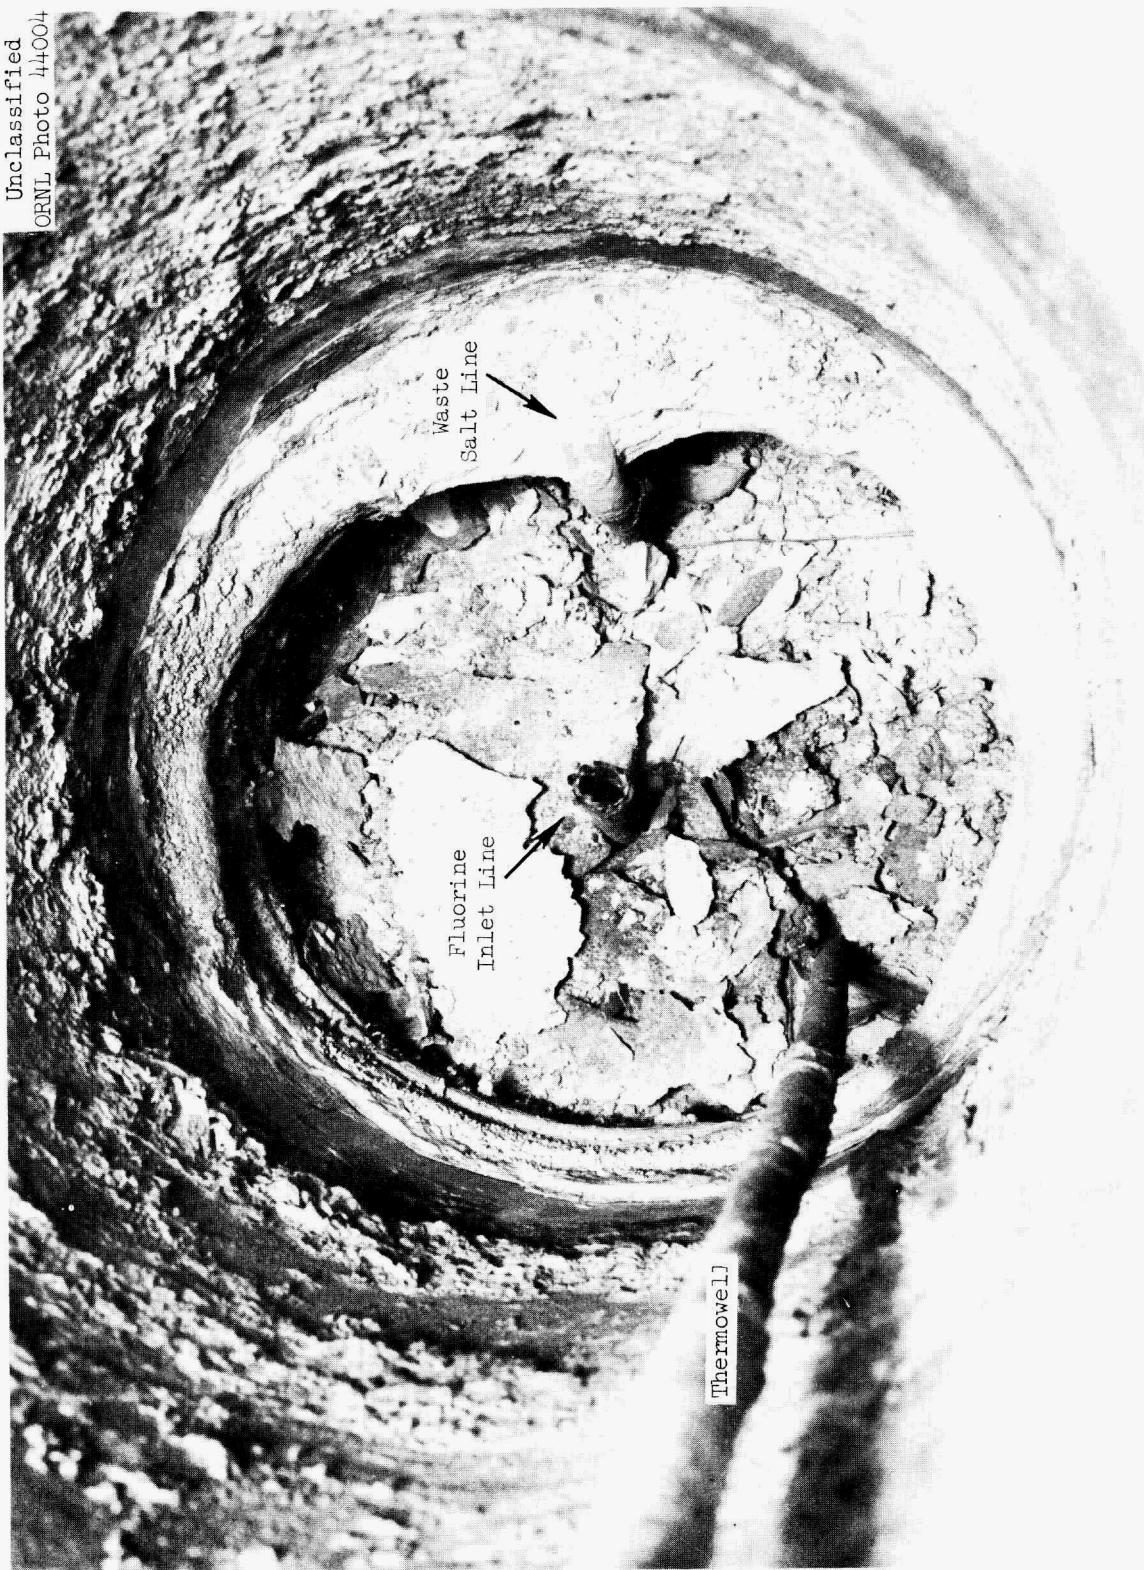
Fig. 14. Interior of Mark II VFP Fluorinator After Run L-4. (Fluorine inlet cut off prior to taking of photograph.)

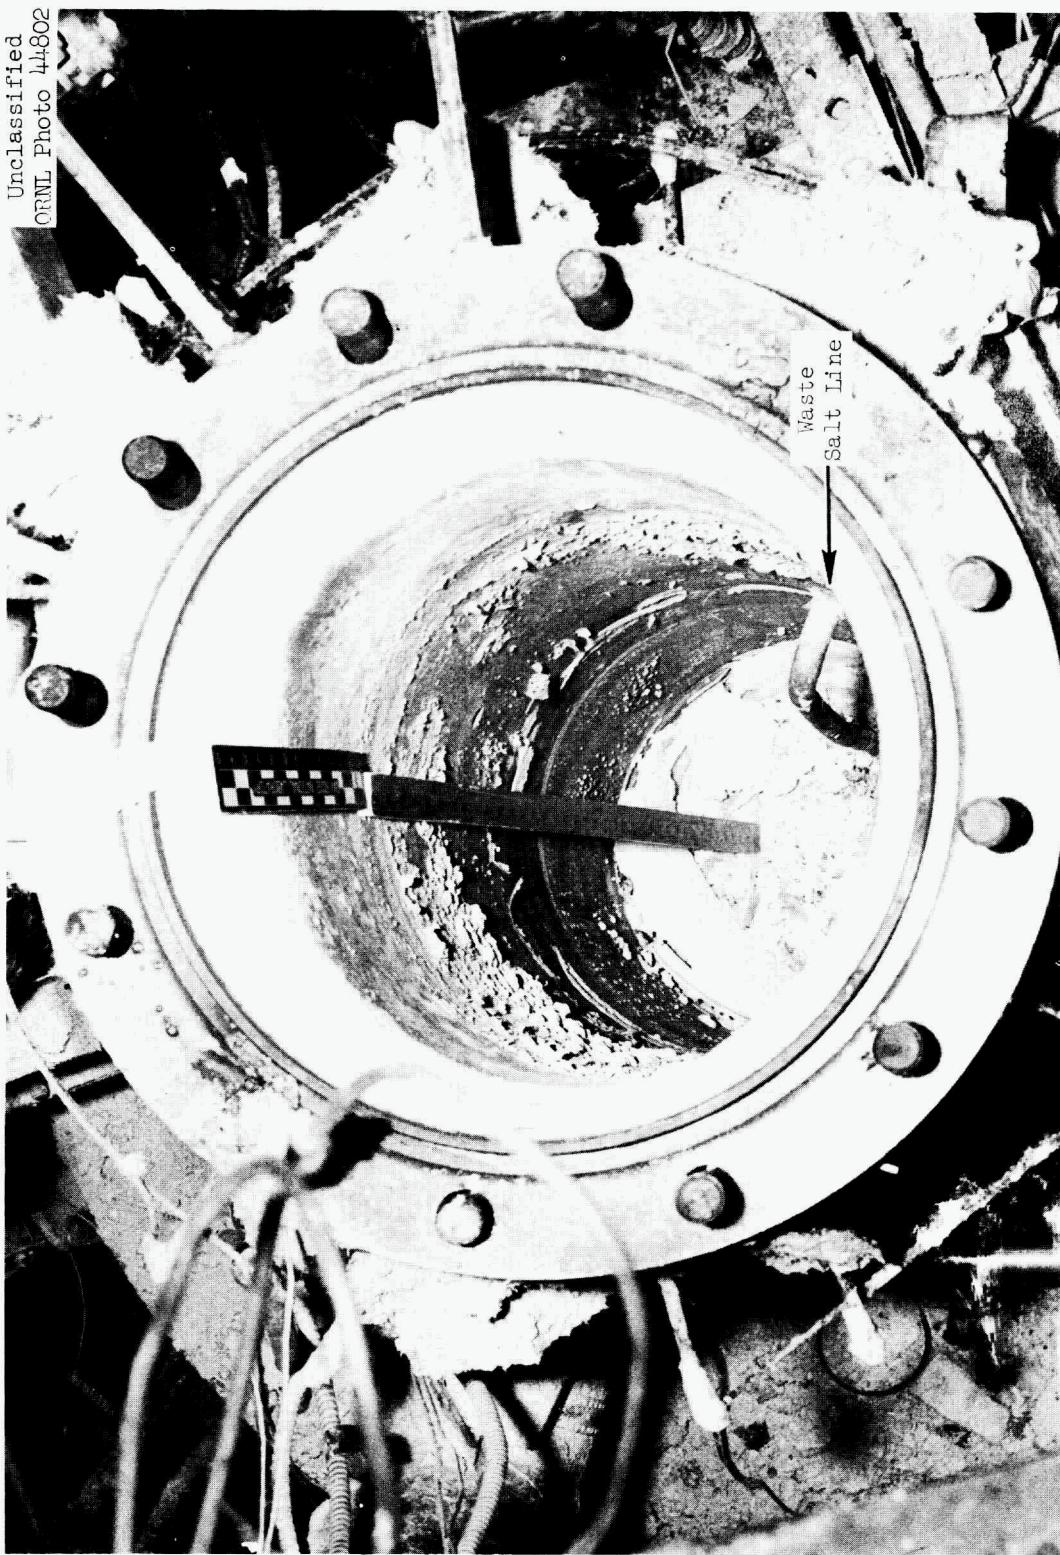
Fig. 15. Interior of the Mark II VPP Fluorinator After Run L-9.

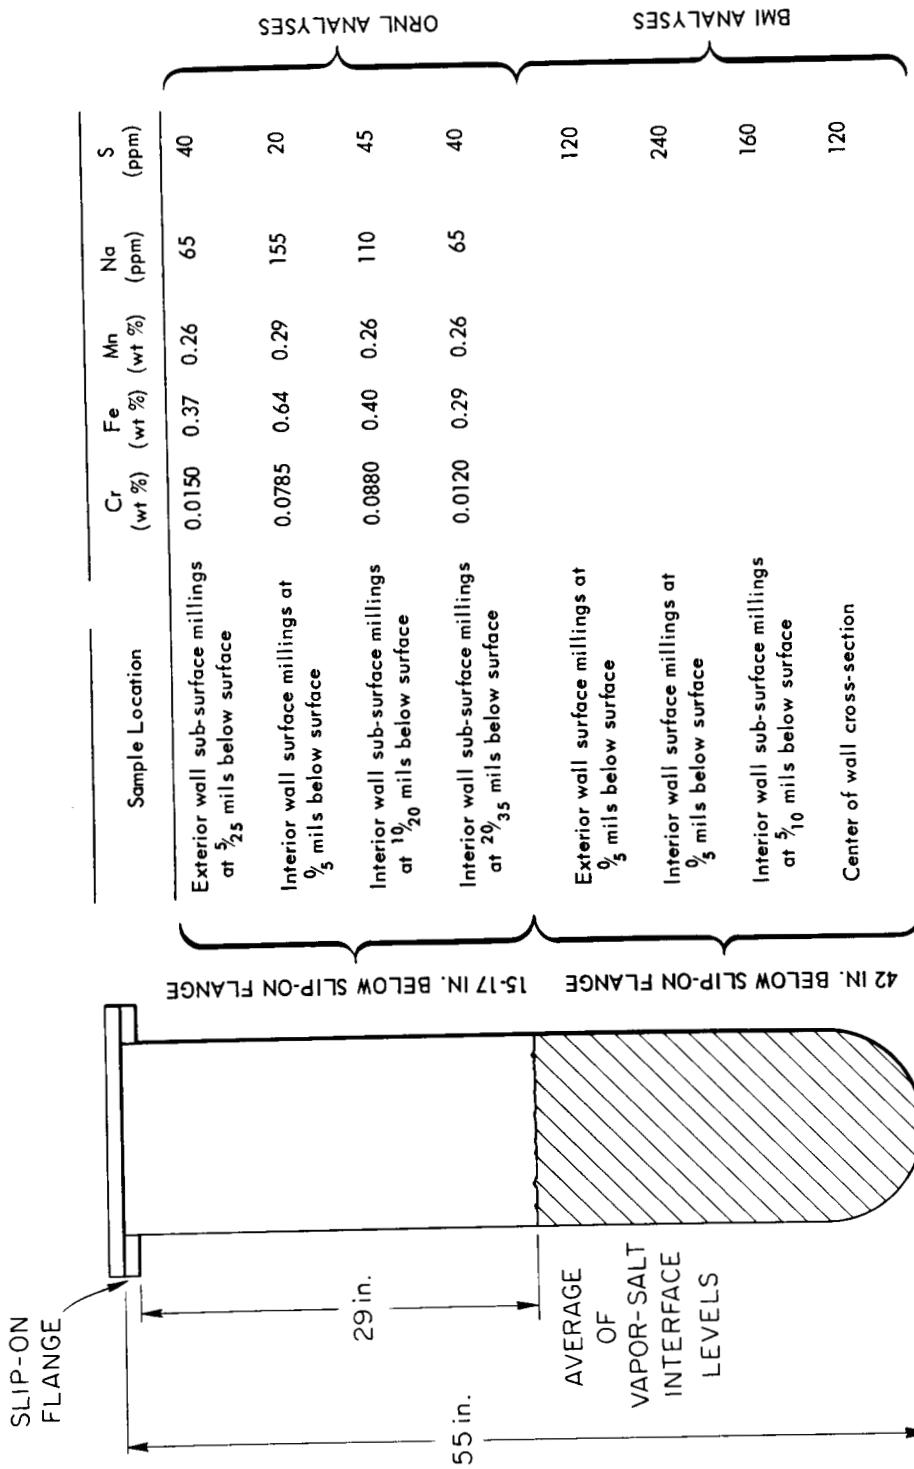
Surface and subsurface millings were taken from the interior wall of the vessel in the region where the green deposit seemed thickest, 15-17 in. below the bottom of the slip-on flange, and submitted for additional chemical analyses. For comparison purposes, subsurface millings were also taken from the exterior vessel wall at the same elevation. The results of the metal chemistry are shown in Fig. 16, and indicate an increase in chromium concentration in the millings near the surface of the interior wall of the vessel. No significant increase in sulfur in the vapor region of the fluorinator over that quantity present in the base material was found. However, on specimens removed from the salt region of the Mark II fluorinator, which were later analyzed by Battelle Memorial Institute (BMI), an increase in the sulfur content of the interior wall specimens was noted. Figure 16 also shows these results.

Fig. 16. Analyses of Millings from Mark II VFP I Nickel Fluorinator After Run L-9 and Vessel Decontamination.

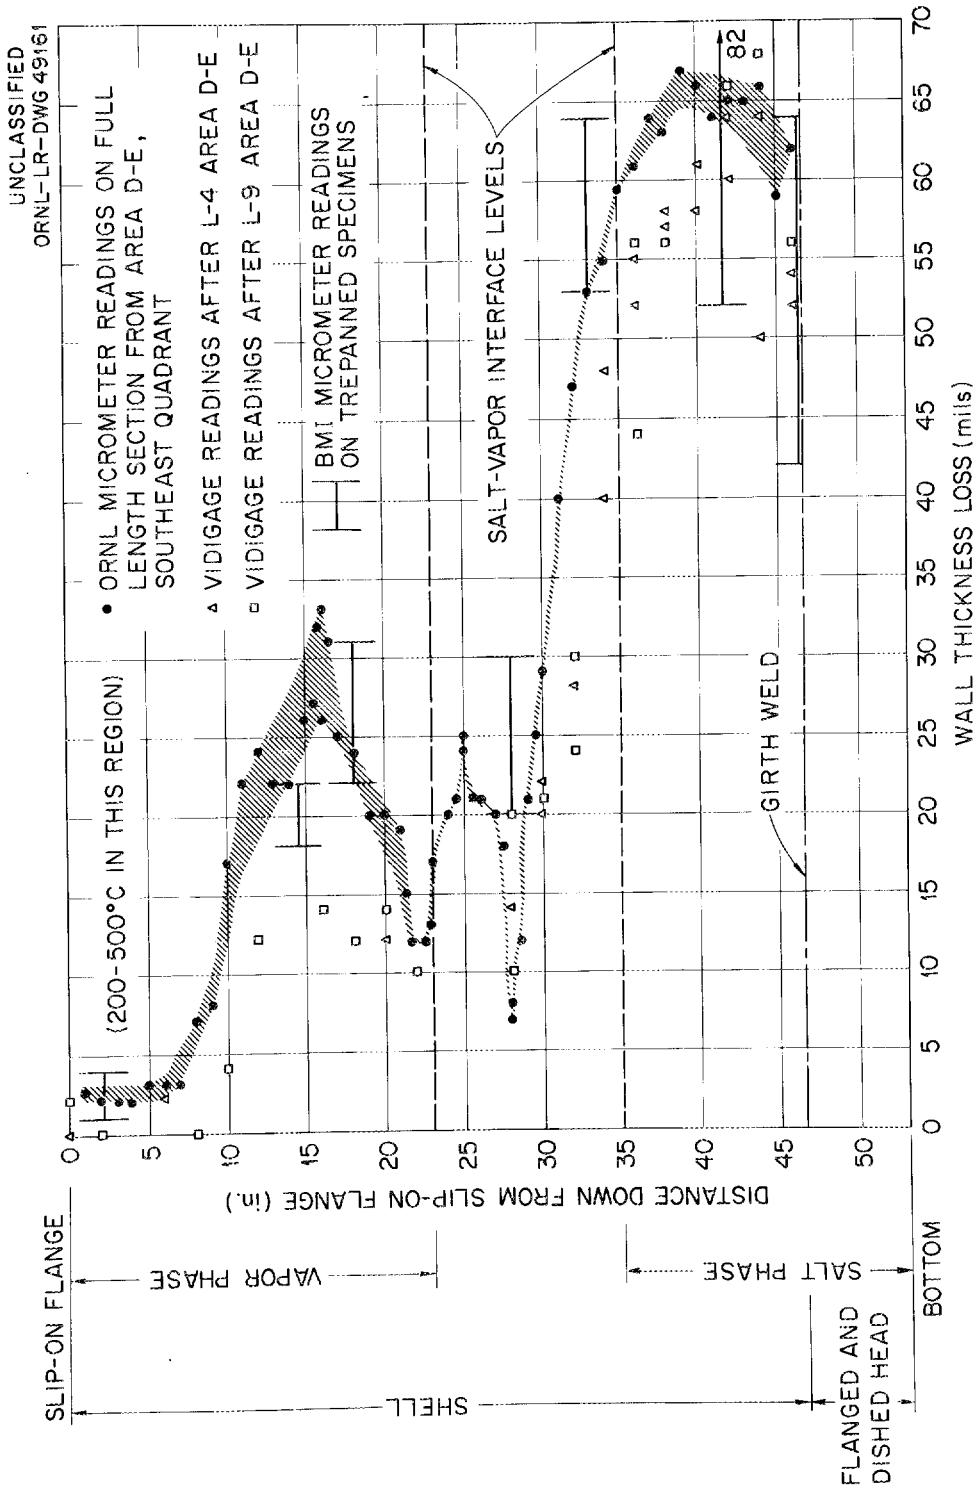
Fig. 18. Corrosion Profile of Mark III VPP L Nickel Fluorinator.

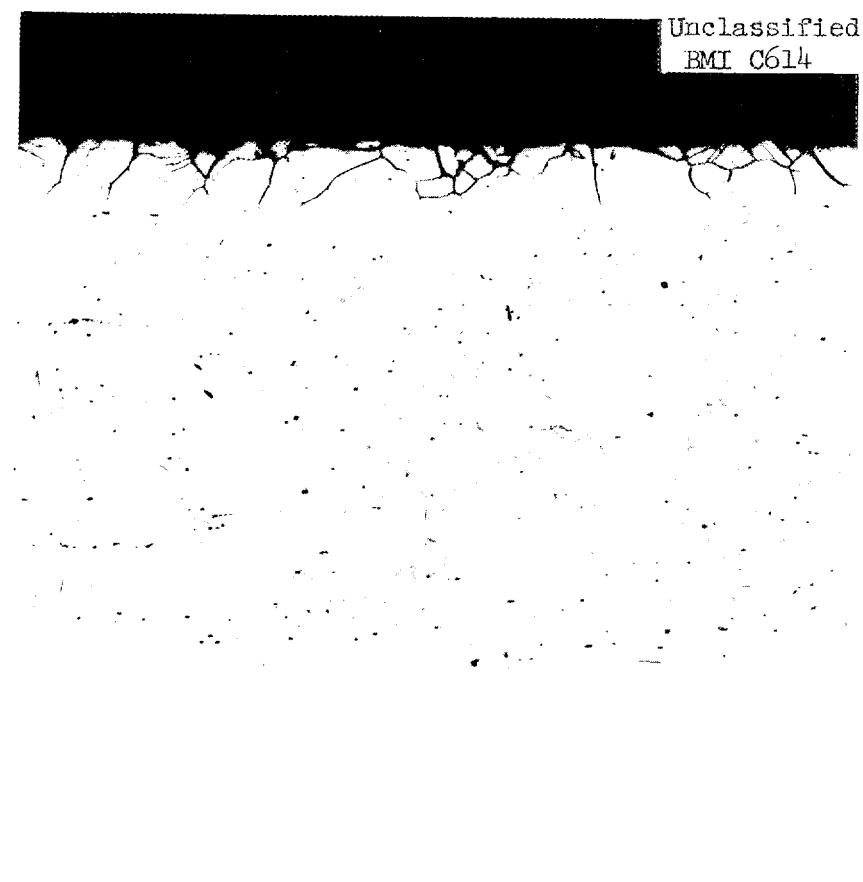
Fig. 19. Microstructure of Sample from Interior Surface of Mark II  
VPP Fluorinator 3 in. Below Slip-on Flange (Vapor Phase, Area A)  
Etchant: Nitric-acetic acid. 100X.

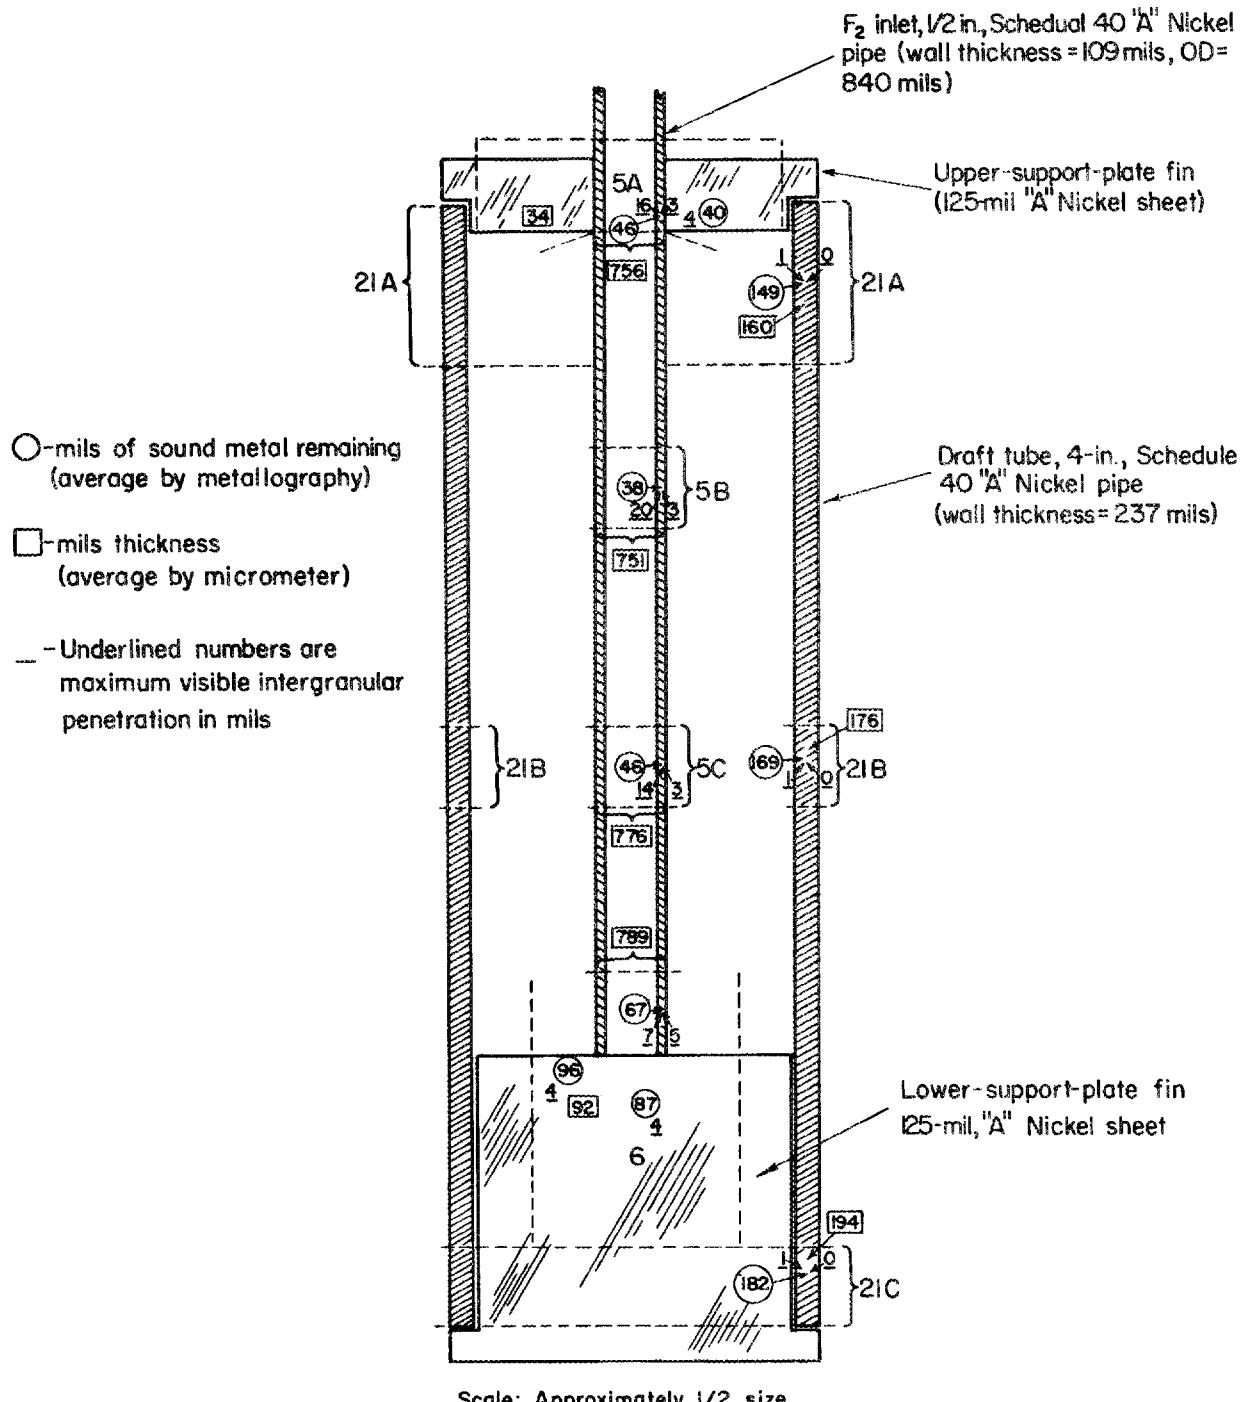
Fig. 29. Corrosion Losses on the Mark IIA Draft Tube and Fluorine Inlet from the Mark II VPP Fluorinator. Considerable metal loss has occurred at all areas but most of the intergranularly attacked grains appear to have sloughed off.

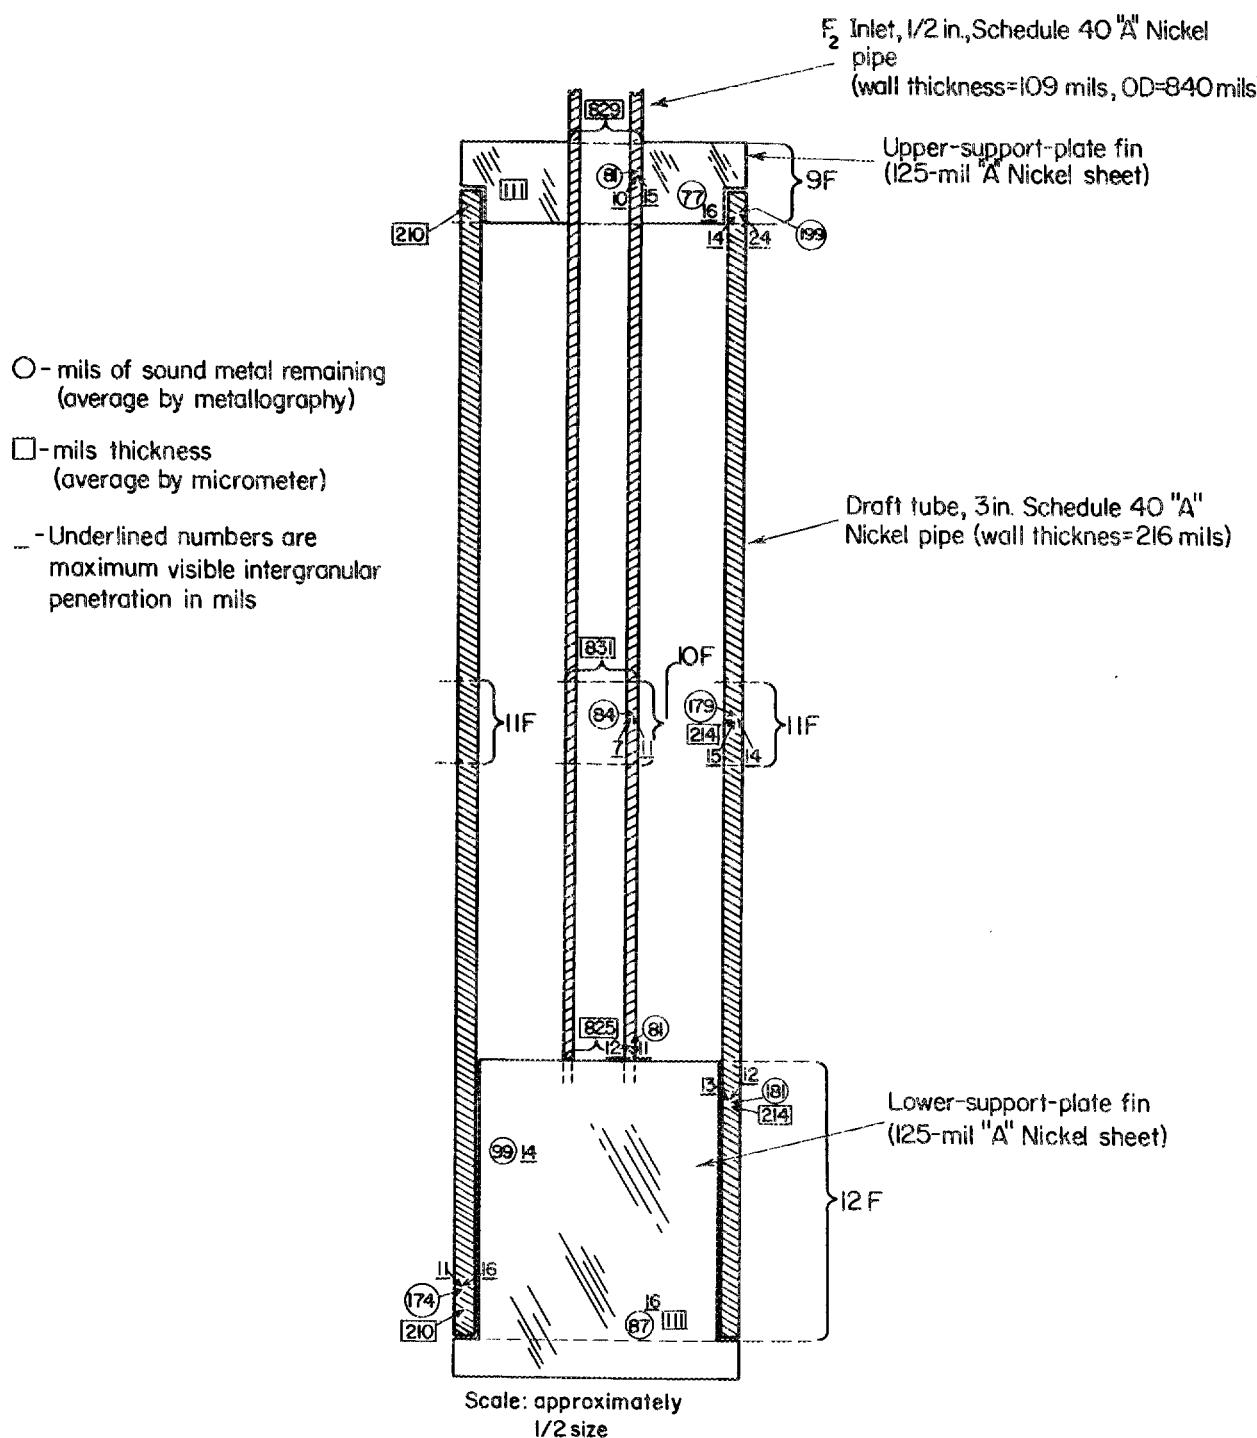
Fig. 30. Corrosion Losses on the Mark IIB Draft Tube and Fluorine Inlet from the Mark II VPP Fluorinator. Metal loss was not as severe as in the case of the Mark TIA assembly and more intergranular penetration was noted.

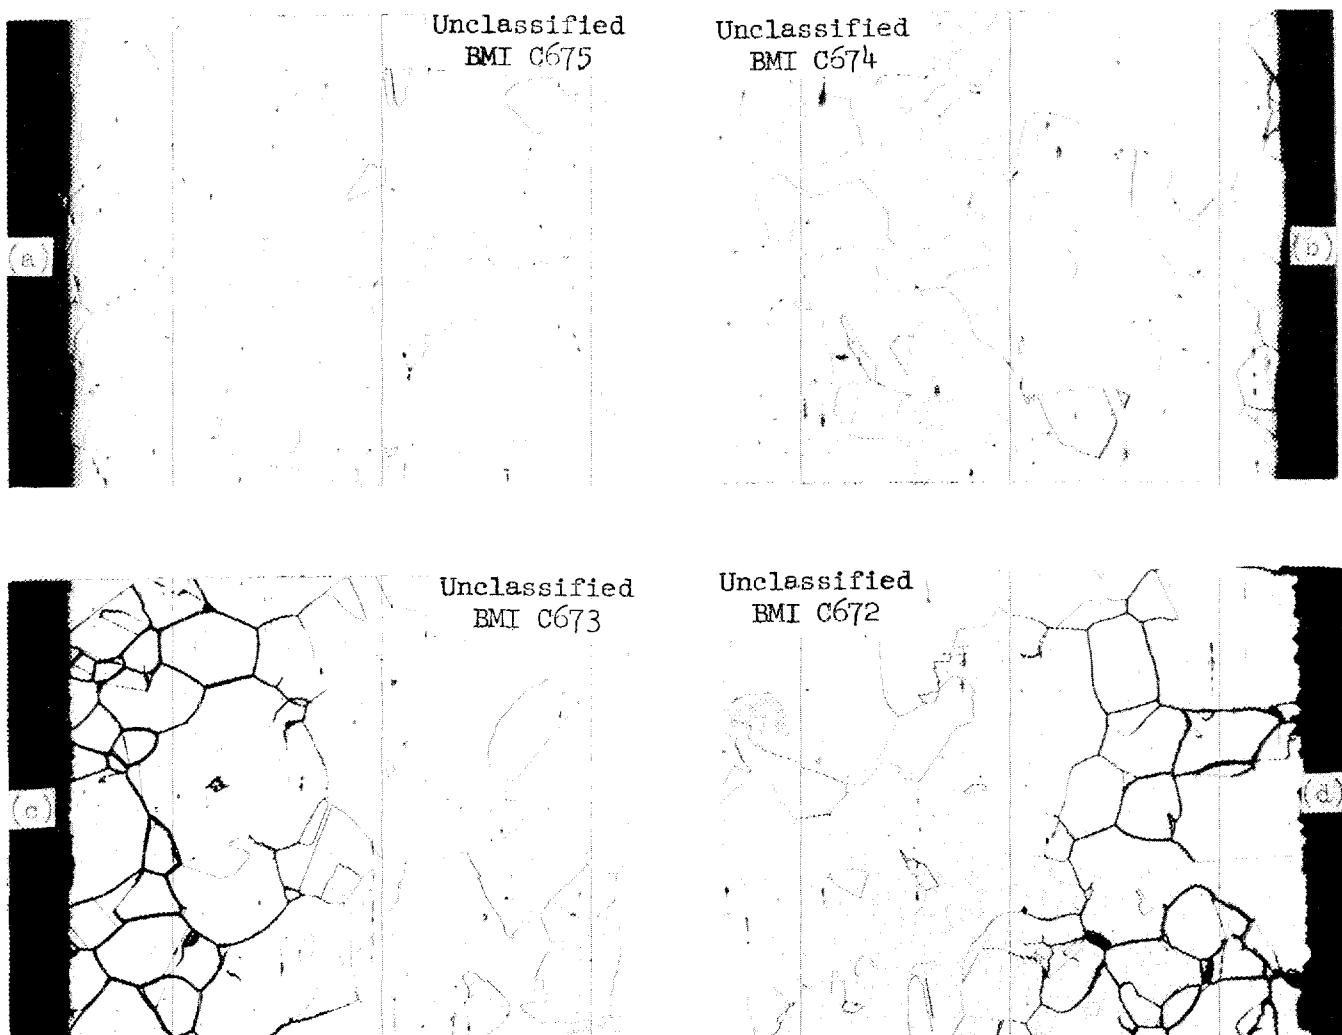
Fig. 31. Microstructures of Samples from A Nickel Draft Tubes Used in Mark II VPP Fluorinator. (a) and (b) exterior and interior surfaces of Mark IIA draft tube at Section 2LB; (c) and (d) exterior and interior surfaces of Mark IIB draft tube at Section 11F. Etchants: (a) and (b) Hydrochloric-nitric acid, (c) and (d) Nitric-acetic acid. 100X.

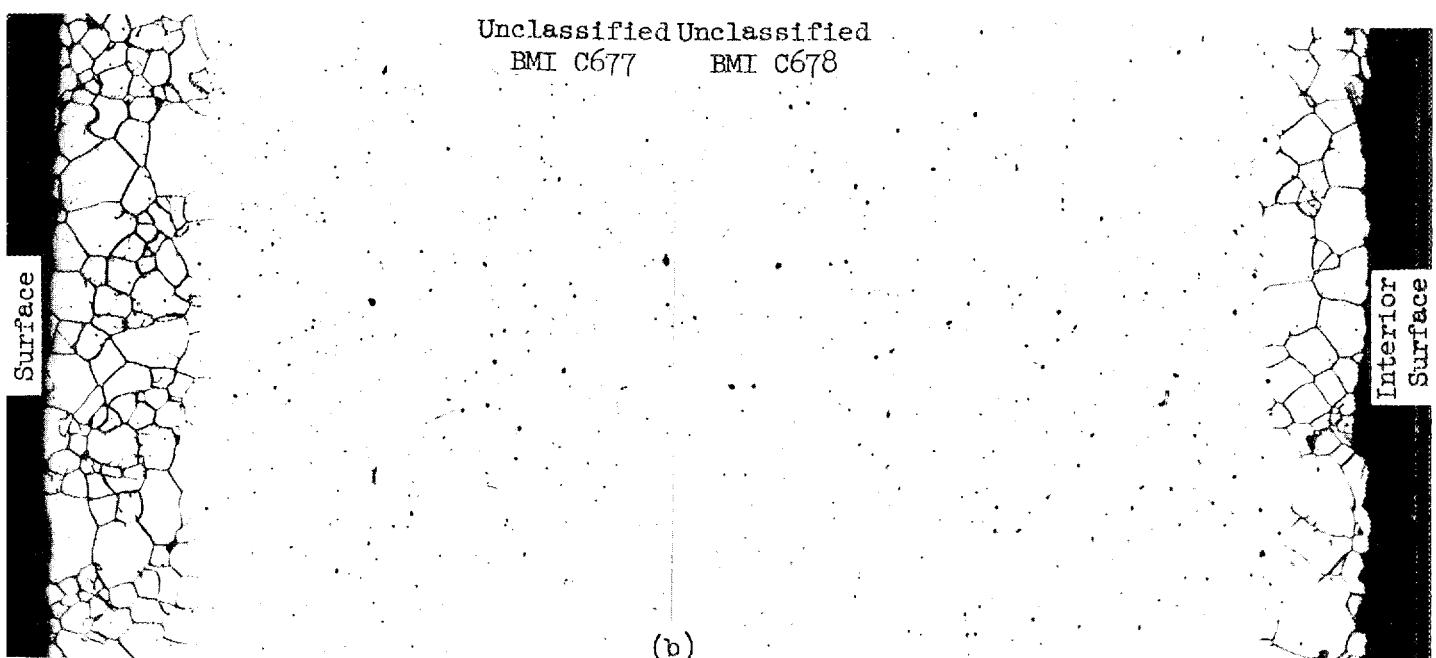
Fig. 32. Microstructures of Cross Sections Through A Nickel Fluorine Inlet Tubes from (a) Mark IIIA Draft Tube (b) Mark IIB Draft Tube.  
Etchants: Nitric-acetic acid. 70X.

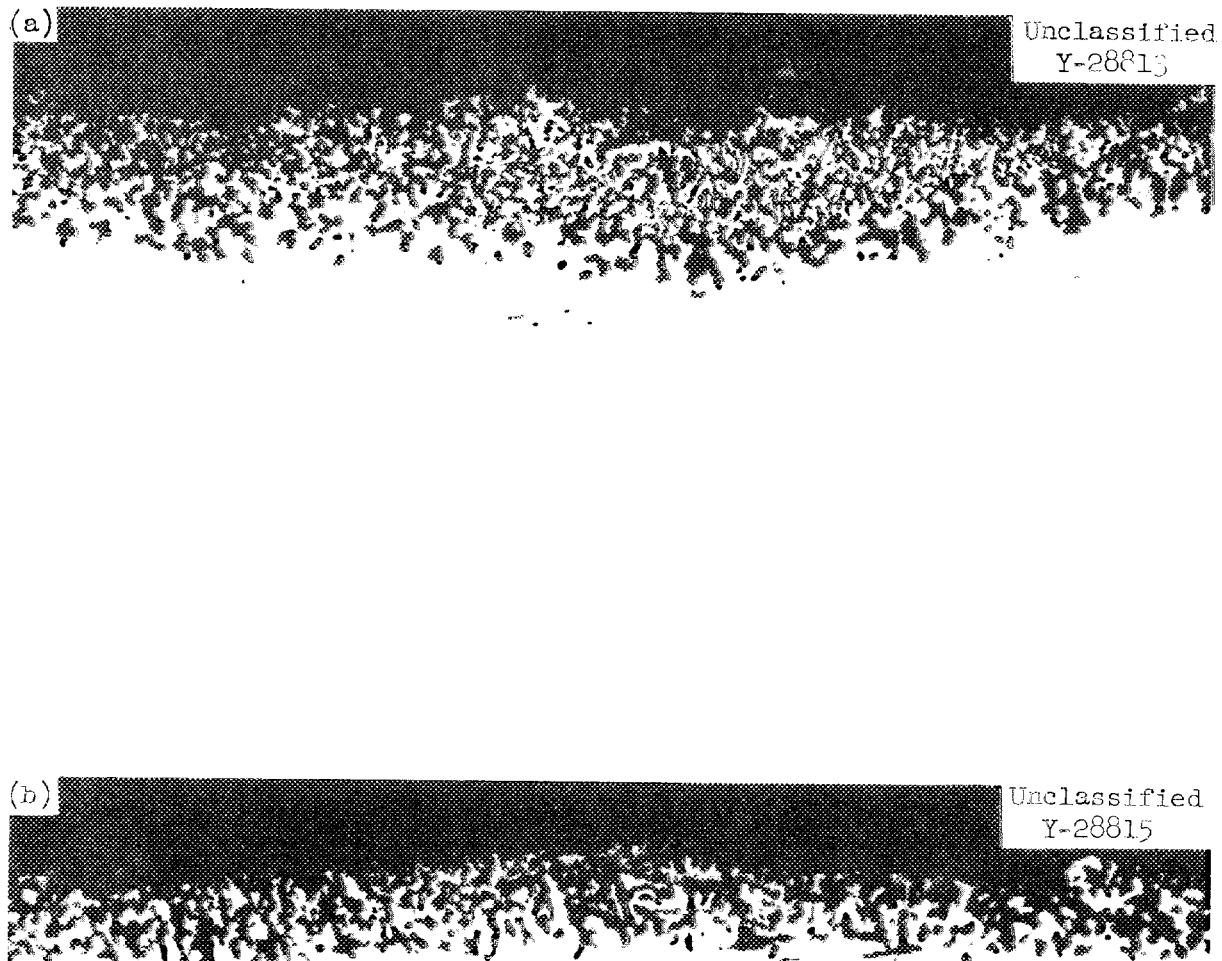
Fig. 49. Typical Spongy Surface Layers from Vapor Region Samples of  
(a) INOR-8 Test Fluorinator No. 2 (b) INOR-8 Test Fluorinator No. 4.  
As-polished. 500X.

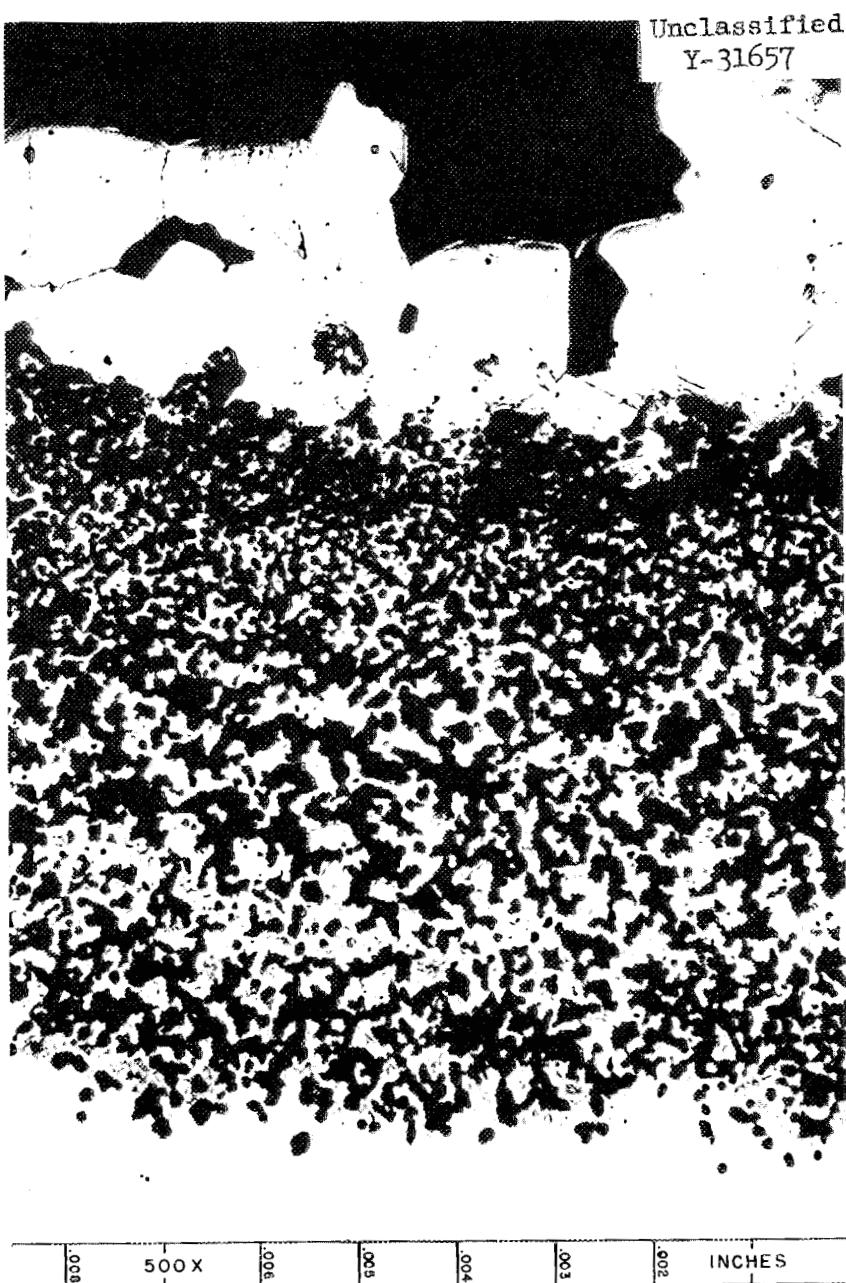
Upon etching the specimen with a mixture of 10% KCN and 10% (NH<sub>4</sub>)<sub>2</sub>S<sub>2</sub>O<sub>8</sub>, 1:1 ratio in water, the outermost layer of the surface showed different characteristics than the INOR-8 base metal. The comparatively mild etchant delineated grain boundaries in the outer layer but left the base metal unaffected, as displayed in Fig. 51.

Fig. 51. Surface Layers on Sample from Vapor Region of INOR-8 Miniature Test Fluorinator No. 2. Etchant: Potassium cyanide-ammonium persulfate. 500X.

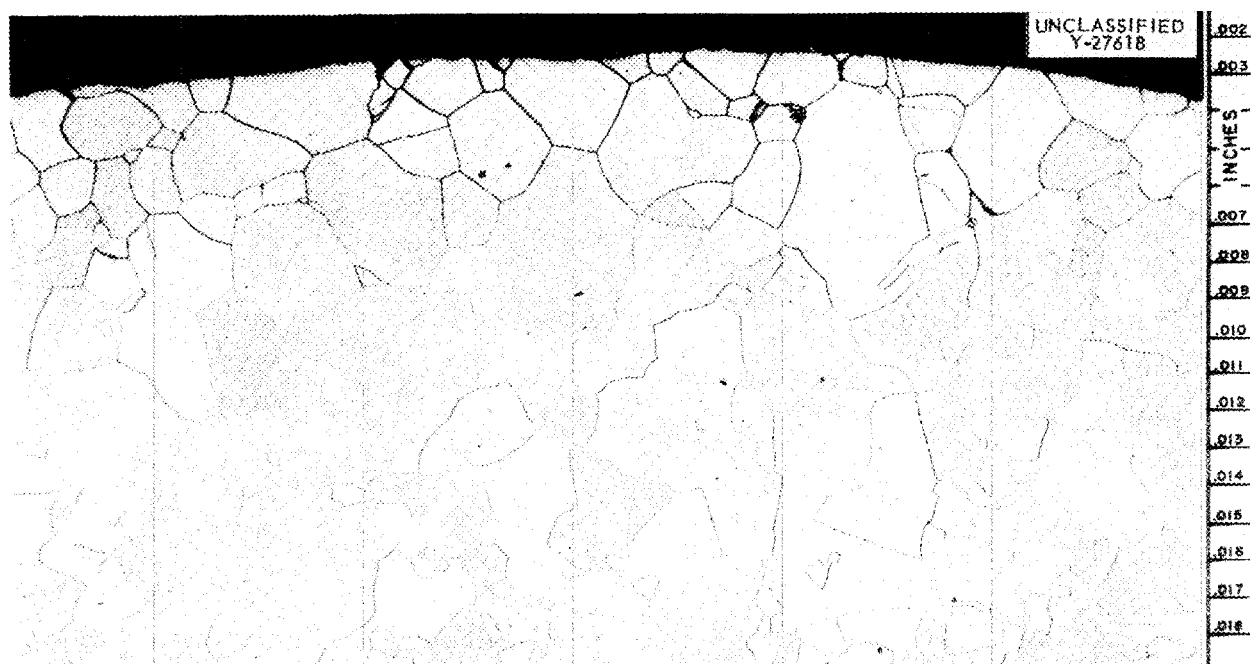
Fig. 59B. Portion of Fig. 59A. Typical Surface and Microstructure. Note intergranular attack. Etchant:  $KCN-(NH_4)_2S_2O_8$ . 200X.
