ORNL-2832

CORROSION ASSOCIATED WITH FLUORINATION  
IN THE OAK RIDGE NATIONAL LABORATORY  
FLUORIDE VOLATILITY PROCESS

CORROSION ASSOCIATED WITH FLUORINATION IN THE  
OAK RIDGE NATIONAL LABORATORY FLUORIDE VOLATILITY PROCESS

A. P. Litman and A. E. Goldman

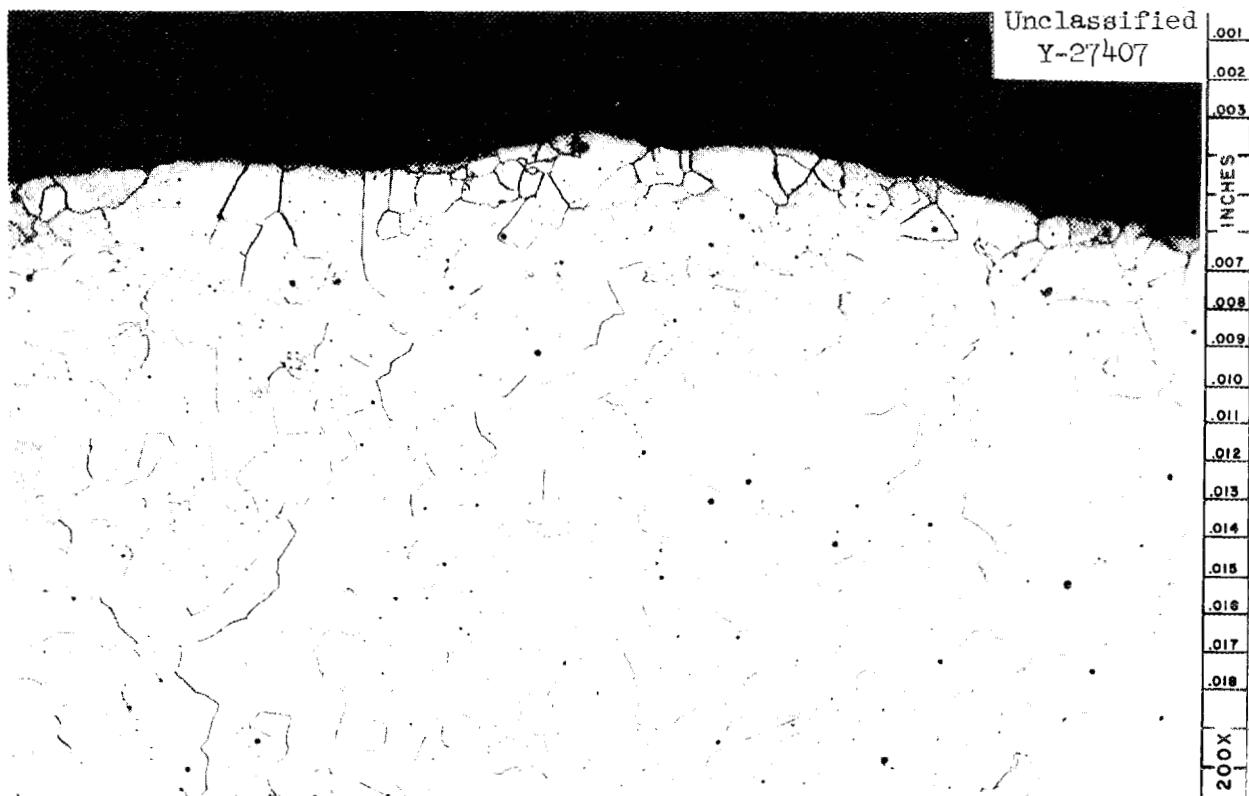
Fig. 60B. Portion of Fig. 60A. Typical Surface and Microstructure. Intergranular attack. Etchant:  $\text{HNO}_3\text{-H}_2\text{SO}_4$ . 200X.

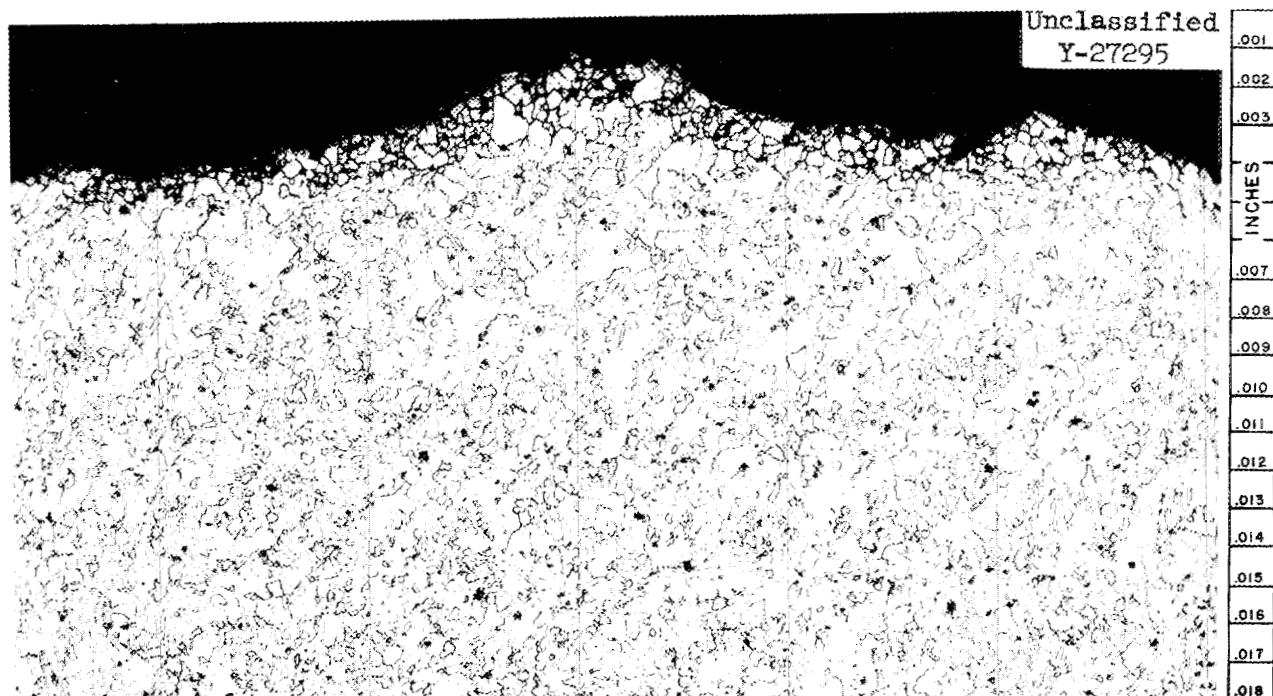
Fig. 73B. Portion of Fig. 73A. Typical Microstructure and Surface Showing intergranular attack. Etchant: Chromium regia. 200X.

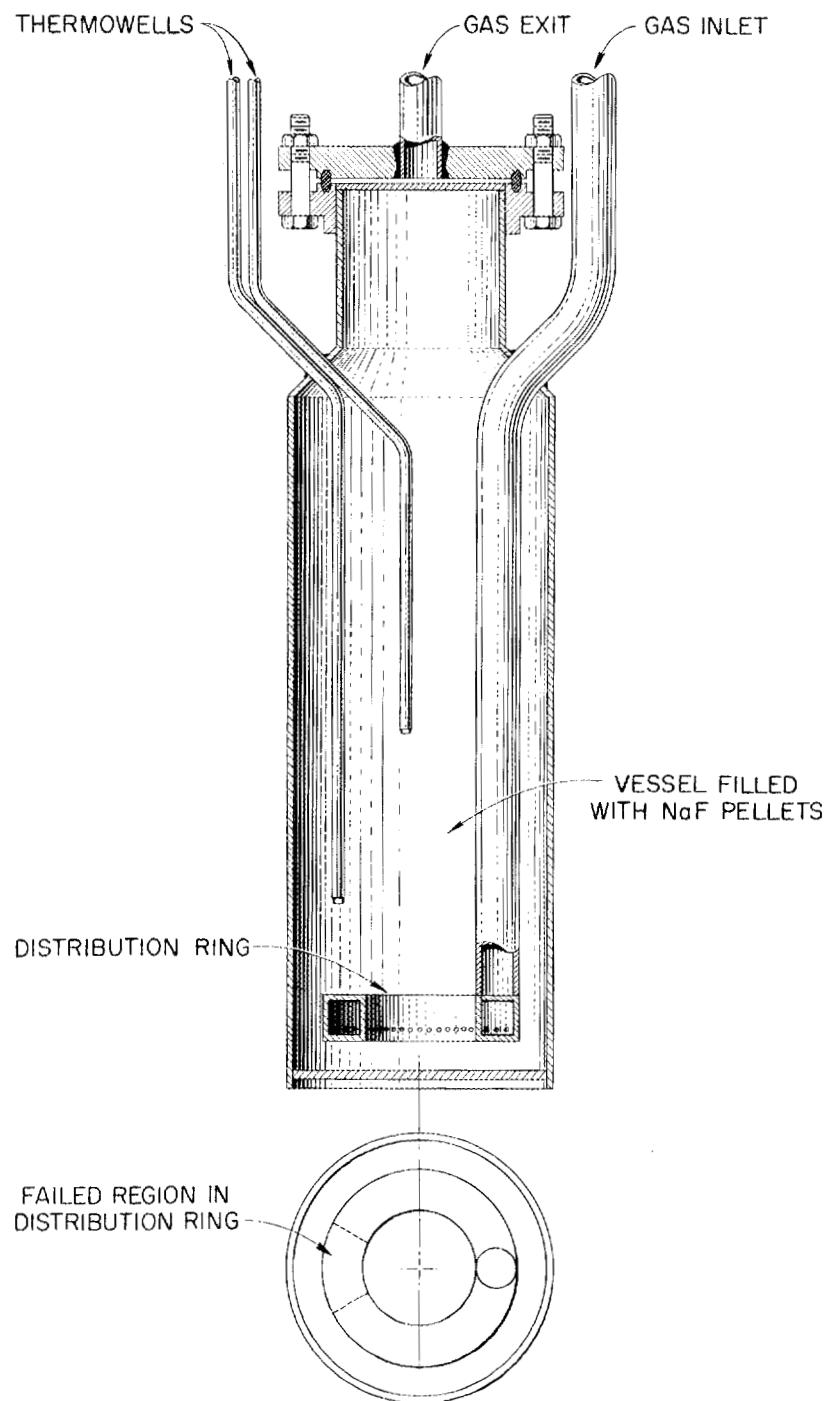
Fig. 84. Schematic View of VPP Inconel Absorber and Gas-Distribution Ring Illustrating Area of Failure.

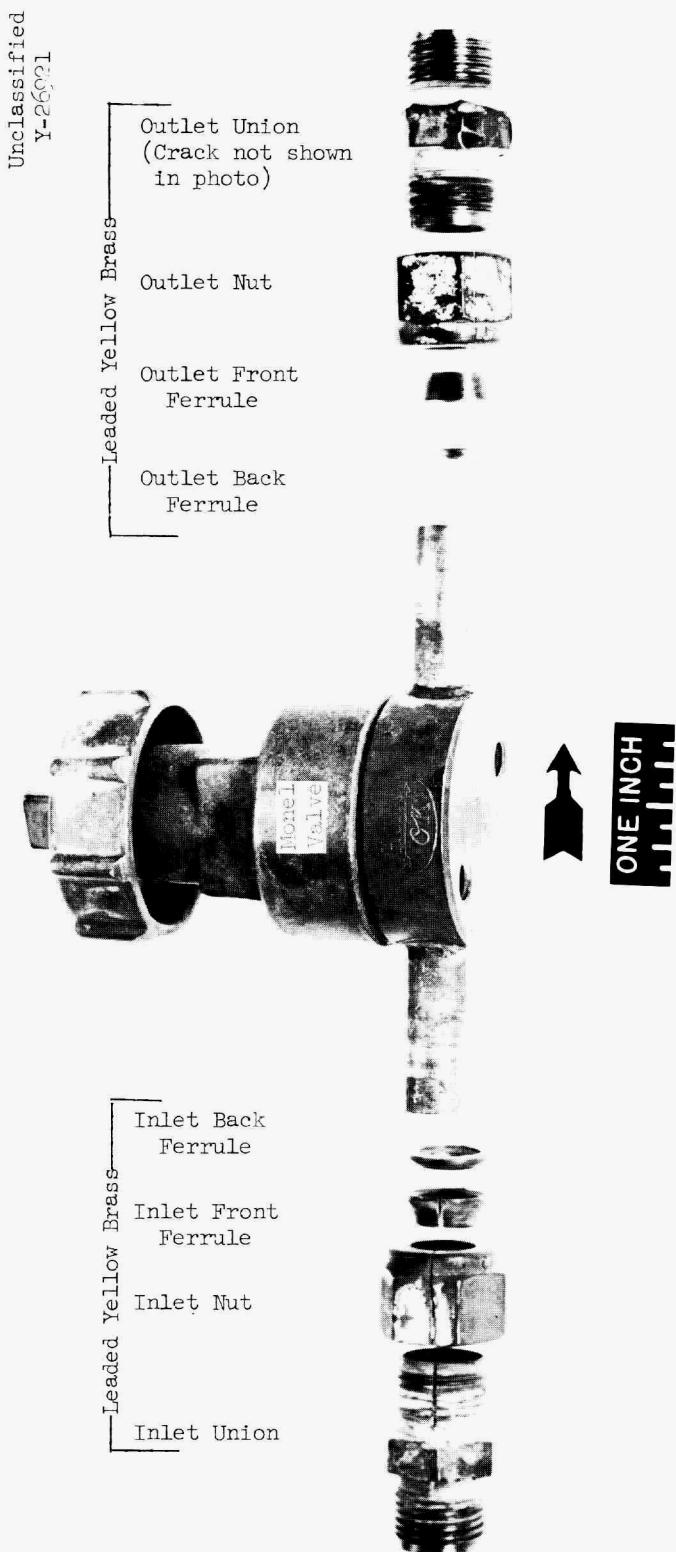
Fig. 88. Photograph of Gas Purge Line (PH-3 $\frac{1}{4}$ ) Valve and Attached Fittings. (Note fractures in inlet union, inlet nut, and inlet front ferrule.)

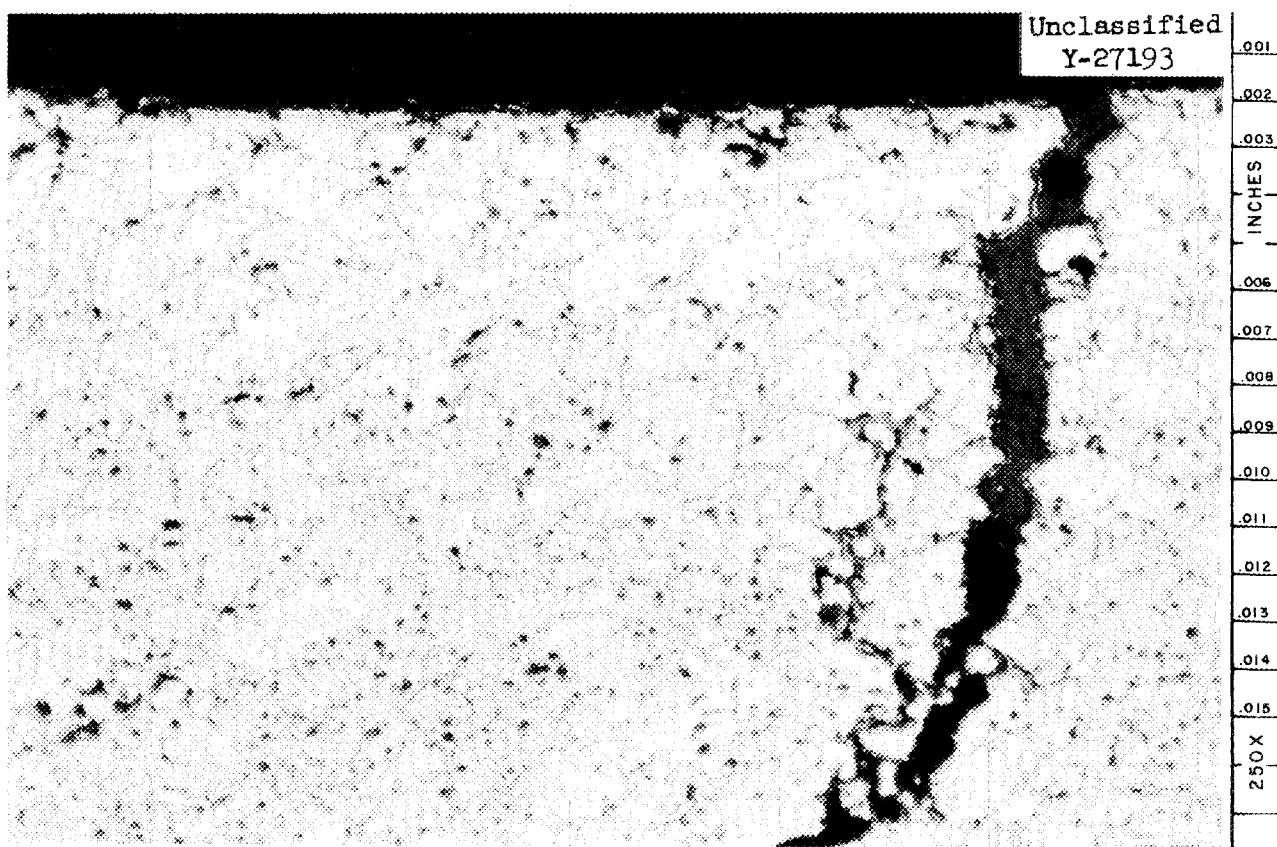
Fig. 89. VPP Leaded, Yellow Brass Inlet Back Ferrule Showing Intergranular Fracture Lined with Copper-Rich Deposits Indicative of Dezincification.  
Etchant:  $\text{NH}_4\text{OH-H}_2\text{-H}_2\text{O}$ . 250X.

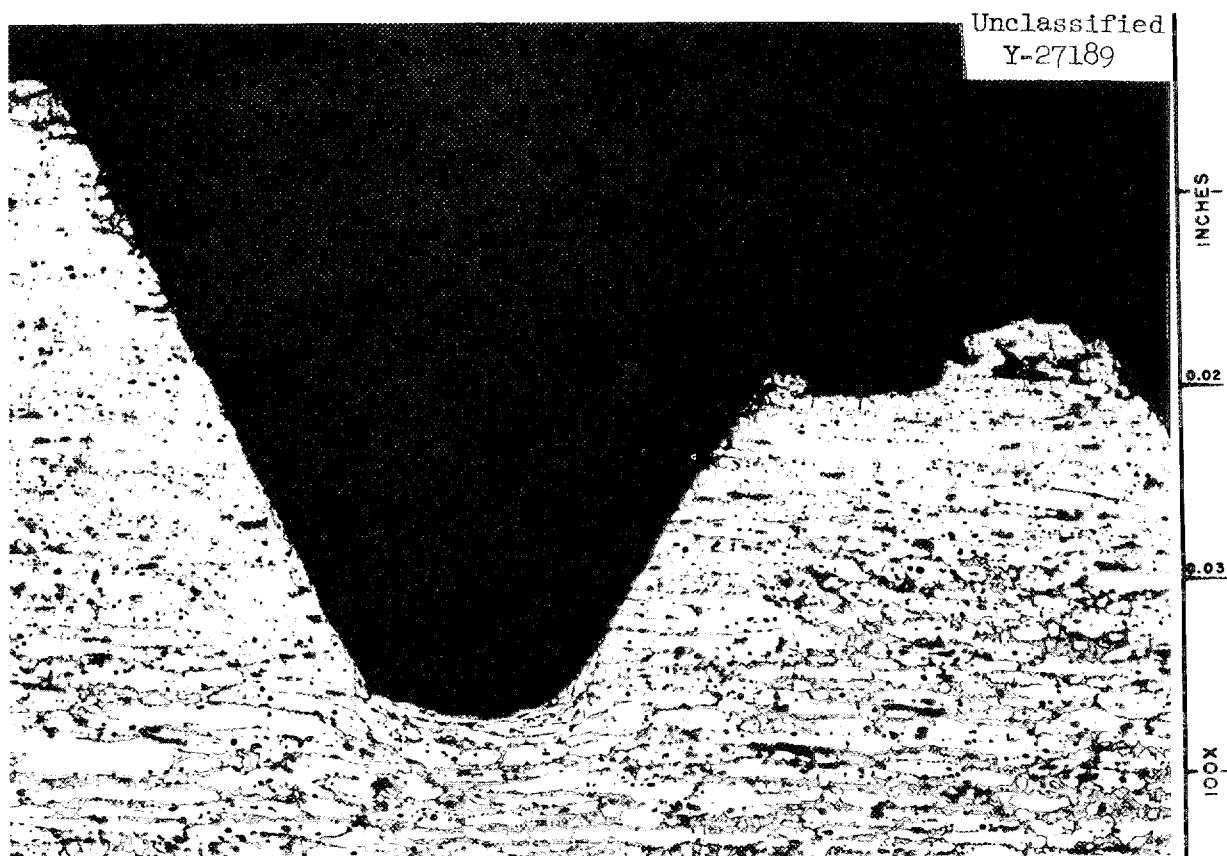
Fig. 90. VPP Leaded, Yellow Brass Inlet Union Showing General Corrosive Attack. Etchant:  $\text{NH}_4\text{OH-H}_2\text{O}_2-\text{H}_2\text{O}$ . 100X.

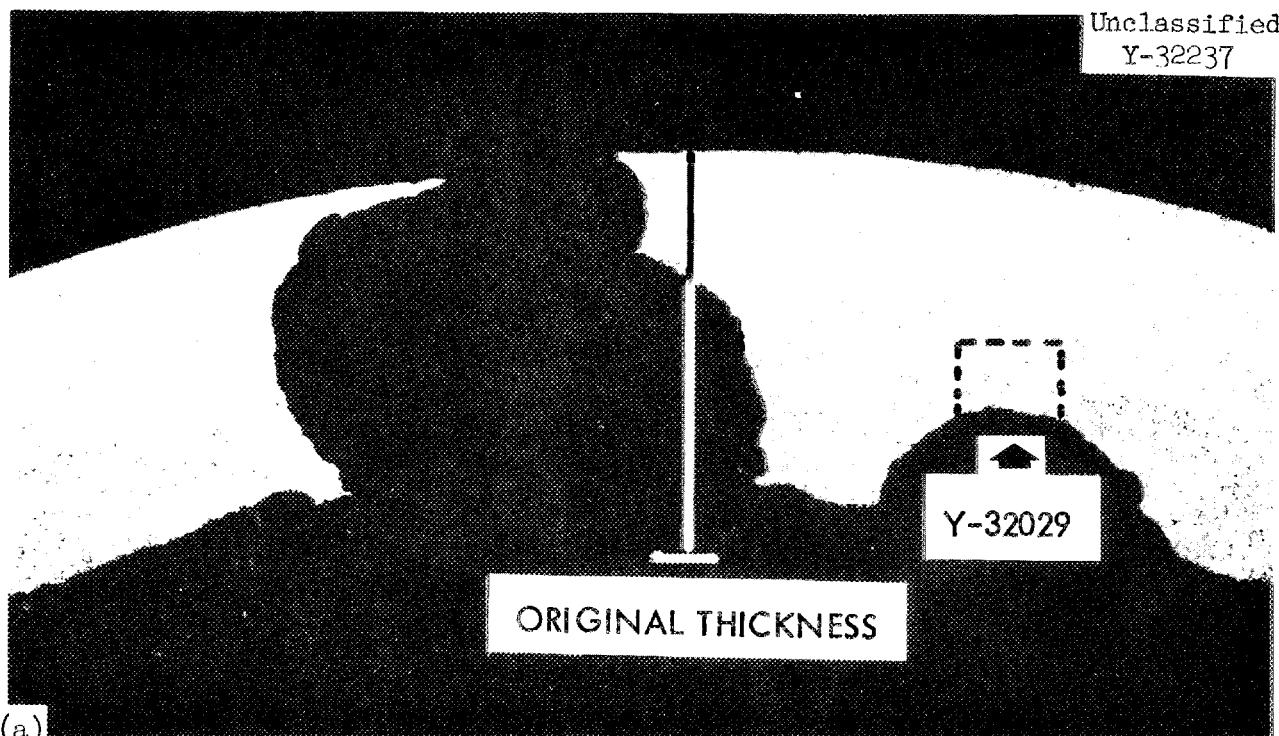
Fig. 93. Cross Sections of Gas Disposal Unit Inlet Pipe (a) Photomacrograph Showing Severe Pitting Attack. 15X. (b) Portion of Fig. 93A showing typical surface at base of pit. 500X. Etchant: Acetic-nitric-hydrochloric acid.
