ORNL-2832

CORROSION ASSOCIATED WITH FLUORINATION  
IN THE OAK RIDGE NATIONAL LABORATORY  
FLUORIDE VOLATILITY PROCESS

CORROSION ASSOCIATED WITH FLUORINATION IN THE  
OAK RIDGE NATIONAL LABORATORY FLUORIDE VOLATILITY PROCESS

A. P. Litman and A. E. Goldman

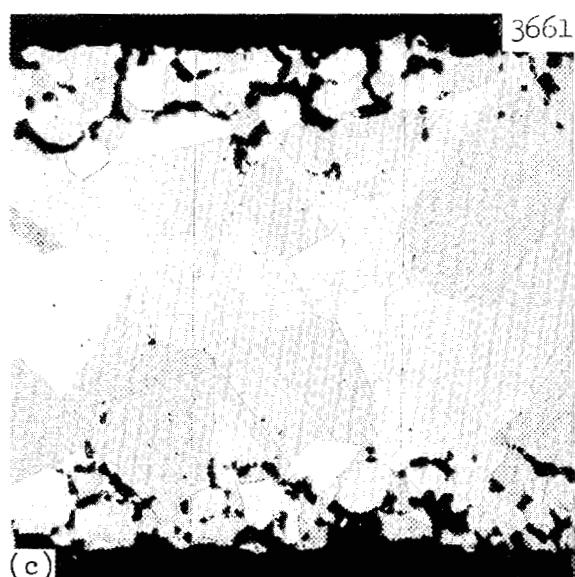
More detailed work in this field has been reported by ORGDP.<sup>16</sup> Nickel was found to form a continuous, adherent fluoride film with an undiluted fluorine atmosphere at temperatures up to about 980°C. Electron microscopy indicated that the nickel fluoride films had few flaws in the individual crystals which would permit direct access of the fluoride to the nickel surface underneath. The studies also indicated that, as the nickel fluoride film thickened, more resistance to attack was obtained. However, considerable intergranular attack of the metallic nickel was noted at temperatures of approx 815 and 980°C (Fig. 12). The depth of intergranular penetration was estimated to be 5 to 8 times the average attack as calculated from scale formation. The report indicated that the primary mechanism of attack appeared to be diffusion along the crystal boundaries.

Fig. 12. Microstructures of A Nickel Coupons (a) As Received; (b) After Exposure to  $F_2$  at  $815^{\circ}C$  for 4 hr and for 32 hr at Lower Temperatures; (c) After Exposure to  $F_2$  at  $980^{\circ}C$  for 35 hr and for 350 hr at Lower Temperatures.  
Etchant: Sodium cyanide, ammonium persulfate. 100X. Reference: C. F. Hale,  
E. J. Barber, H. A. Bernhardt, and Karl E. Rapp, High Temperature Corrosion  
Study, Interim Report for the Period, November, 1958, Through May, 1959, KL-498  
(July 28, 1959).

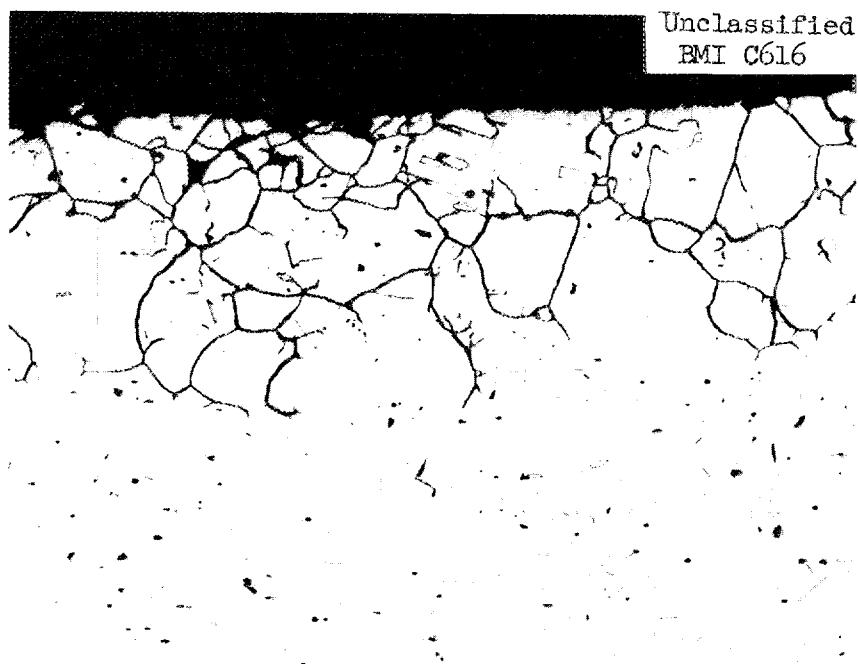
Fig. 21. Microstructure of Sample from Interior Surface of Mark II  
VPP Fluorinator 3<sup>1/4</sup> in. Below Slip-on Flange (Vapor-Salt Interface, Area A).  
Etchant: Nitric-acetic acid. 100X.

sections in all regions but penetration was deepest in the samples from the interface and salt regions. Maximum grain-boundary attack was found to be 33 mils in the salt-phase sample A-3b which was in the vicinity of the shell to head girth weld.

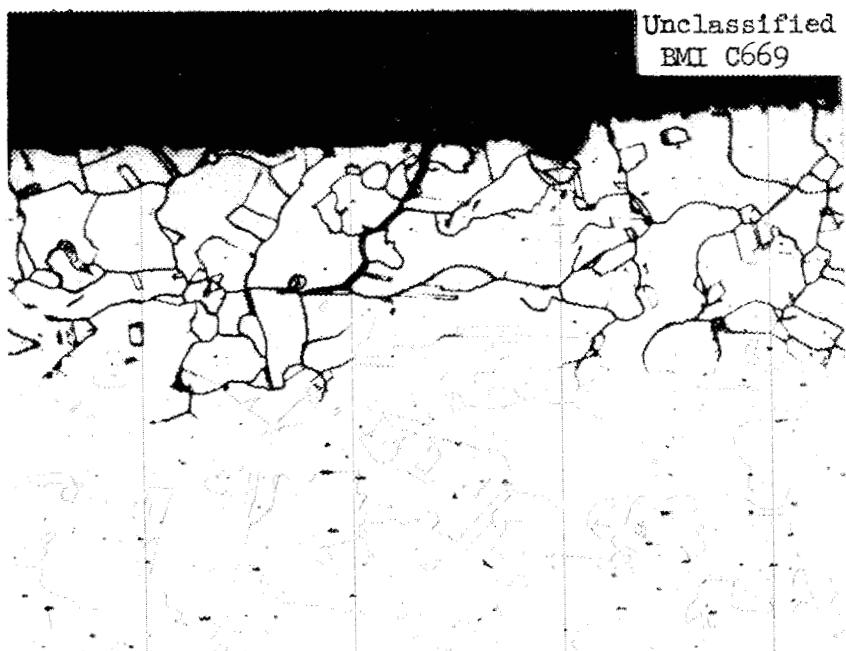
Fig. 22. Microstructure of Sample from Interior Surface of Mark II  
VPP Fluorinator 42 in. Below Slip-on Flange (Salt Phase, Area C).  
Etchant: Nitric-acetic acid. 100X.

In the salt region of Area C, a few small intergranular cracks were found on the interior of the vessel wall. A typical crack is shown in the unetched condition in Fig. 26 and in the etched condition in Fig. 22. Very pronounced darkening of the grain boundaries to approximately the same depth as the crack was evident after etching.

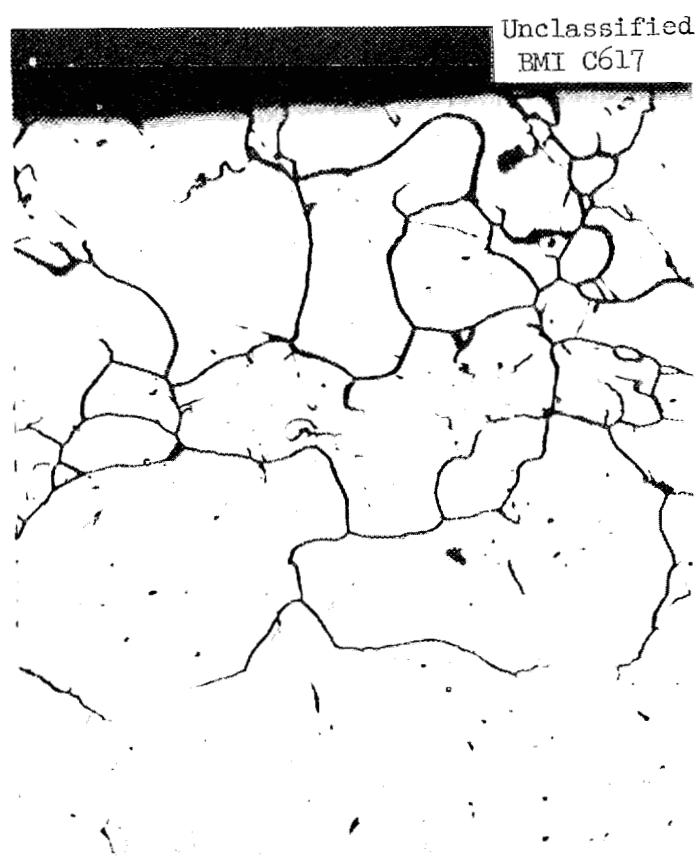
Fig. 23. Microstructure of Sample from Interior Surface of Mark II  
VPP Fluorinator Approx 47 in. Below Slip-on Flange (Salt Phase, Area A)  
Vicinity of Girth Shell to Bottom Head Weld. Etchant: Nitric-acetic acid.  
100 X.

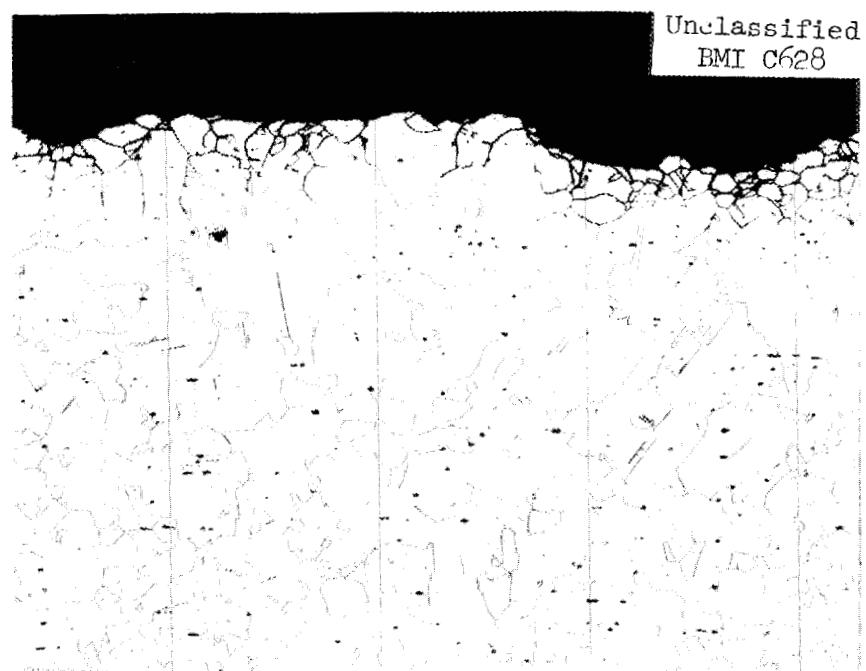
A pitting attack was found on the interior wall near Area C in the vapor region, about 3 in. down from the bottom of the slip-on flange. Figure 24 shows the appearance of the surface at 3X, and Fig. 25 shows a metallographic section through this pitted area. The latter indicates a level of intergranular penetration similar to that found in other upper-vapor regions. The depth of intergranular attack did not appear to vary from top to bottom of the pits.

Fig. 25. Microstructure of Sample from Interior Surface of Mark II VPP Fluorinator 3 in. Below Slip-on Flange (Vapor Phase, Area C) in Region of Pitting-Type Attack. Etchant: Nitric-acetic acid. 100X.

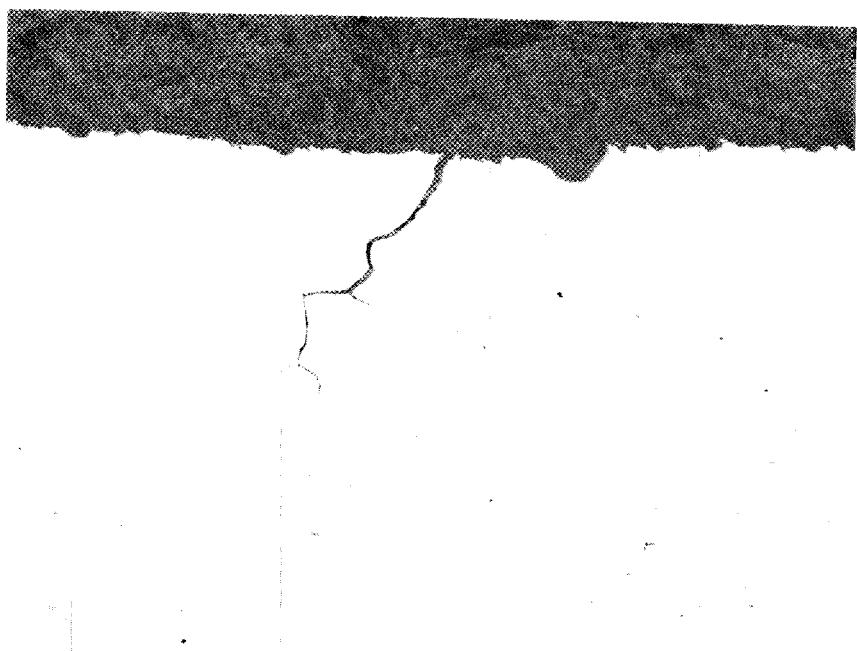
Unclassified  
EMI C668

Fig. 26. Photomicrograph of Sample from Interior Surface of Mark II VPP Fluorinator 42 in. Below Slip-on Flange (Salt Phase, Area C) Showing Crack Easily Visible Before Sectioning. As-polished. 100X.

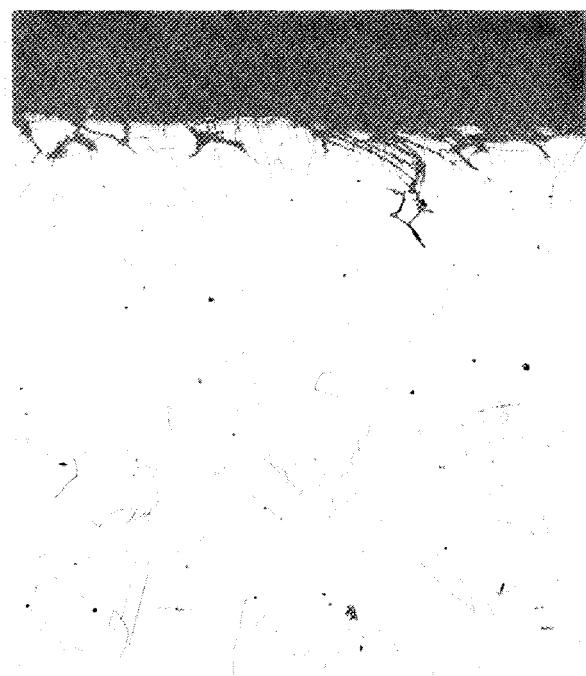
Unclassified  
BMI C618

The exterior of the vessel displayed a corrosive attack which appeared to be intergranular in nature. Penetration varied from 1-6 mils, the maximum occurring at or below the vapor-salt interface (Fig. 28, Sample A-3b). However, there was one exception to this pattern. A grain-boundary penetration of approx 12 mils in depth was found on the exterior surface opposite the pitted region in the vapor near Area C.

Fig. 28. Microstructure of Sample from Exterior Surface of Mark II VPP Fluorinator Approx 47 in. Below Slip-on Flange (Salt Phase, Area A) Showing Result of Air Oxidation. Etchant: Nitric-acetic acid. 100X.

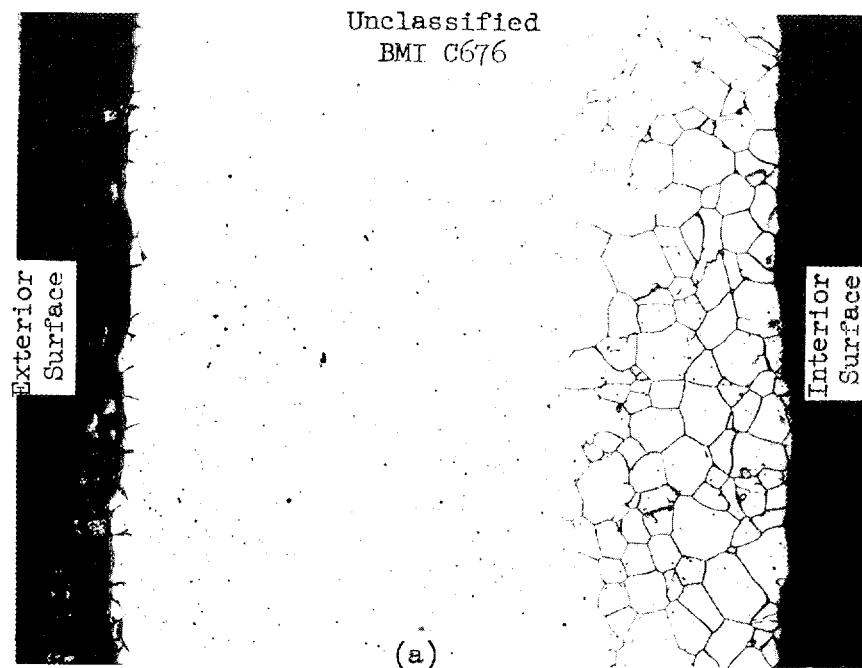
Fig. 32. Microstructures of Cross Sections Through A Nickel Fluorine Inlet Tubes from (a) Mark IIIA Draft Tube (b) Mark IIB Draft Tube.  
Etchants: Nitric-acetic acid. 70X.

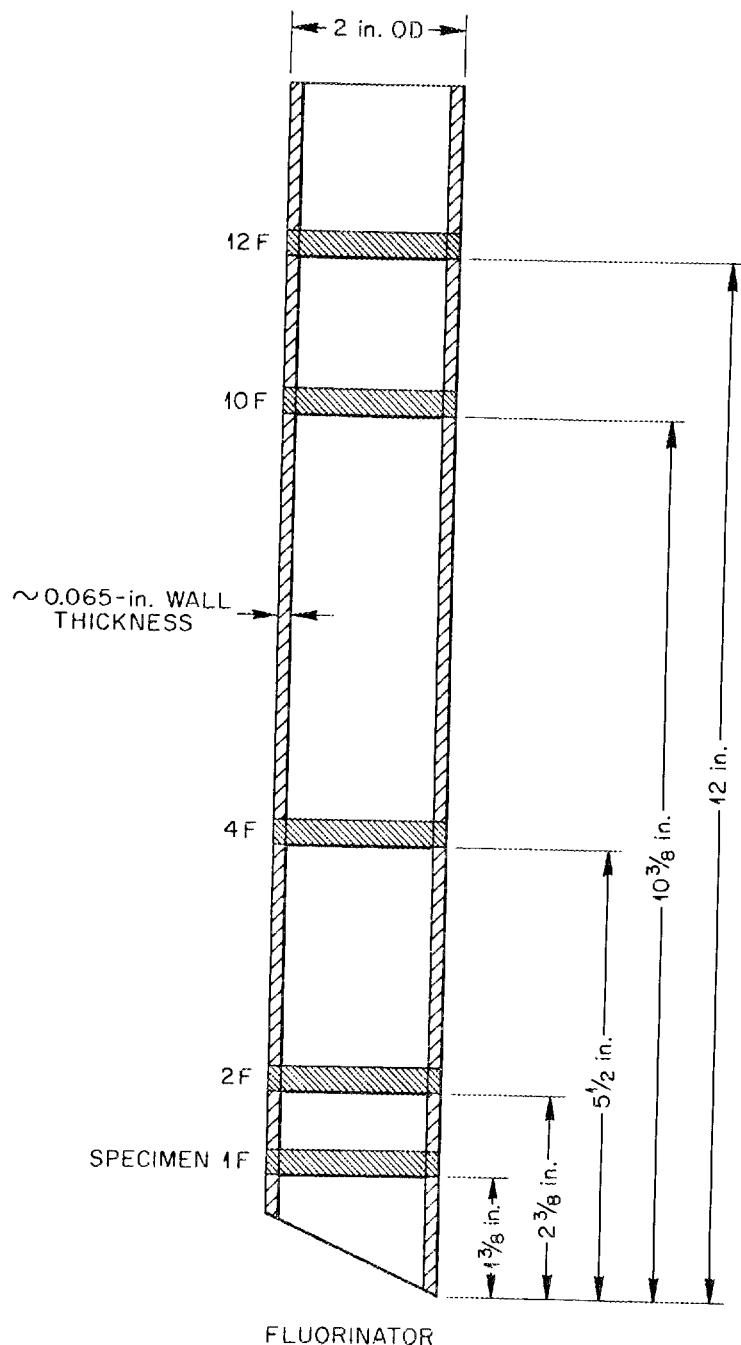
UNCLASSIFIED  
ORNL-LR-DWG 49162

After exposure operations, areas from the vessel were selected for micrometer measurements and metallographic examination. Figure 33 shows a cross section of the vessel and the location of the sample areas removed for study. A summary of corrosive attack found is shown in Table XII where total losses are reported in mils per hour, based on fluorine sparge time, and mils per month, based on residence time in molten salts. Representative photomicrographs are grouped in Fig. 34.

Fig. 33. Cross Section of the Chemical Development Section A Inconel Fluorinator. Metallographic specimens were removed as shown.

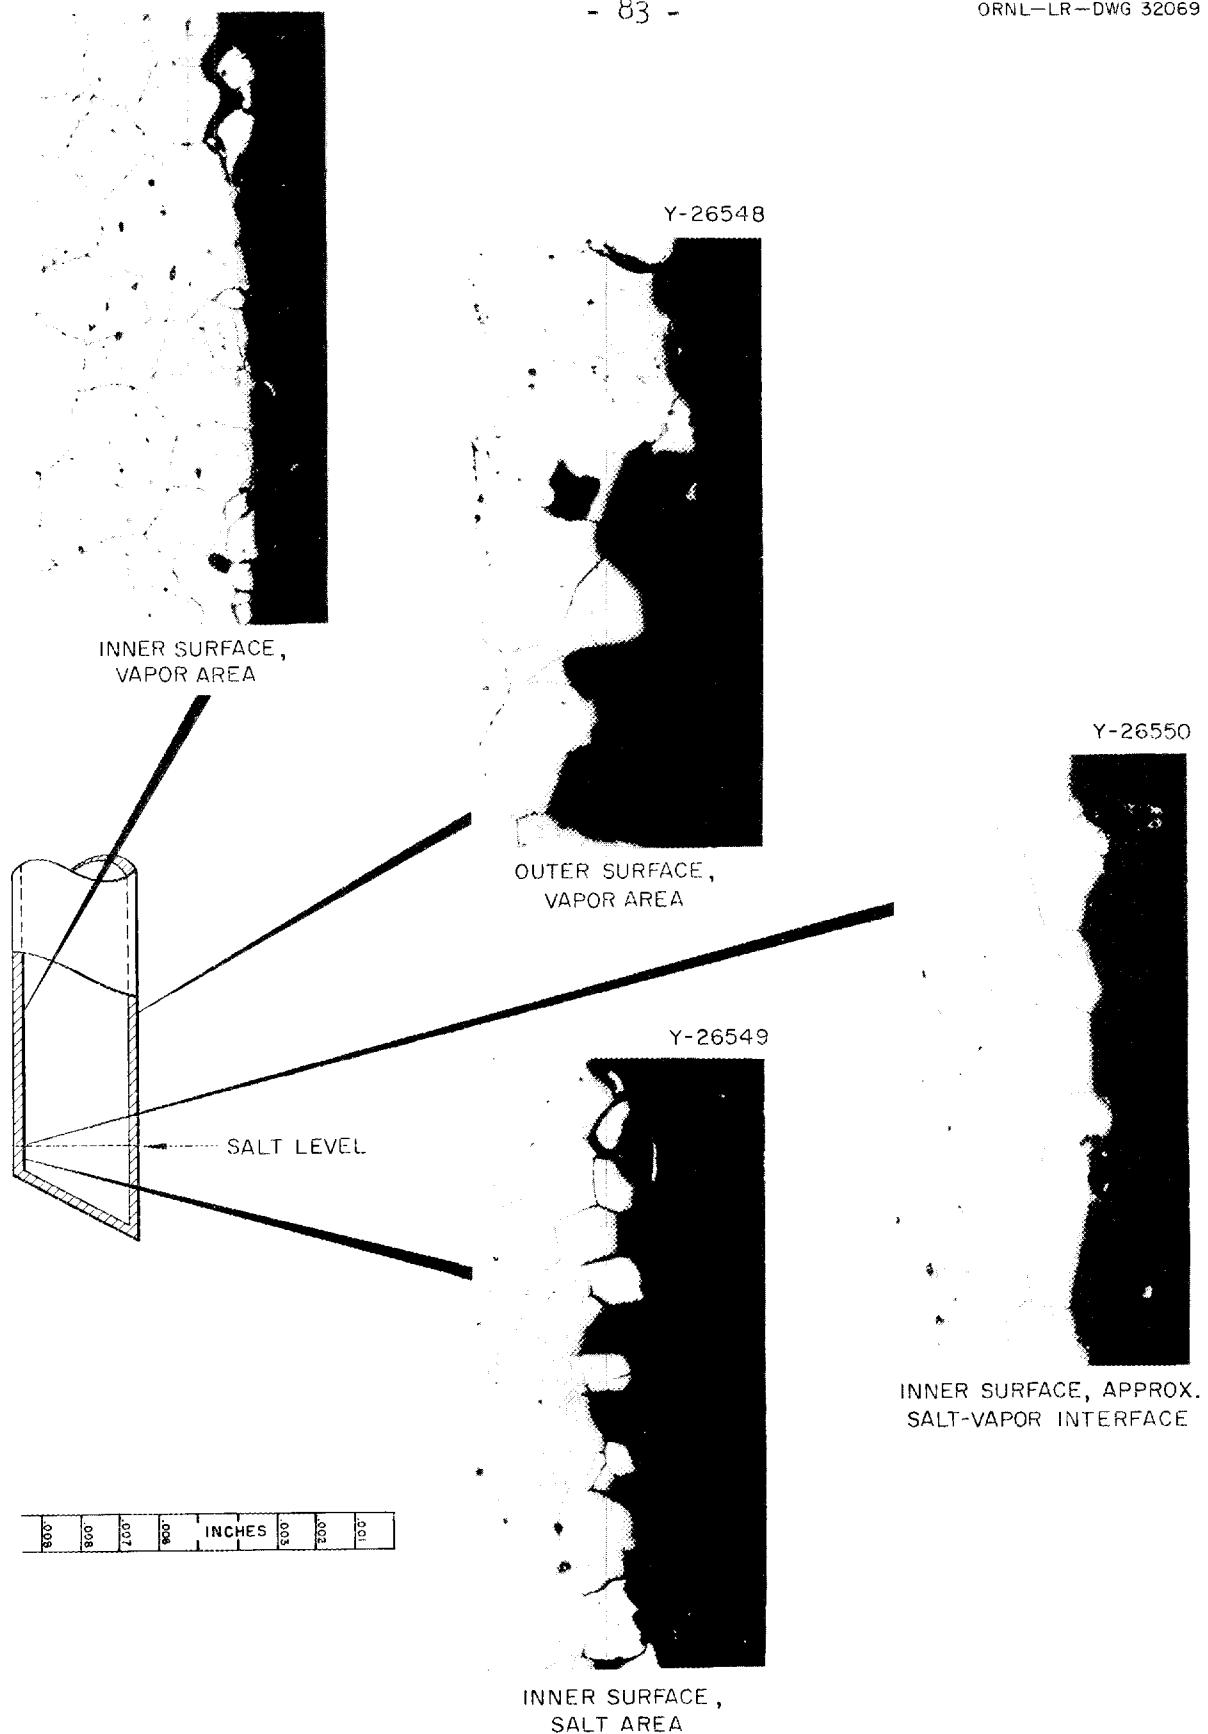
UNCLASSIFIED  
ORNL-LR-DWG 32069

In the Inconel bench fluorinator, it appears that after intergranular penetration had proceeded to about one grain in depth, many of the affected grains could not be retained in position by the remainder of the grain-boundary material and sloughed off, leaving new material ready for corrosive attack. This method of metal loss would seem devastating to the vessel

Fig. 34. Typical Microstructures of Samples Removed from Chemical Development Inconel Fluorinator. Etchant: Glyceria regia. 250X. Reduced 32%.

in service, but the anomaly of the situation is that maximum wall-thickness losses occurred in the Inconel vessel at the vapor-salt interface and at that point no evidence of intergranular attack could be found.

No explanation can be given for the interior wall interface anomaly described nor can one be given for the heavy exterior intergranular attack which has localized in a cooler region of this Inconel fluorinator (see Fig. 34).

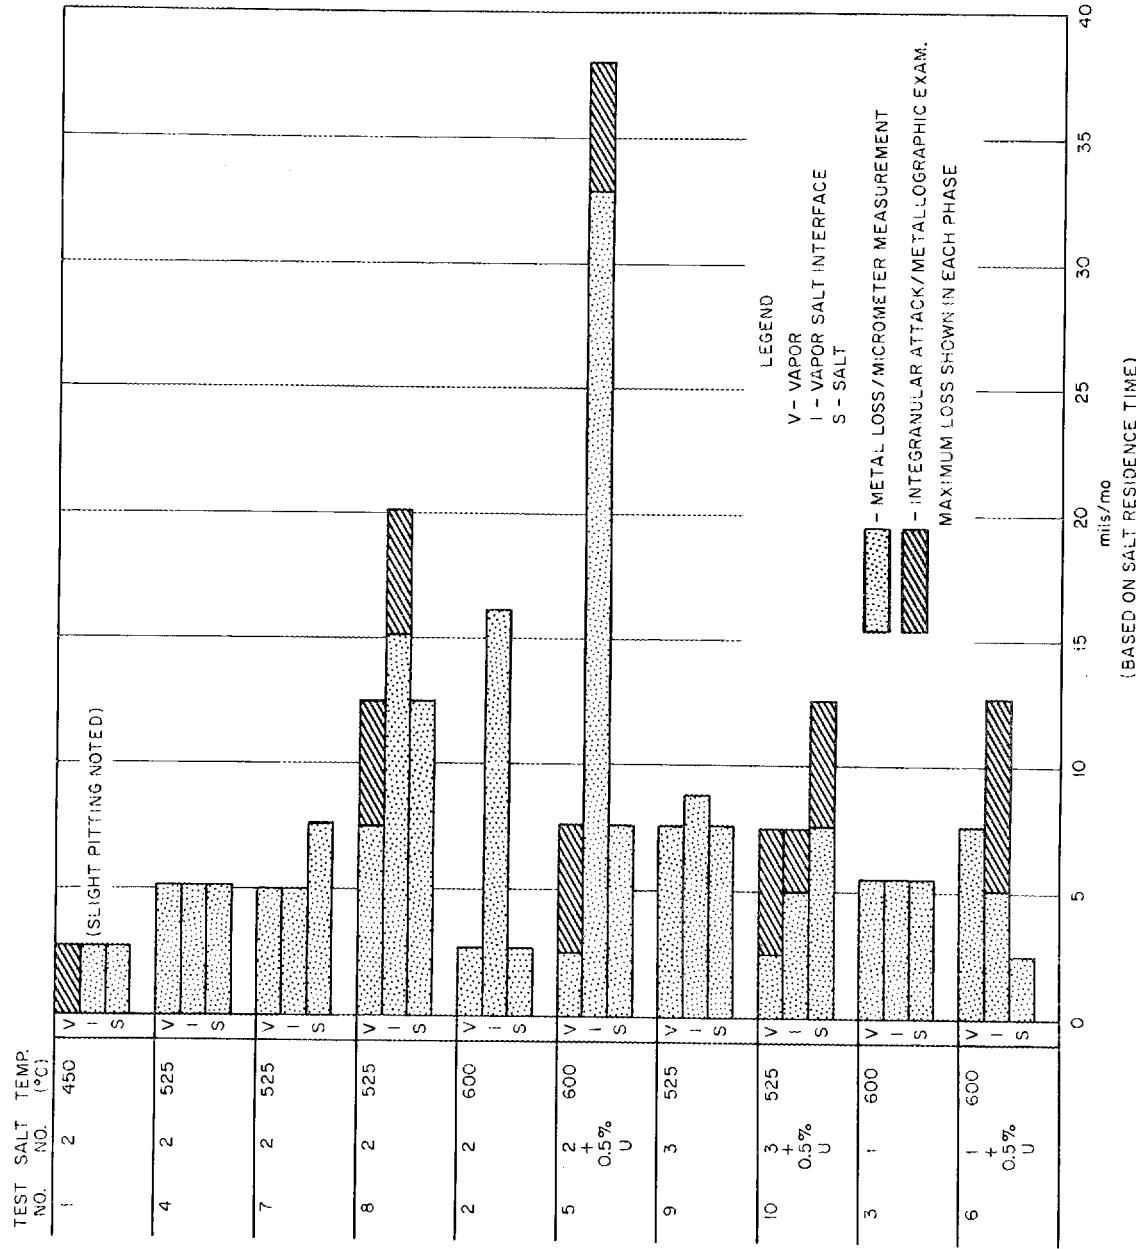
In all tests, the salts were kept molten for over 200 hr while under a nitrogen purge. This was done to facilitate the test procedure, that is, avoid remelting salts for the next fluorine test period. Figures 36 and 37 illustrate the corrosion results obtained by micrometer measurements and

Fig. 36. Summary of Corrosion on A Nickel Miniature Fluorinator Using Different Process Flowsheets.

metallographic examinations of specimens removed from the vessels. The losses are reported both in mils per hour of fluorine sparge and mils per month based on total residence time in molten salts for comparison with other studies. Figures 38 through 42 show representative photomicrographs from this test series.

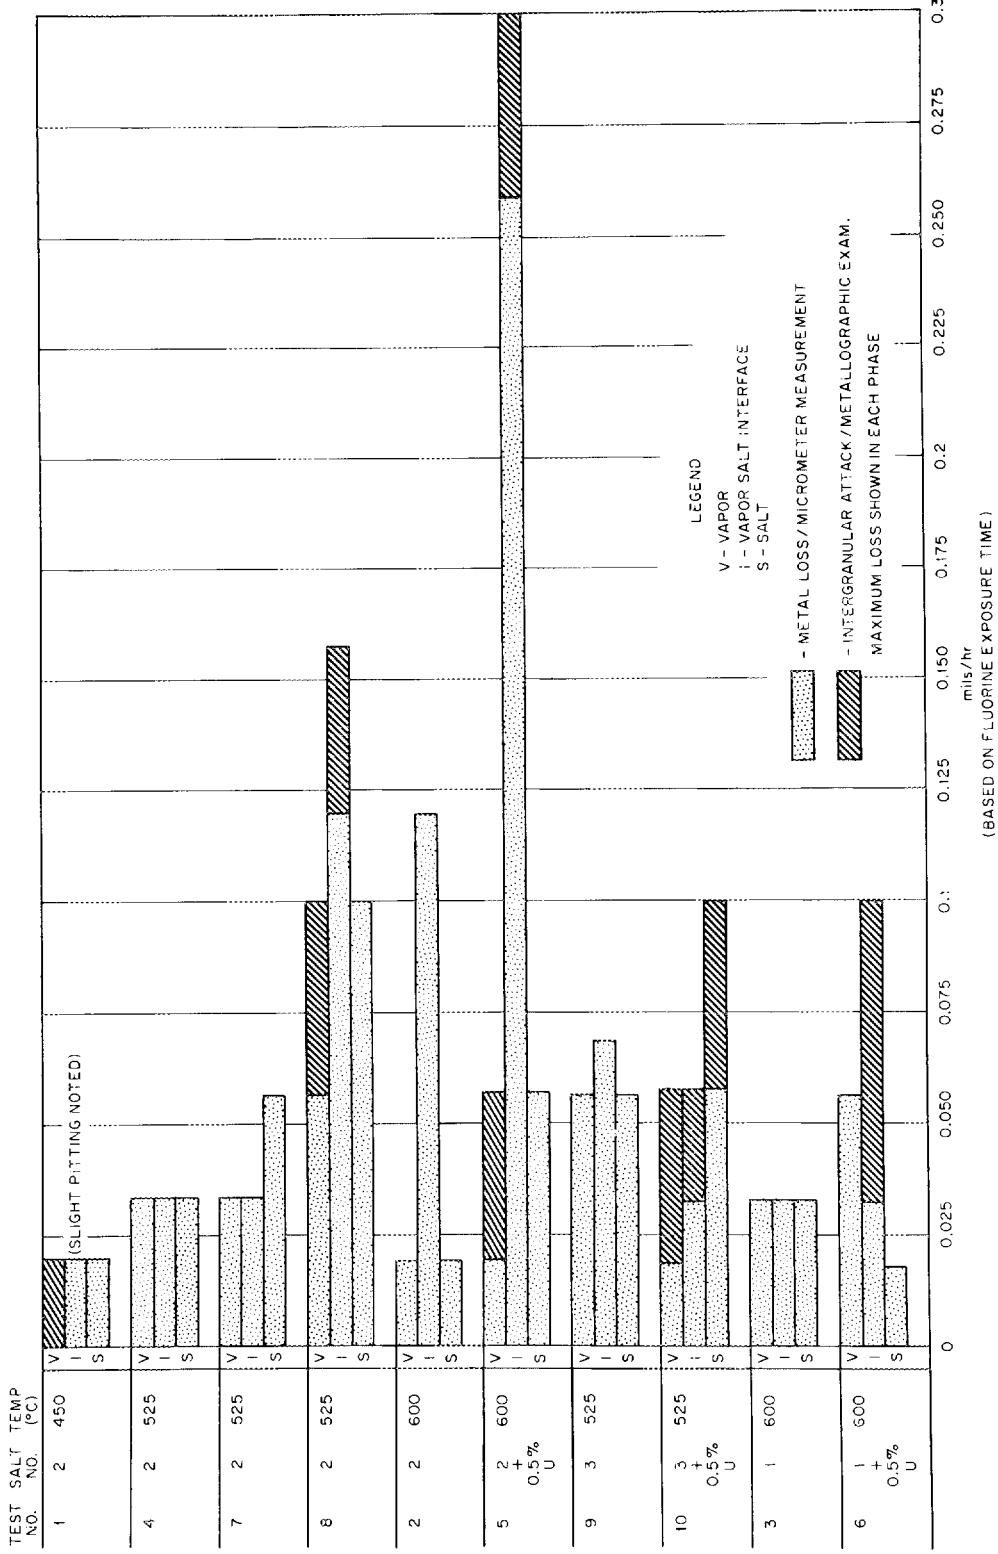
Fig. 37. Summary of Corrosion on A Nickel Miniature Fluorinators Using Different Process Flowsheets.

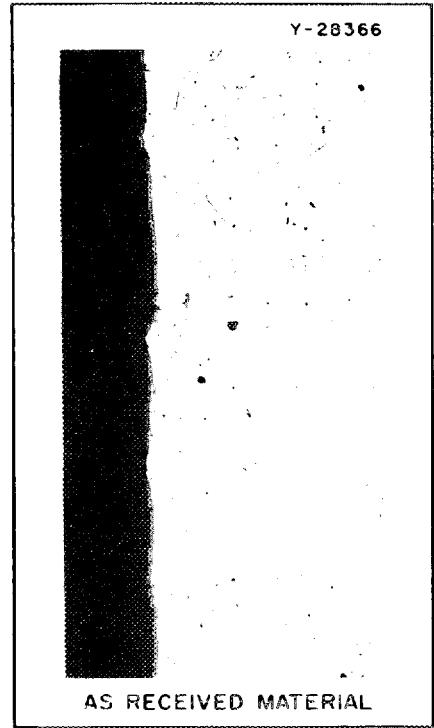
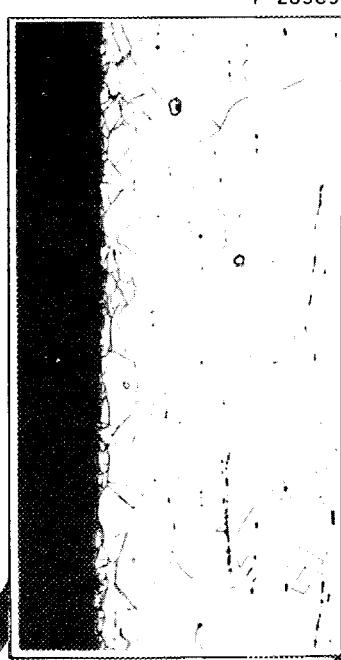
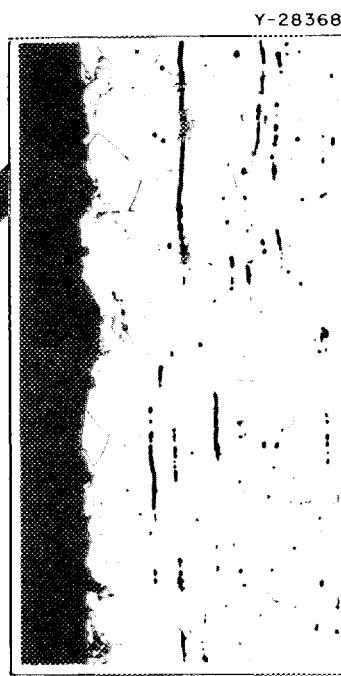
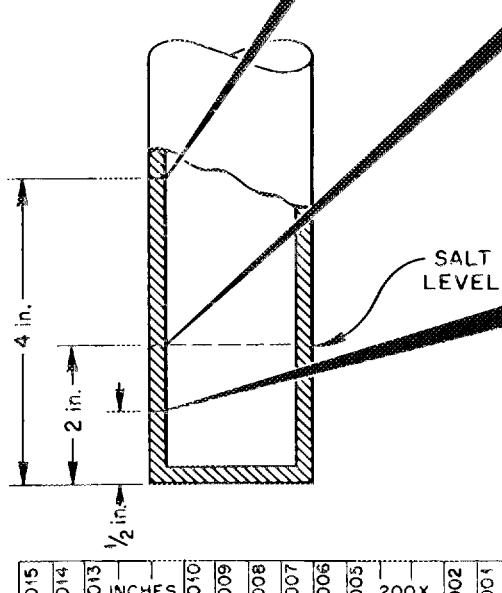
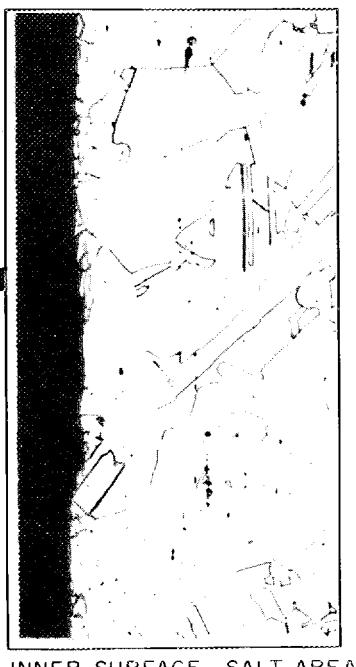
Fig. 38. Typical Microstructures of Samples from A Nickel Miniature Test Fluorinator No. 1. Etchant: Acetic-nitric-hydrochloric acid. 200X.

Lowering the process temperature to 450°C and utilizing the same lithium-bearing salt (No. 2) reduced corrosive attack to the lowest levels found in this test series. These results were provided by vessel No. 1 where the approximate losses were 0.02 mil/hr, based on fluorine sparge time. This is especially significant since lithium-sodium-zirconium fluoride salt mixtures can be used in the volatility process at lower operating temperatures than the NaF-ZrF<sub>4</sub> composite system because of the lower liquidus line of the lithium-bearing system.

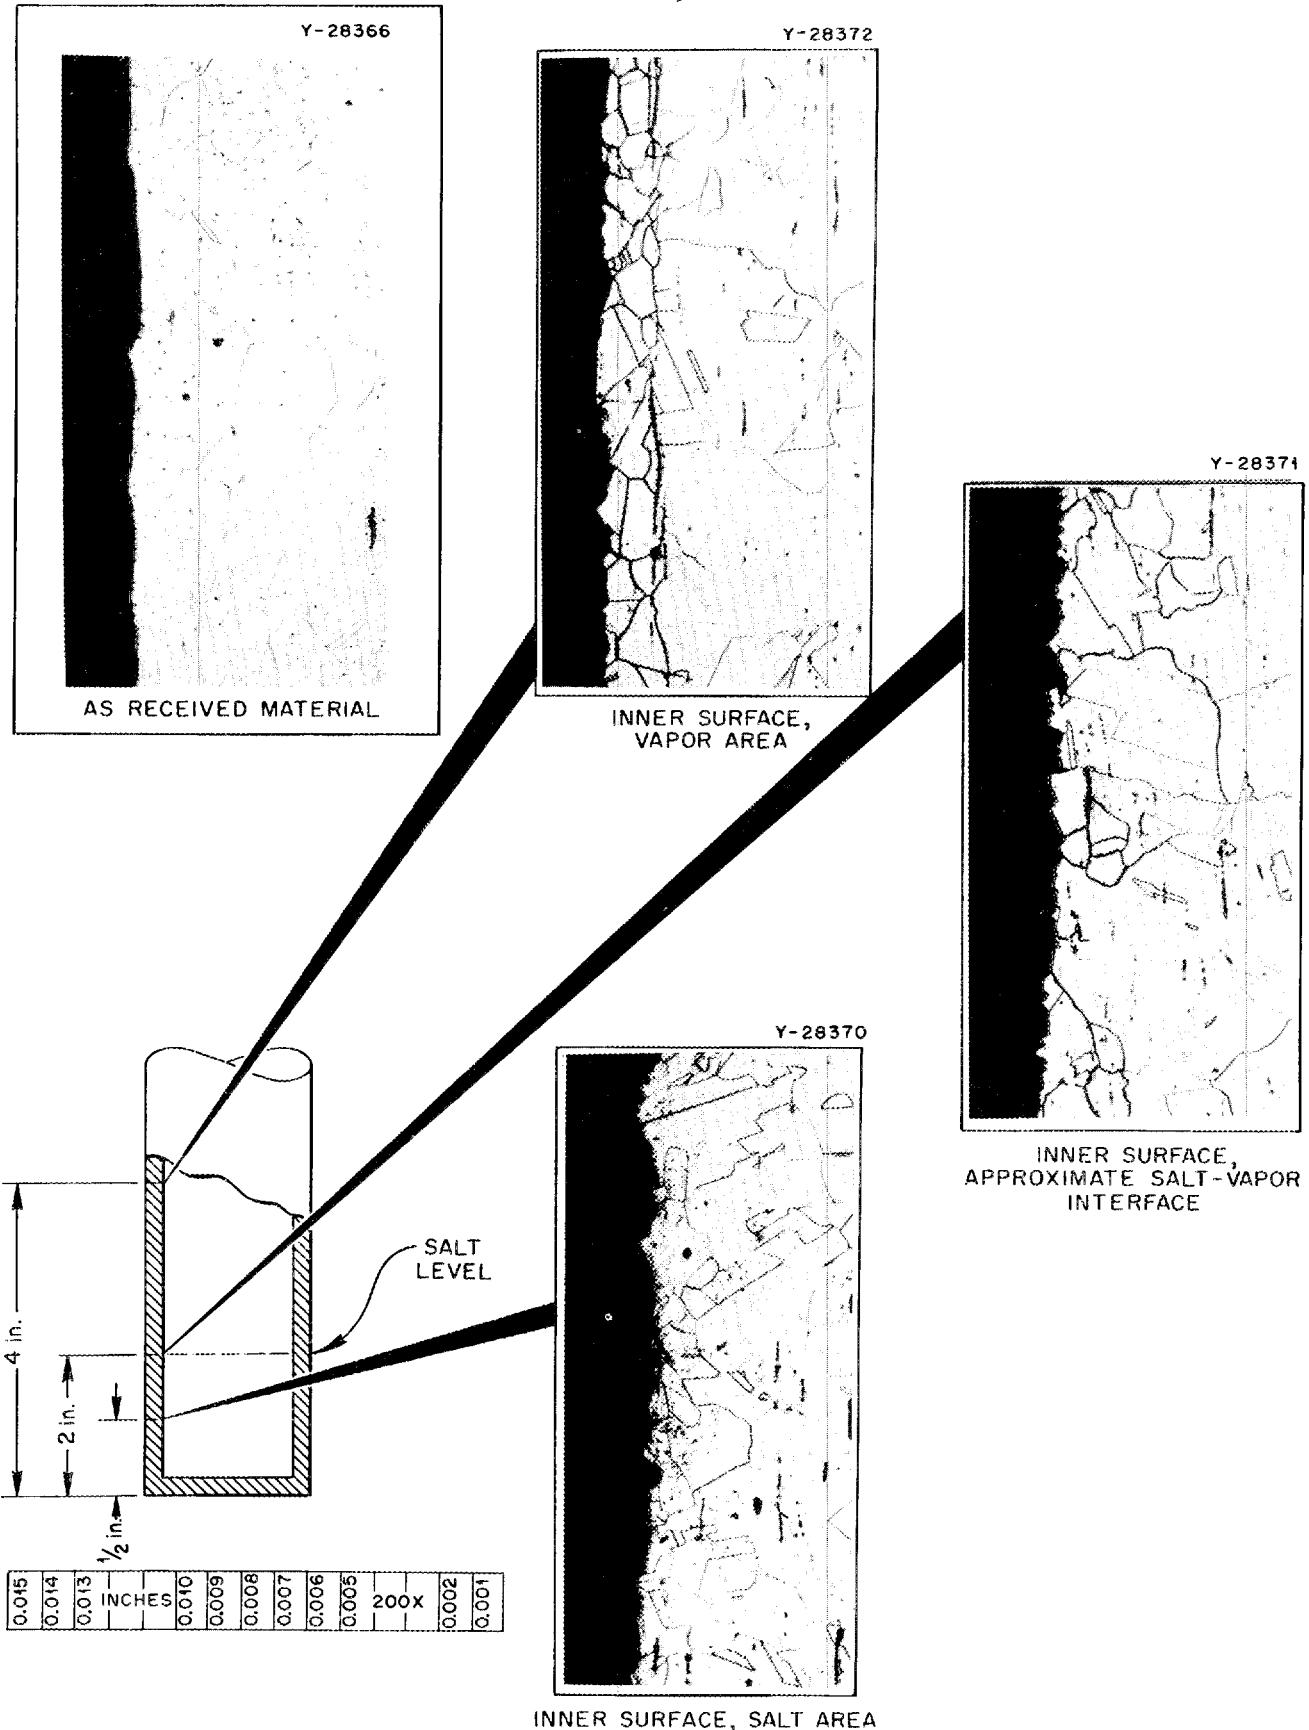
Fig. 39. Typical Microstructures of Samples from A Nickel Miniature Test Fluorinator No. 5. Etchant: Acetic-nitric-hydrochloric acid. 200X.

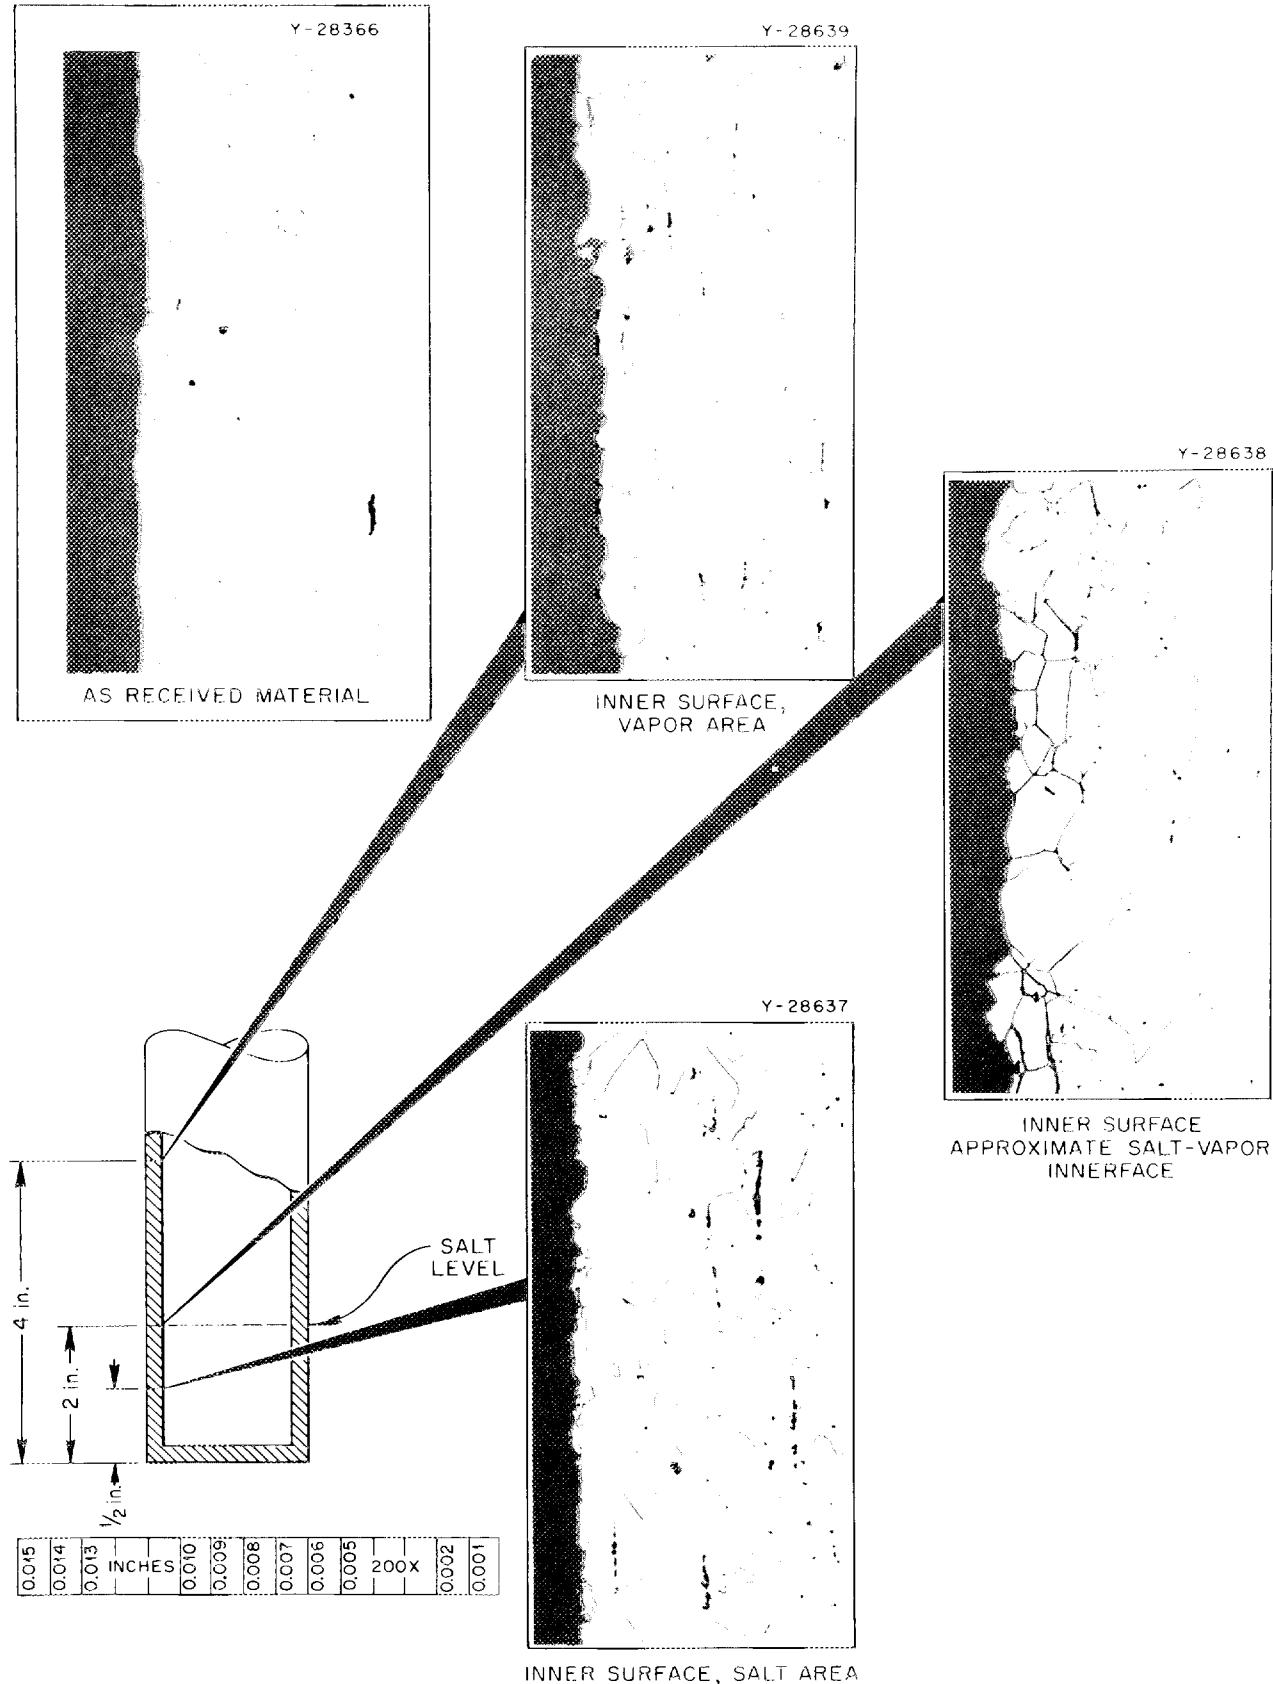
Fig. 40. Typical Microstructures of Samples from A Nickel Miniature Test Fluorinator No. 6. Etchant: Acetic-nitric-hydrochloric acid. 200X.

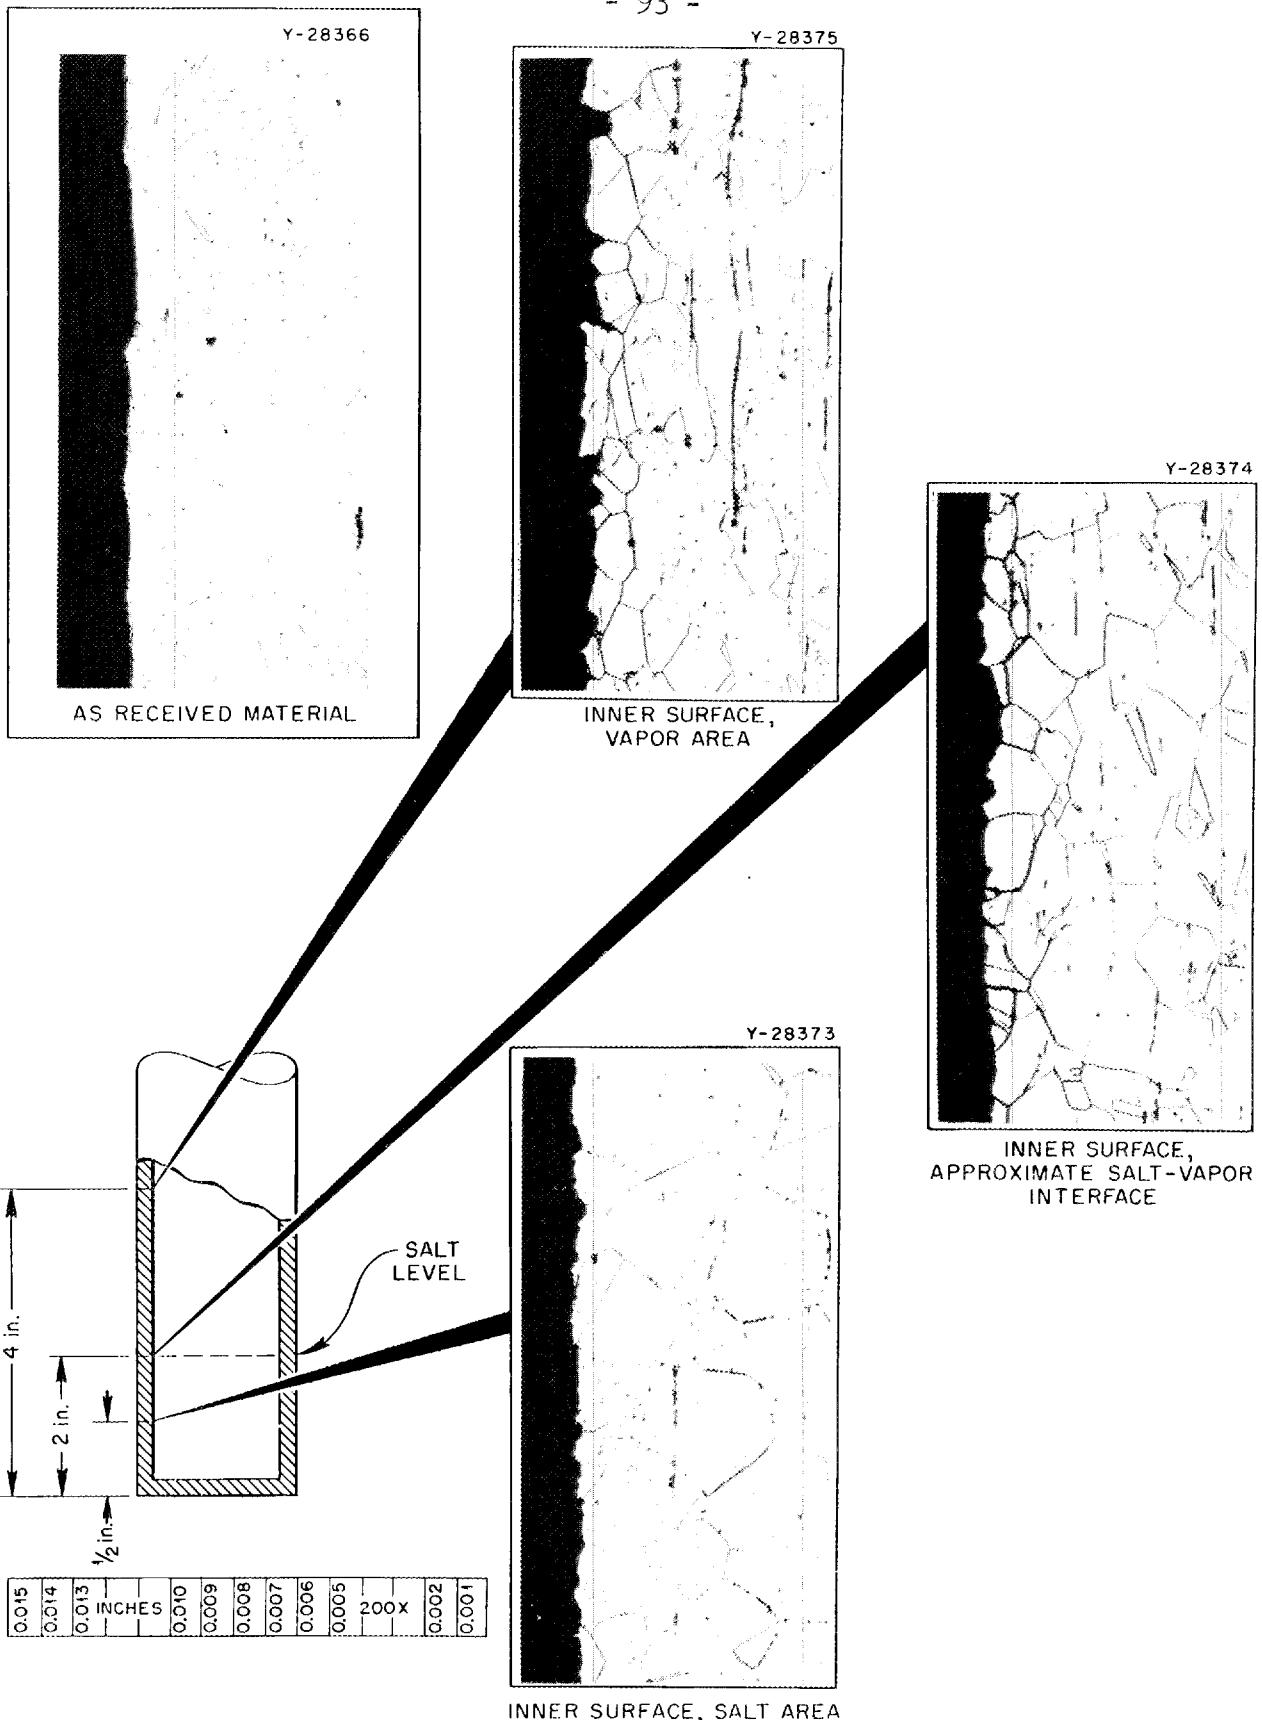
Lowering the temperature of the reactor containing the same LiF-bearing salt, LiF-NaF-ZrF<sub>4</sub> (26-37-37 mole %), to 525°C produced erratic corrosion results. Two of the vessels, Nos. 4 and 7, showed uniform, comparatively small metal losses in all regions while vessel No. 8 showed an increased attack, especially at the vapor-salt interface. Intergranular attack was also exhibited by vessel No. 8. As shown in Table XIII, vessel No. 8 was in a downstream position from vessels Nos. 4 and 7, and the deviation in behavior may, therefore, have been the result of carry-over and collection of certain constituents conducive to greater corrosive attack.

Fig. 41. Typical Microstructures of Samples from A Nickel Miniature Test Fluorinator No. 8. Etchant: Acetic-nitric-hydrochloric acid. 200X.

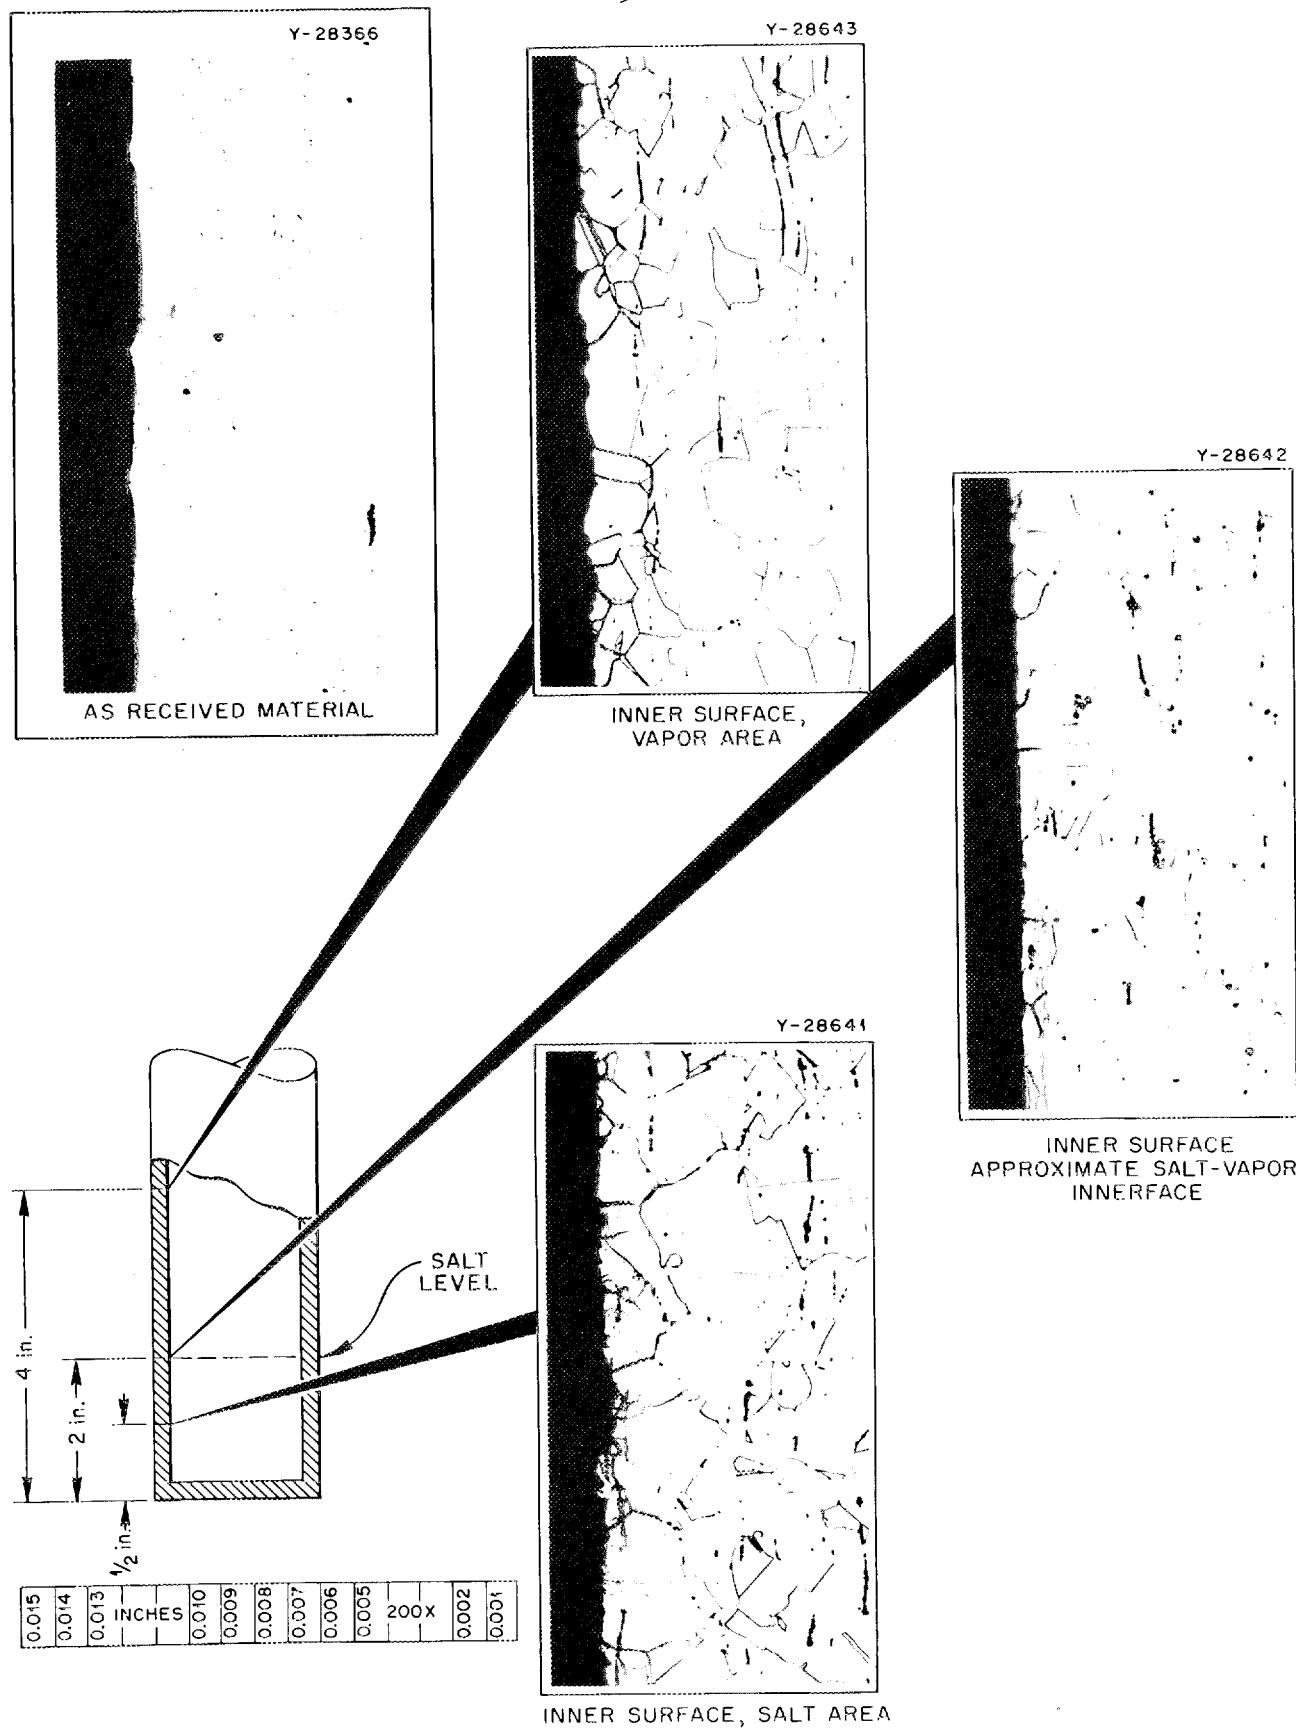
Fig. 42. Typical Microstructures of Samples from A Nickel Miniature Test Fluorinator No. 10. Etchant: Acetic-nitric-hydrochloric acid. 200X.
