ORNL-2832

CORROSION ASSOCIATED WITH FLUORINATION  
IN THE OAK RIDGE NATIONAL LABORATORY  
FLUORIDE VOLATILITY PROCESS

CORROSION ASSOCIATED WITH FLUORINATION IN THE  
OAK RIDGE NATIONAL LABORATORY FLUORIDE VOLATILITY PROCESS

A. P. Litman and A. E. Goldman

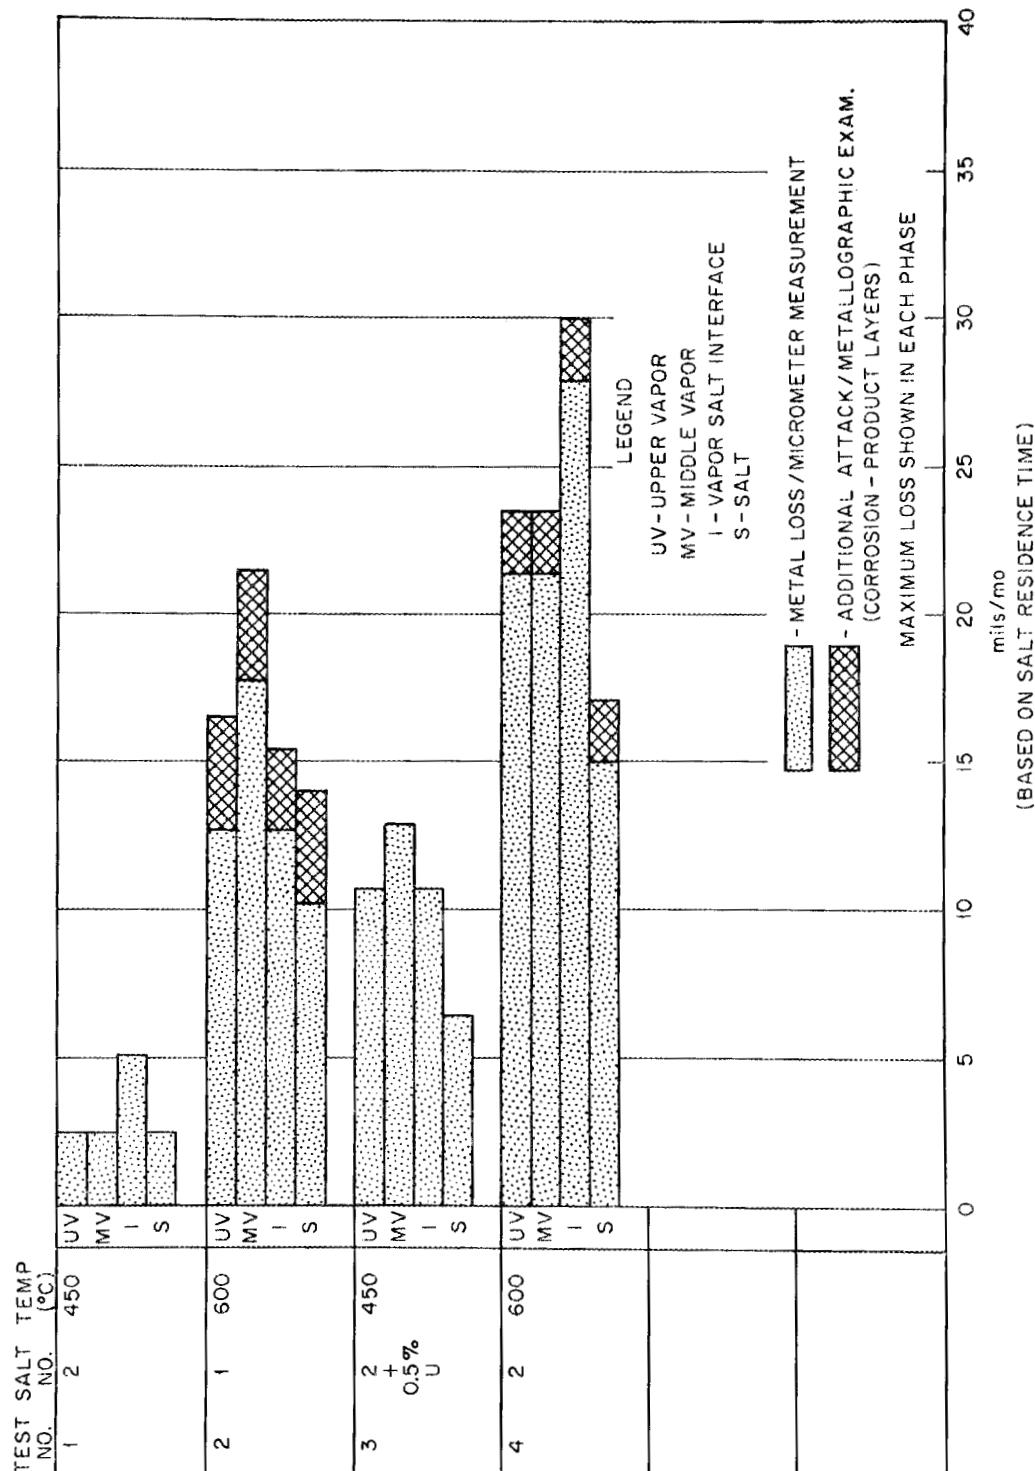
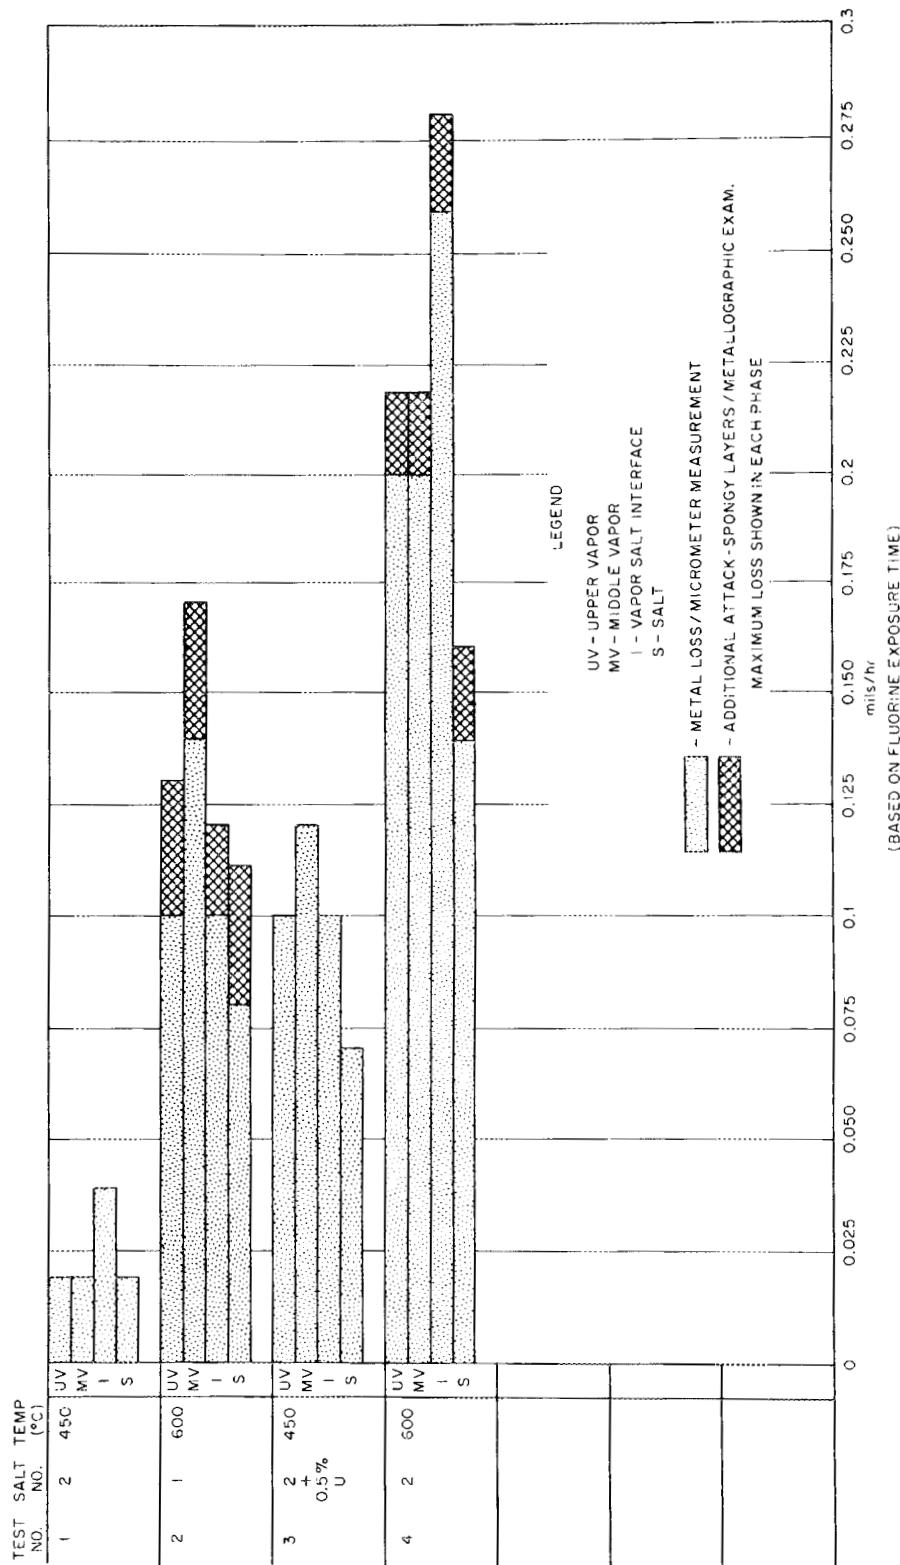
Fig. 43. Summary of Corrosion on INOR-8 Miniature Fluorinators Using Different Process Flowsheets.

Fig. 44. Summary of Corrosion on INOR-8 Miniature Fluorinators Using Different Process Flowsheets.

Maximum attack in the latter vessel occurred at the vapor-salt interface at a rate of 30 mils/month, based on residence time in the molten salts. This was the maximum attack rate for the entire INOR-8 series.

Reducing the operating temperature to 450°C and using the same lithium-bearing salt significantly reduced attack as indicated for vessel No. 1 (Figs. 43 and 44). The maximum attack found in this vessel was also at the vapor-salt interface at a rate of 5 mils/month. The addition of uranium to the lithium-bearing salt described plus operation at 450°C more than doubled the corrosive attack when compared to the nonuranium-containing salt. This occurred in vessel No. 3.

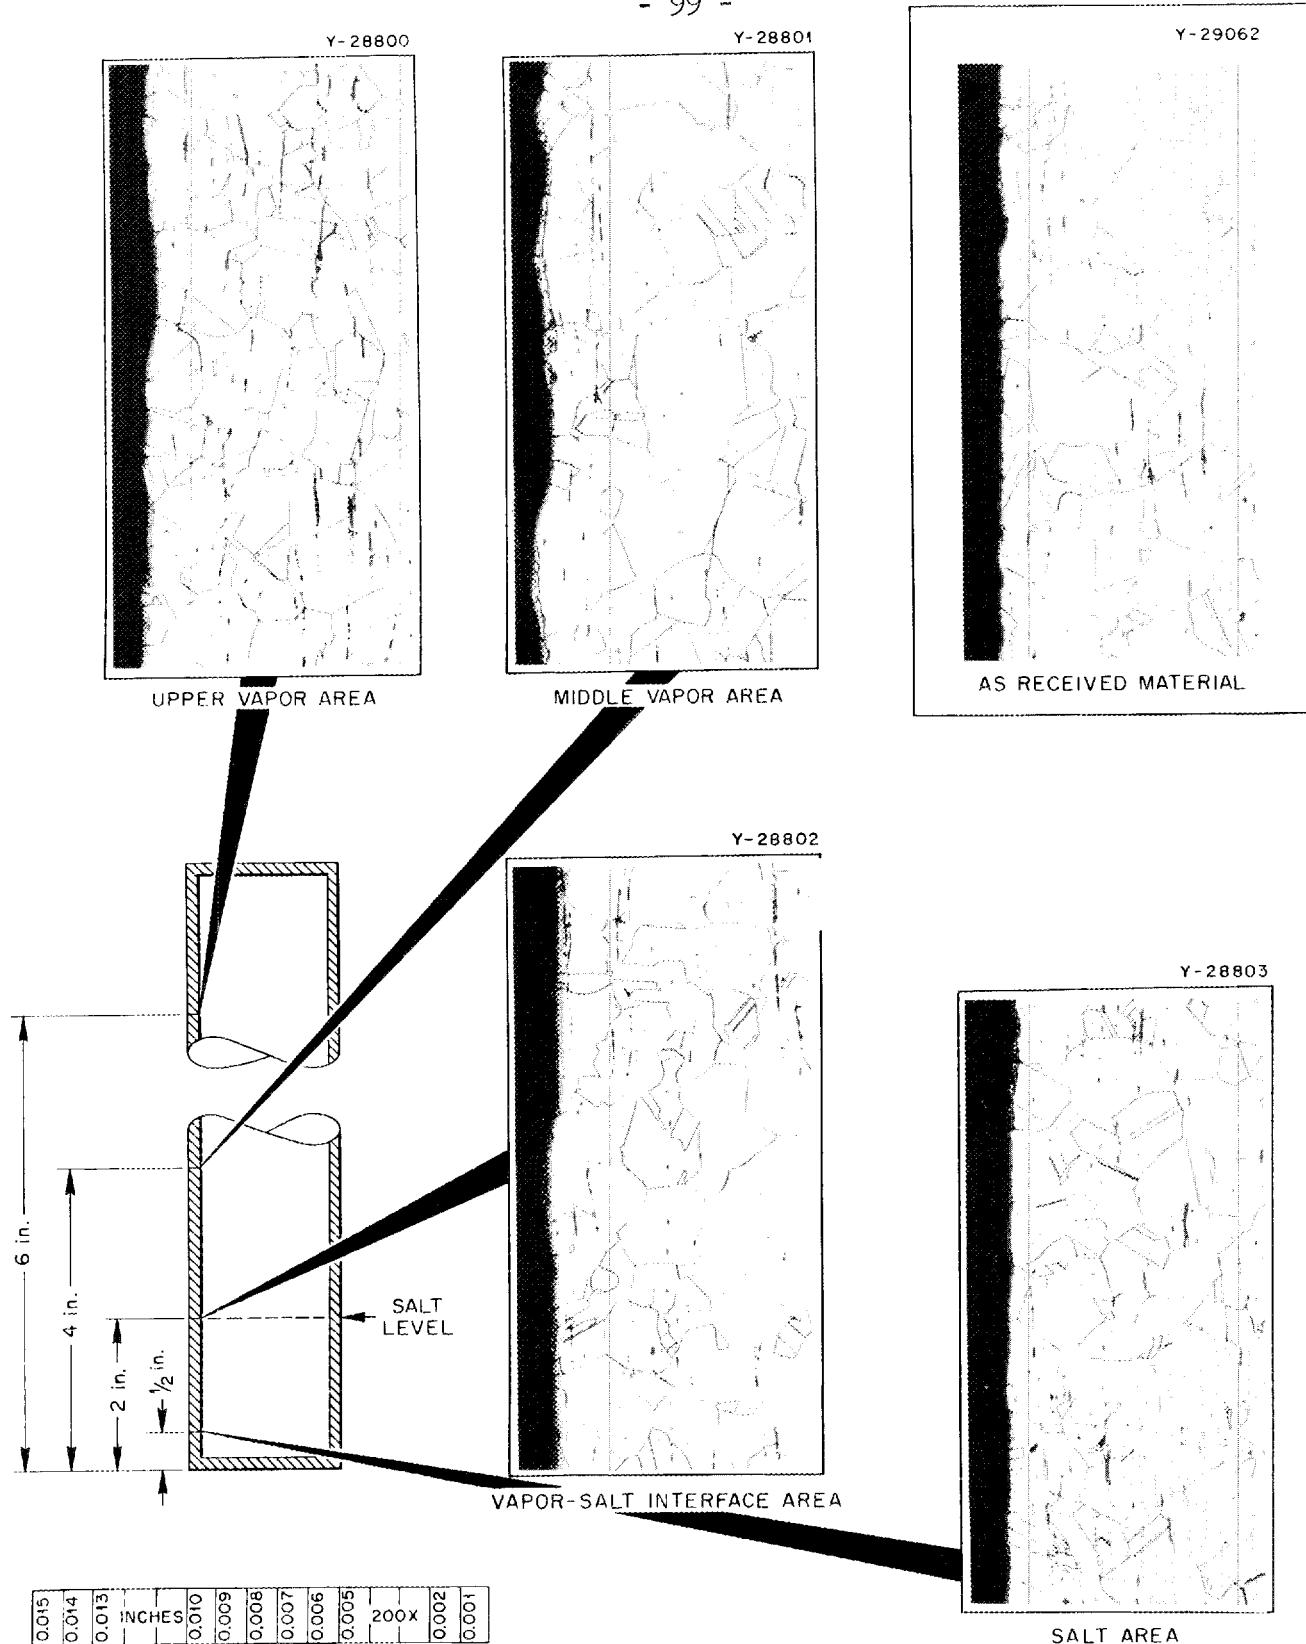
Fig. 45. Typical Microstructures of Samples from INOR-8 Miniature Test Fluorinator No. 1. Etchant: Modified aqua regia. 200X.

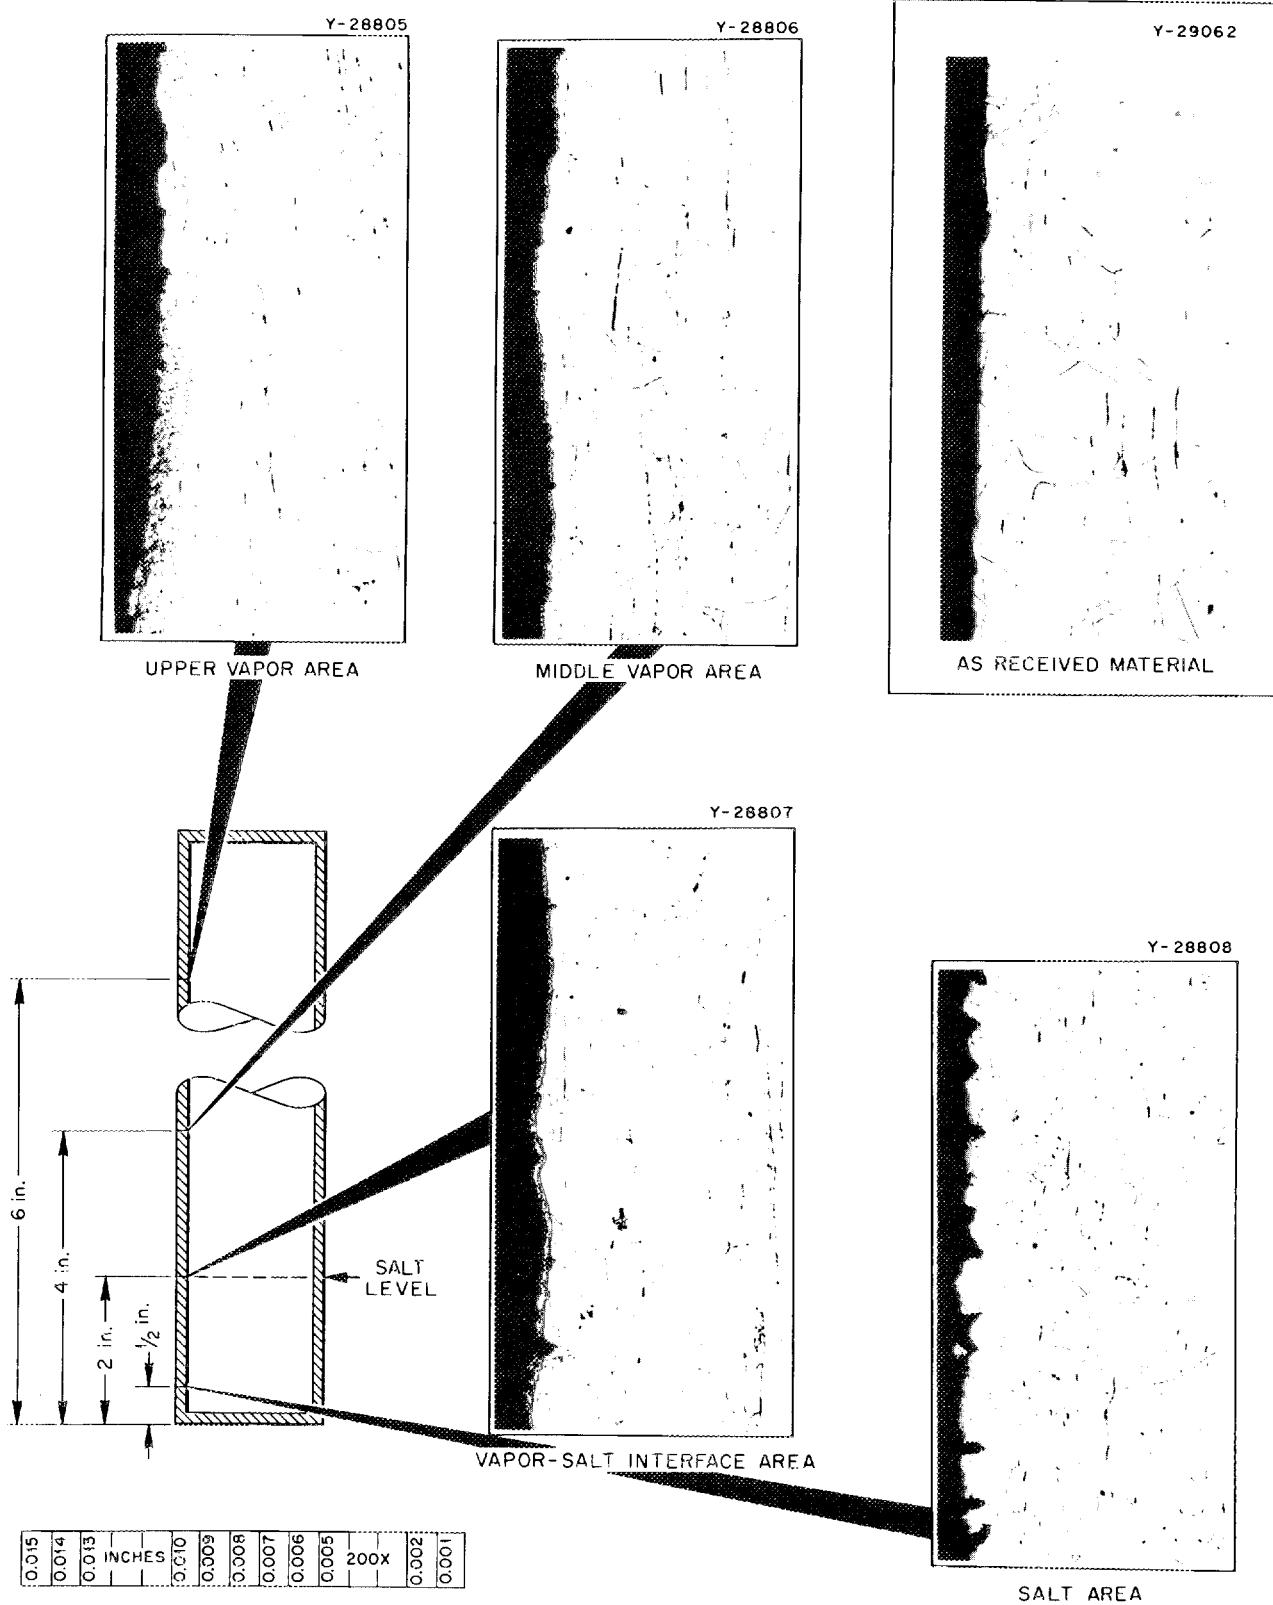
Fig. 46. Typical Microstructures of Samples from INOR-8 Miniature Test Fluorinator No. 2. Etchant: Modified aqua regia. 200X.

Examination of the metallographic specimens in the as-polished state, Fig. 49, disclosed spongy layers on the surfaces of the vapor region specimens from vessels Nos. 2 and 4. These two vessels operated at the highest temperatures of the test series. Upon etching with a modified aqua regia solution, 5:1, HCl:HNO<sub>3</sub>, the spongy regions were for the most part destroyed. Figures 46 and 49 display the microstructures for specimens from the two vessels and show that in only one region, the upper vapor area of vessel No. 2 (Fig. 46) did significant amounts of the spongy region remain.

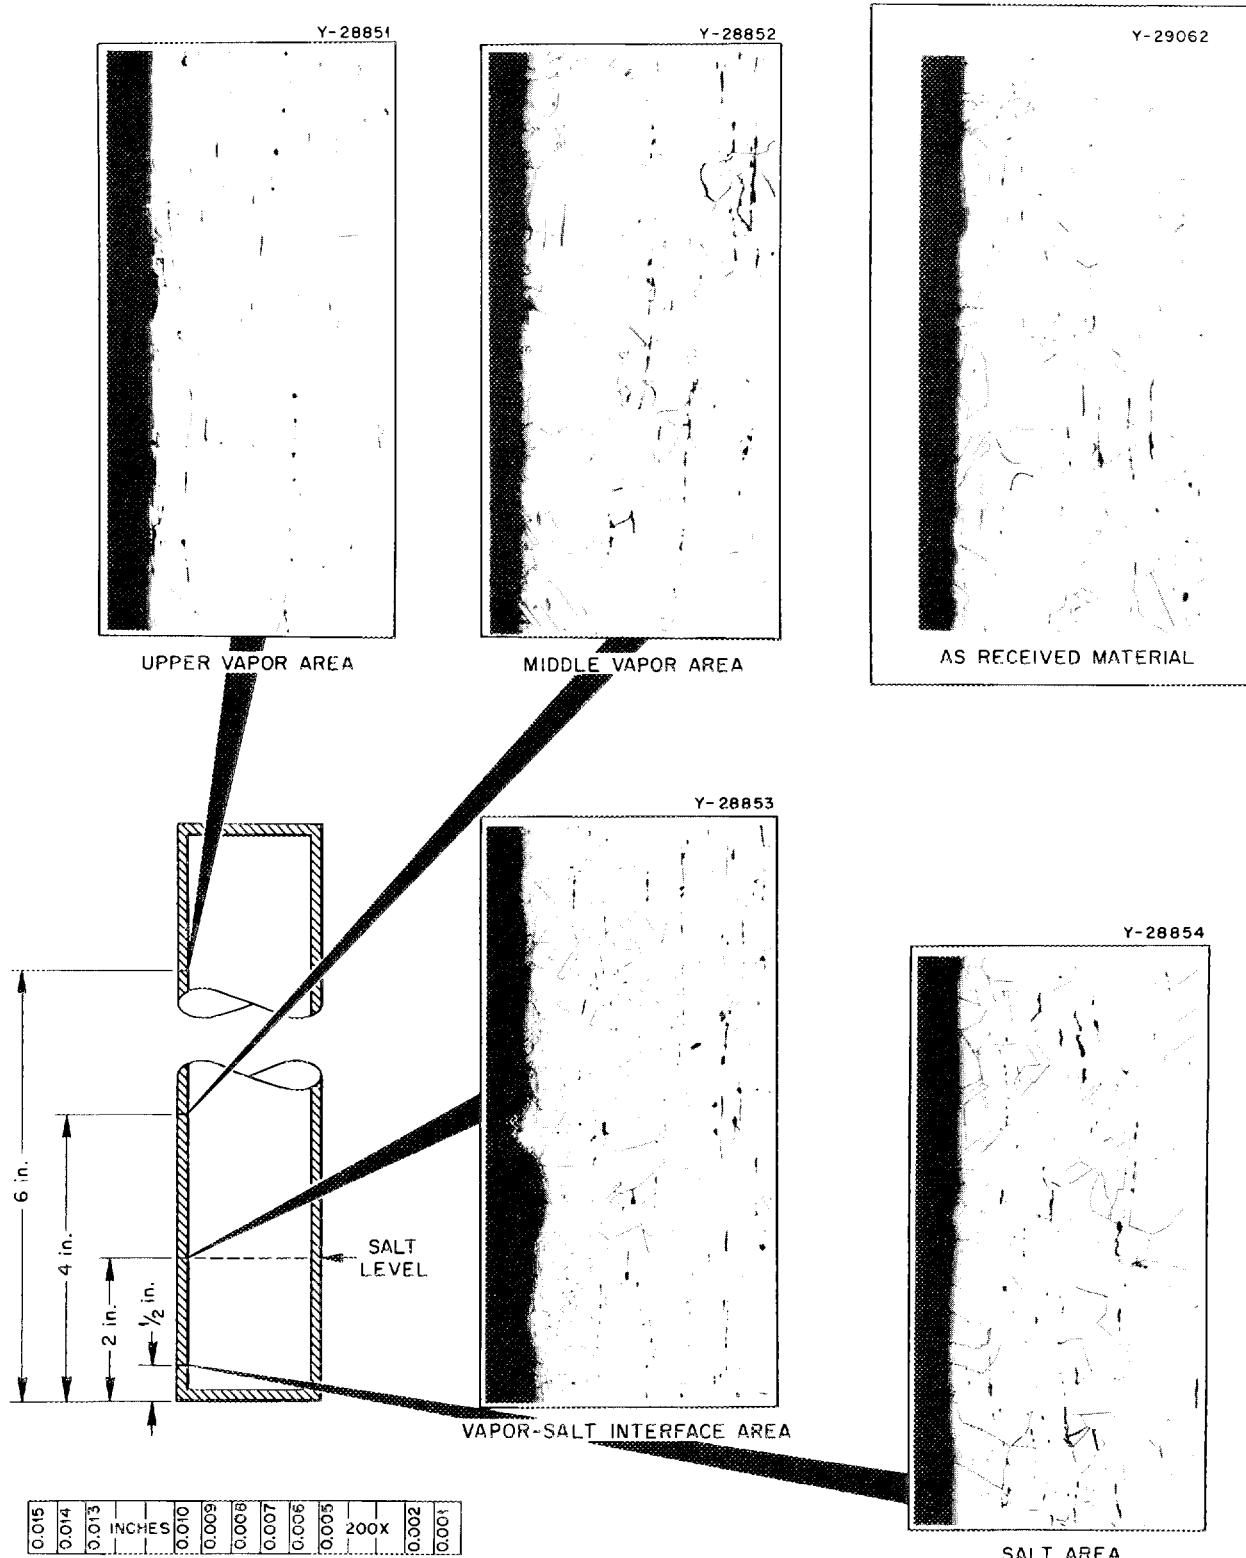
Fig. 47. Typical Microstructures of Samples from INOR-8 Miniature Test Fluorinator No. 3. Etchant: Modified aqua regia, 200X.

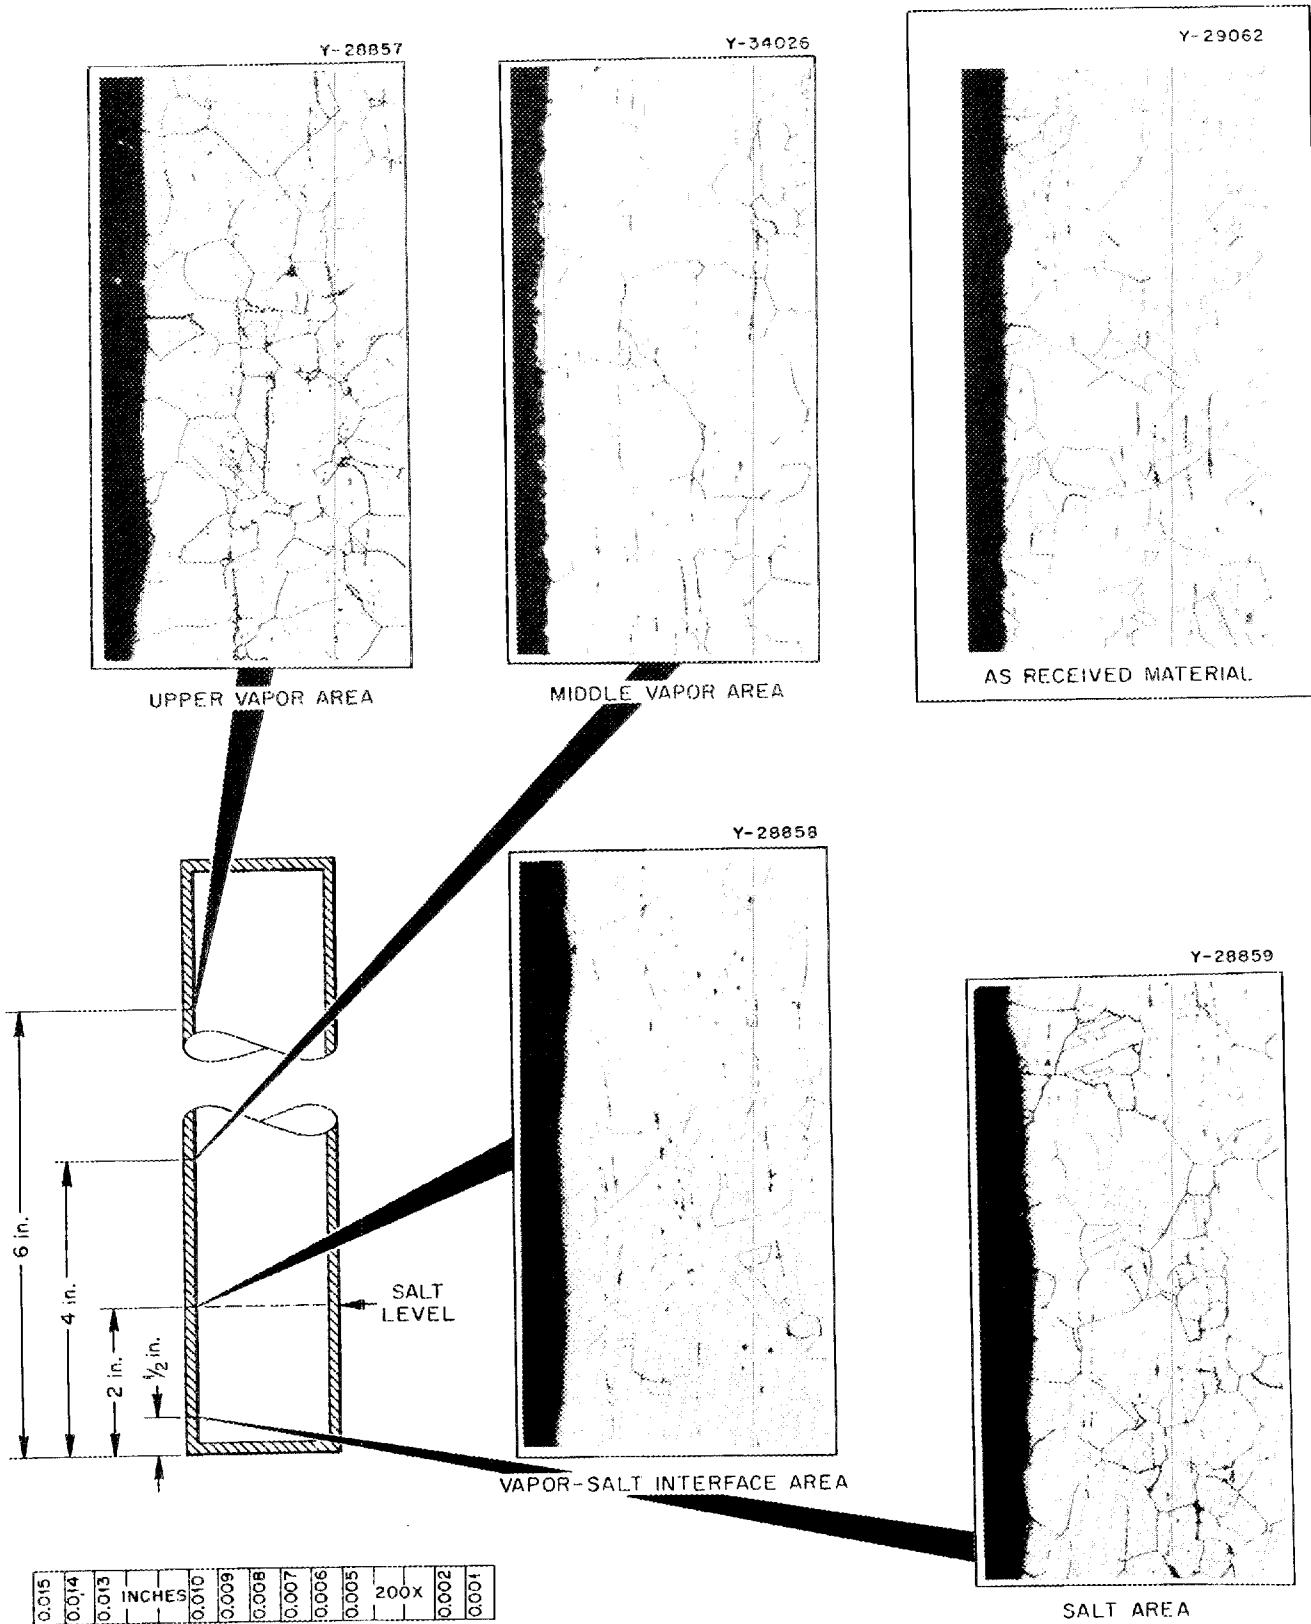
Fig. 48. Typical Microstructures of Samples from INOR-8 Miniature Test Fluorinator No. 4. Etchant: Modified aqua regia. 200X.

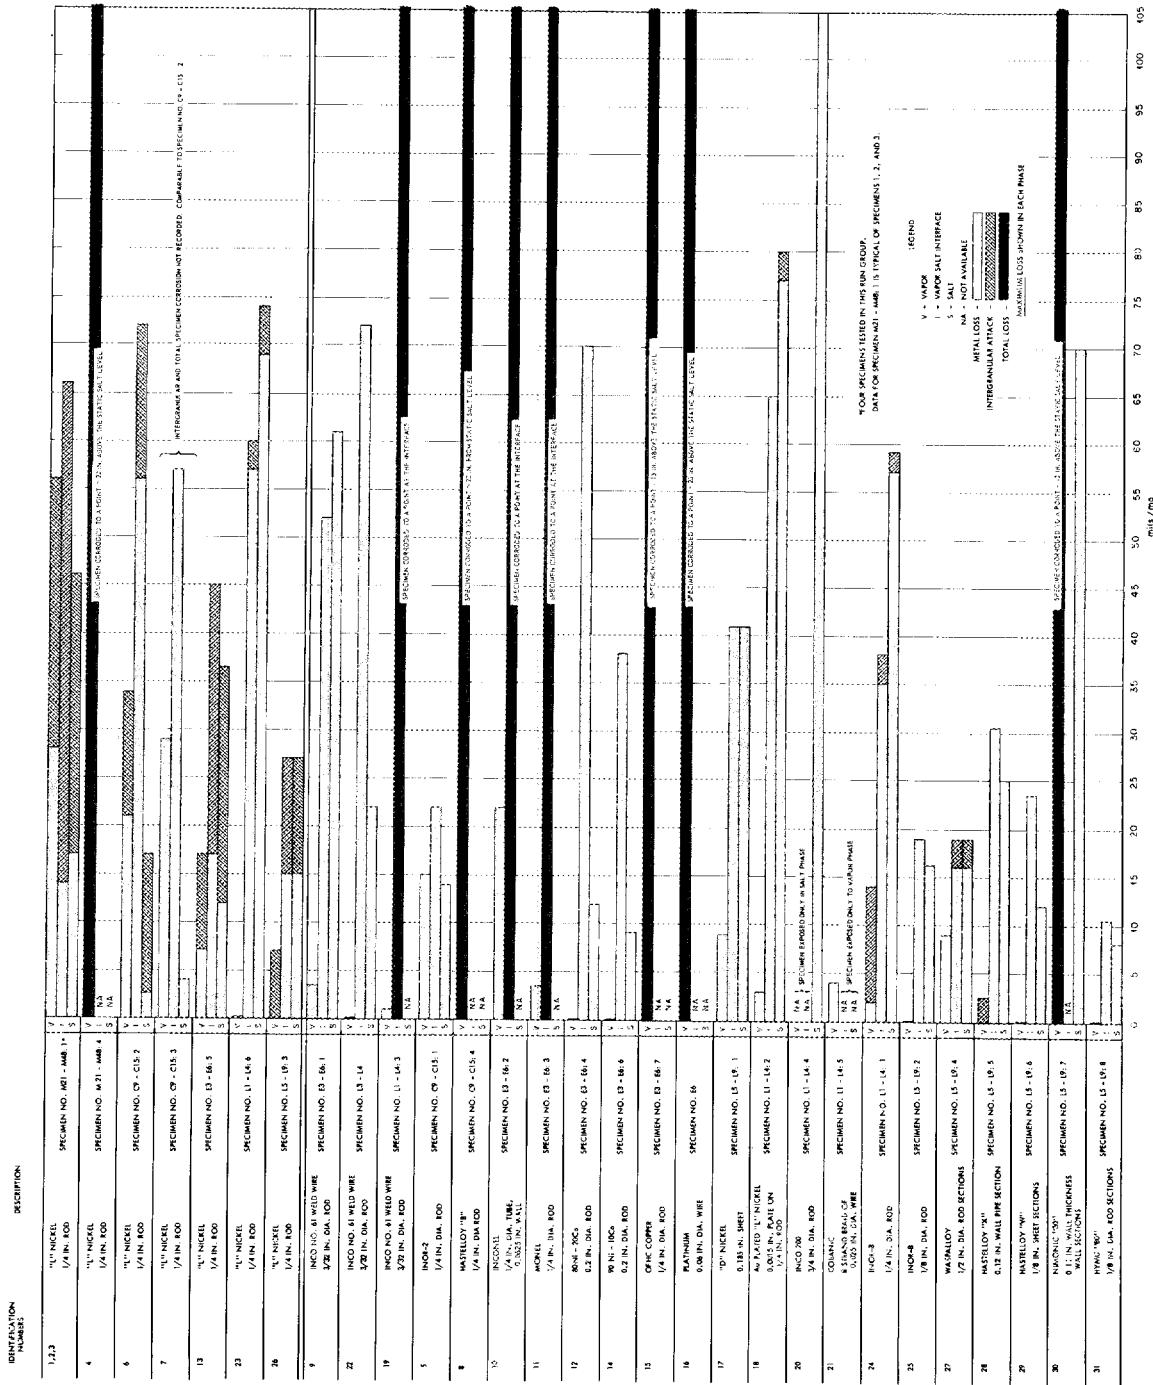
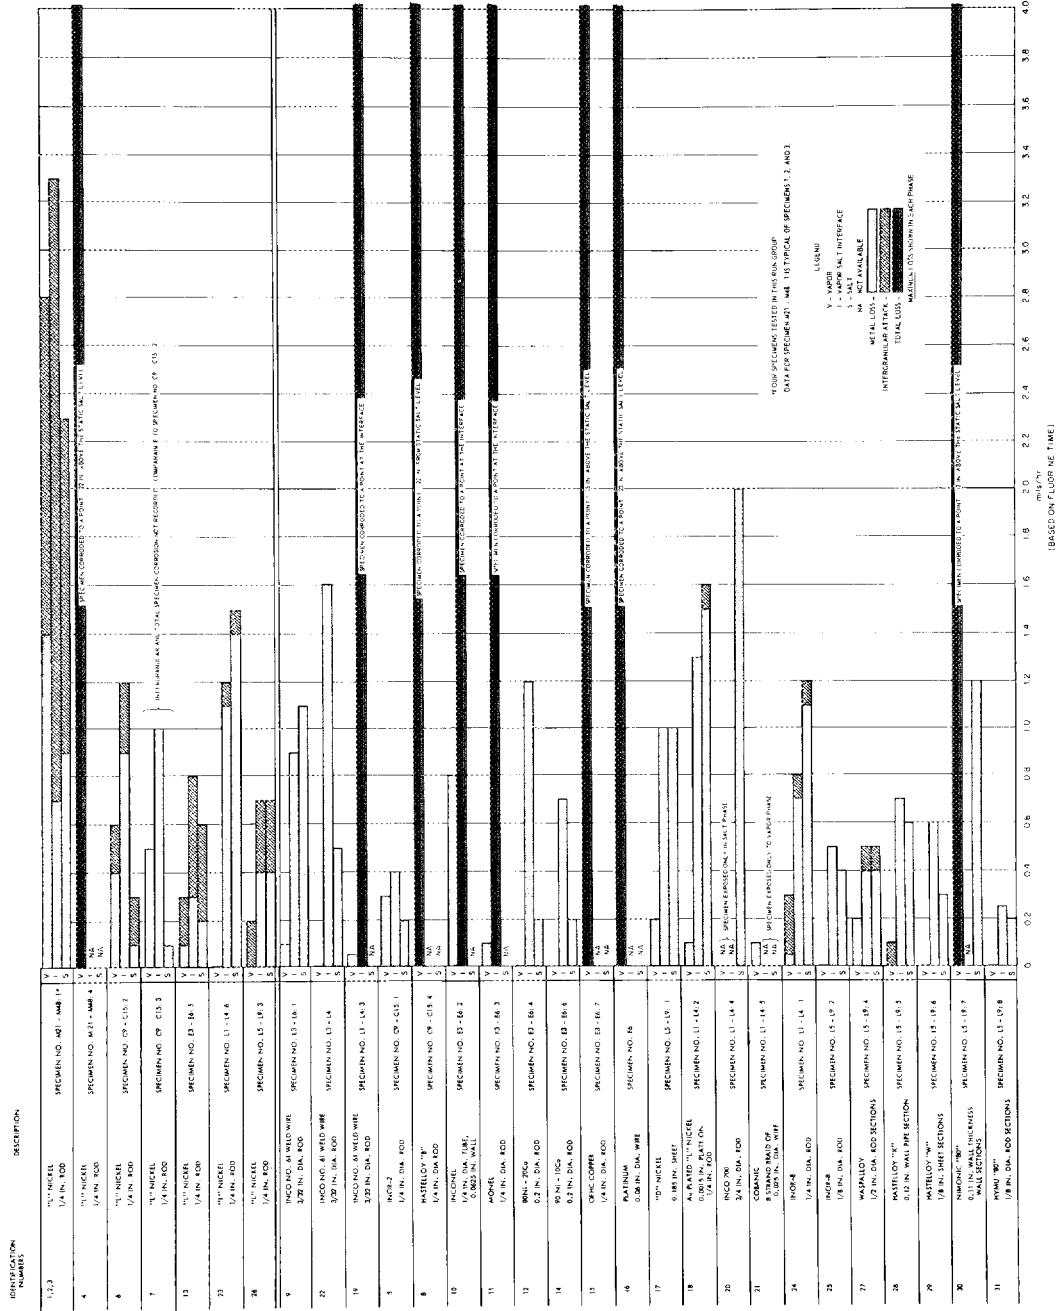
Fig. 55. Summary of Corrosion on Specimens Exposed in VPP Fluorinators.

Fig. 56. Summary of Corrosion on Specimens Exposed in VPP Fluorinators.

mils per hour, based on operational fluorine sparge time. In both figures dotted and cross hatched bars represent bulk metal losses and visible intergranular attack, respectively, while solid bars indicate a total loss of the specimen occurred at the point indicated.

Several specimens registered lower rates of maximum corrosive attack than the L nickel control rods. These specimens included Hymu 80, INOR-2, INOR-8, Hastelloy W, Hastelloy X, Waspalloy, and the 90 wt % Ni-10 wt % Co alloys. In particular, Hymu 80 was superior to all test specimens in all runs, although the specimen registered a maximum bulk loss rate of 11 mils/month, based on molten-salt residence time, at the vapor-salt interface. Total loss of corrosion specimens, indicating corrosion rates of > 105 mils/month based on molten-salt time, was found for one L nickel specimen, one INCO-61 weld wire specimen, and for the Hastelloy B, Nimonic 80, Inconel, Monel, copper, and platinum specimens.

The behavior of the gold-plated L nickel corrosion specimens indicated that no protection was provided by the plating. Comparison with L nickel specimen number L-1-L-4:6 in Fig. 55 shows comparable losses.

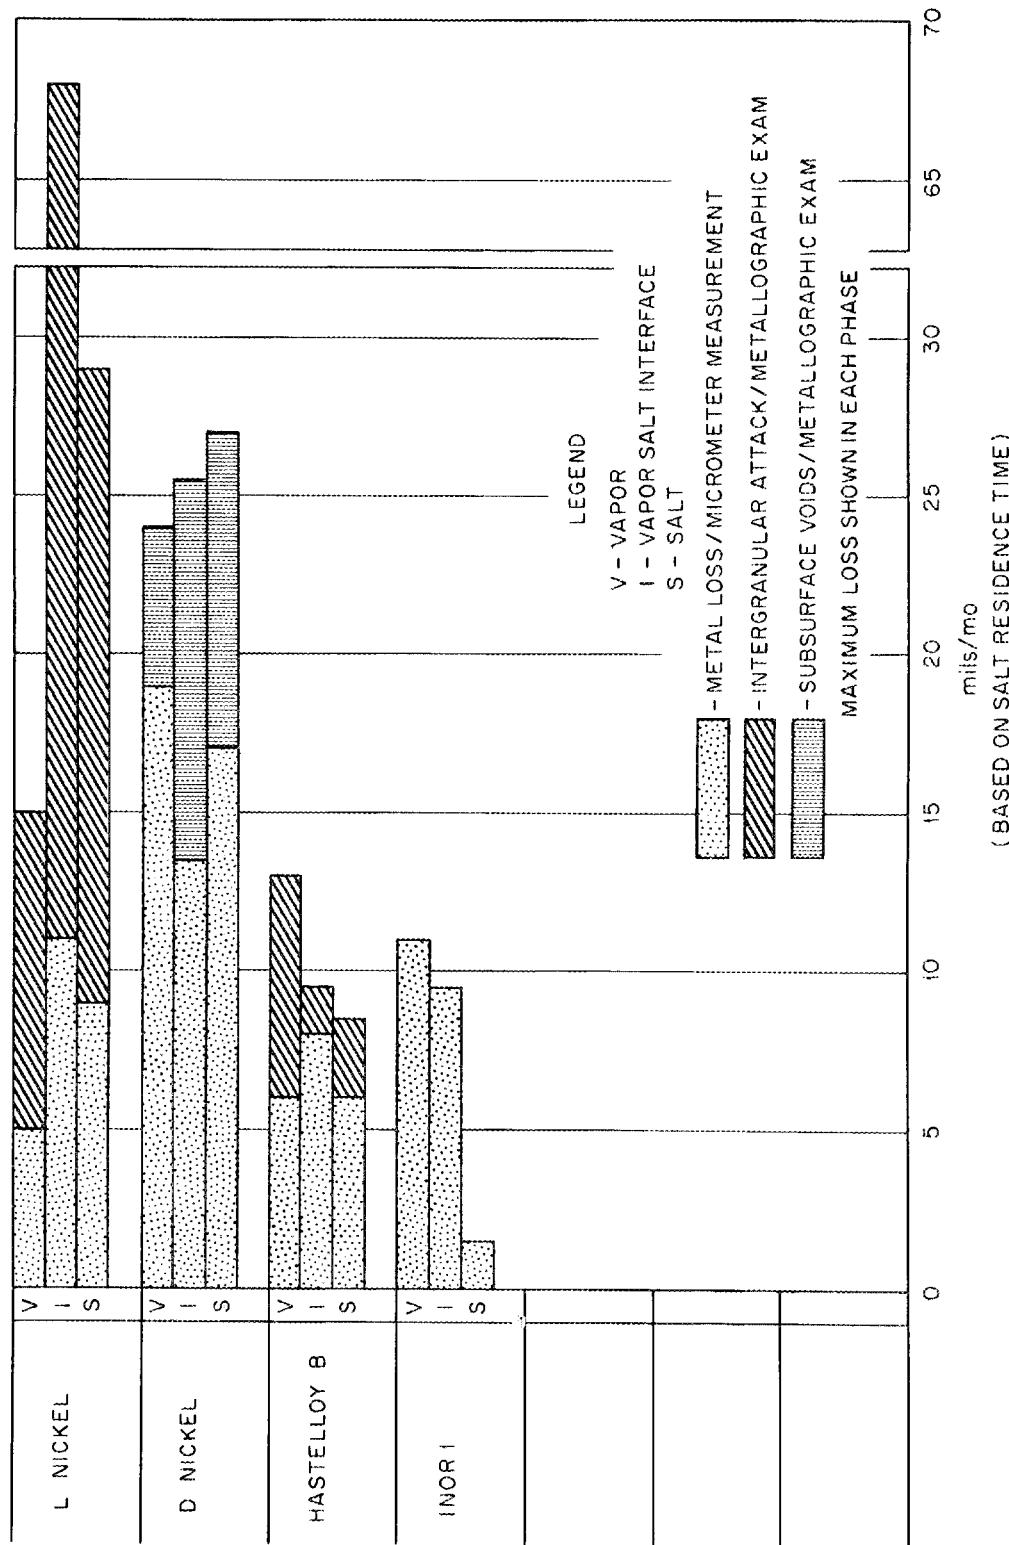
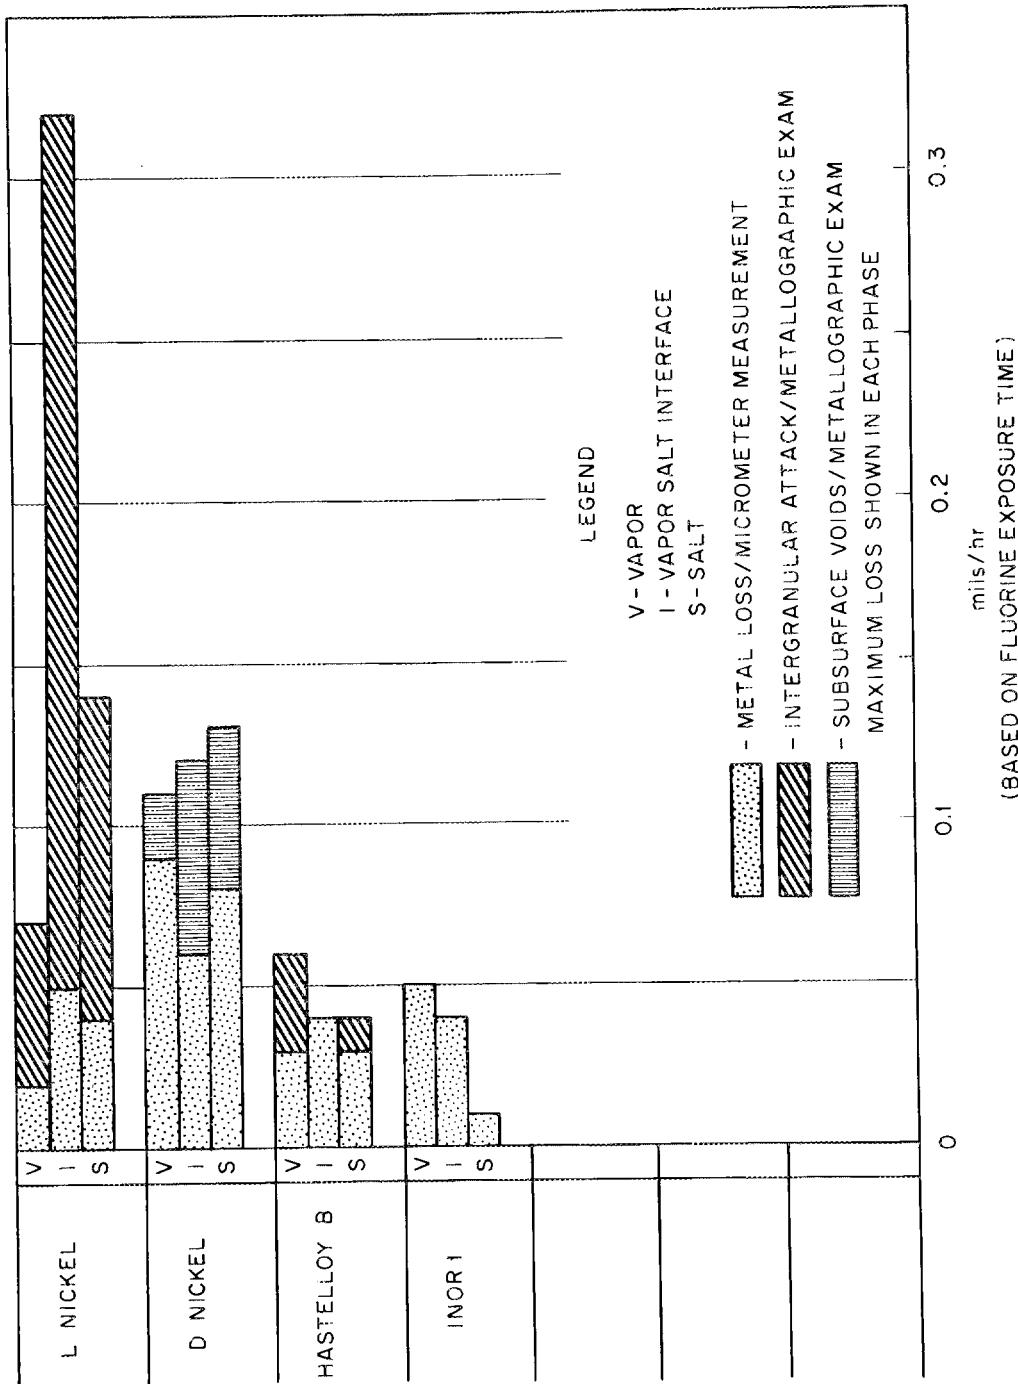
Comparison of the Argonne National Laboratory corrosion results with those obtained at ORNL is difficult because of differences in test procedures which include fluorine flow rates, specimen location and geometry, and salt compositions. However, Argonne's results on L nickel fit the corrosion limits determined for the ORNL scouting corrosion reference specimens in the salt and at the salt-vapor interfaces. Vapor-phase specimens are not readily comparable, since Argonne specimens were only 3 to 4 in. above the salt surface.

The Argonne National Laboratory Hastelloy B and the D nickel specimens generally had less attack than scouting specimens at ORNL. The differences may be attributed to more severe operating conditions in the ORNL pilot plant fluorinator. Since no INOR-1 specimen had been tested at ORNL, no comparisons could be derived.

Fig. 57. Summary of Corrosion on Coupons Exposed to a Fluorination Environment by the Argonne National Laboratory.

Fig. 58. Summary of Corrosion on Coupons Exposed to a Fluorination Environment by the Argonne National Laboratory.

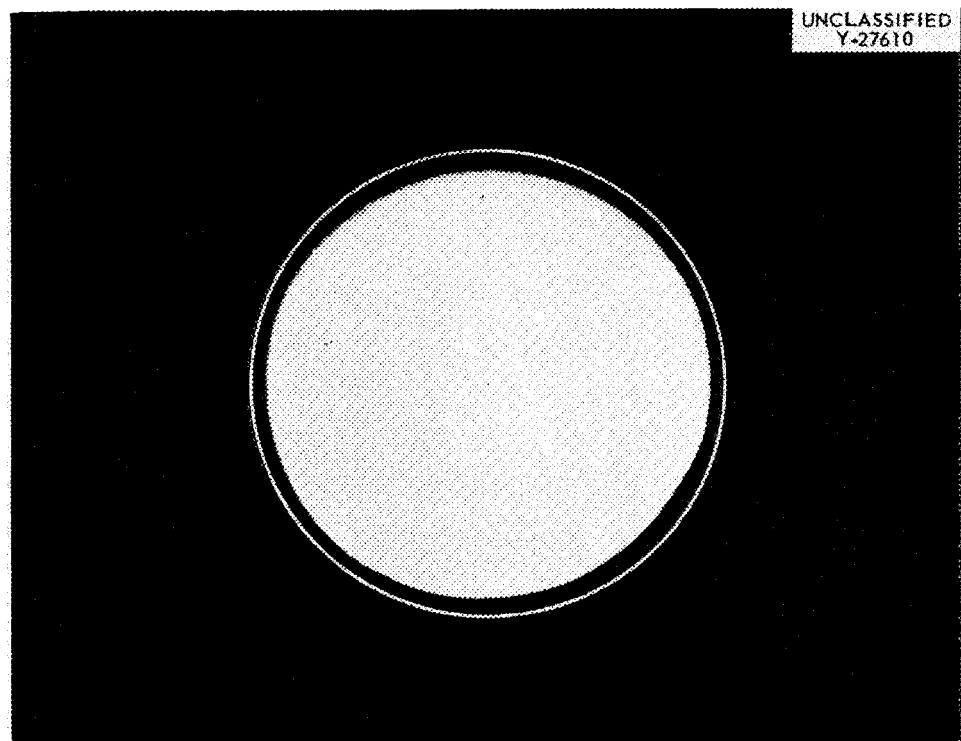
Fig. 59A. Cross Section of Interface Region Sample from L Nickel Corrosion Specimen (Runs L-5-L-9:3). Interior circumference of white circle indicates original size. As-polished. 10X.

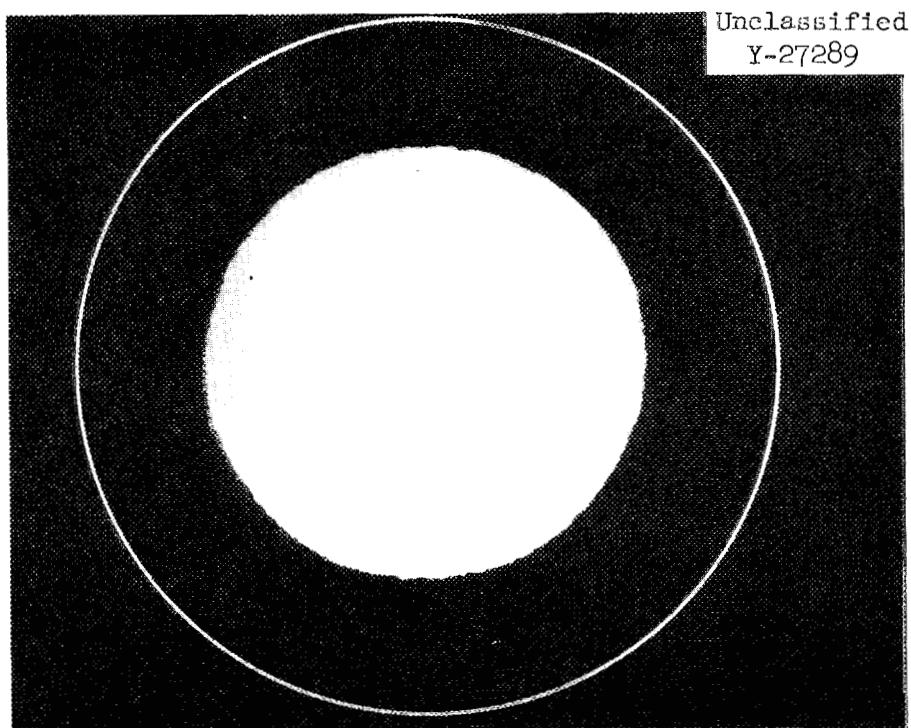
Fig. 60A. Cross Section of Salt Region Sample from Gold Plated L Nickel Corrosion Specimen (Runs L-1-L-4:2). Interior circumference of white circle indicates original size. As-polished. 15X.

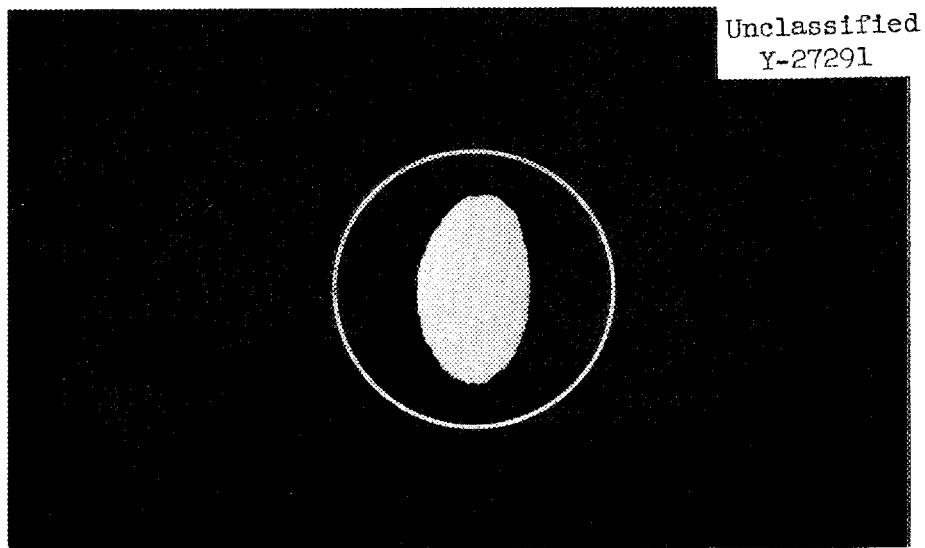
Fig. 61A. Cross Section of Interface Region Sample from INCO-61 Weld Wire Corrosion Specimen (Runs L-3-L-4). Interior circumference of white circle indicates original size. As-polished. 15X.

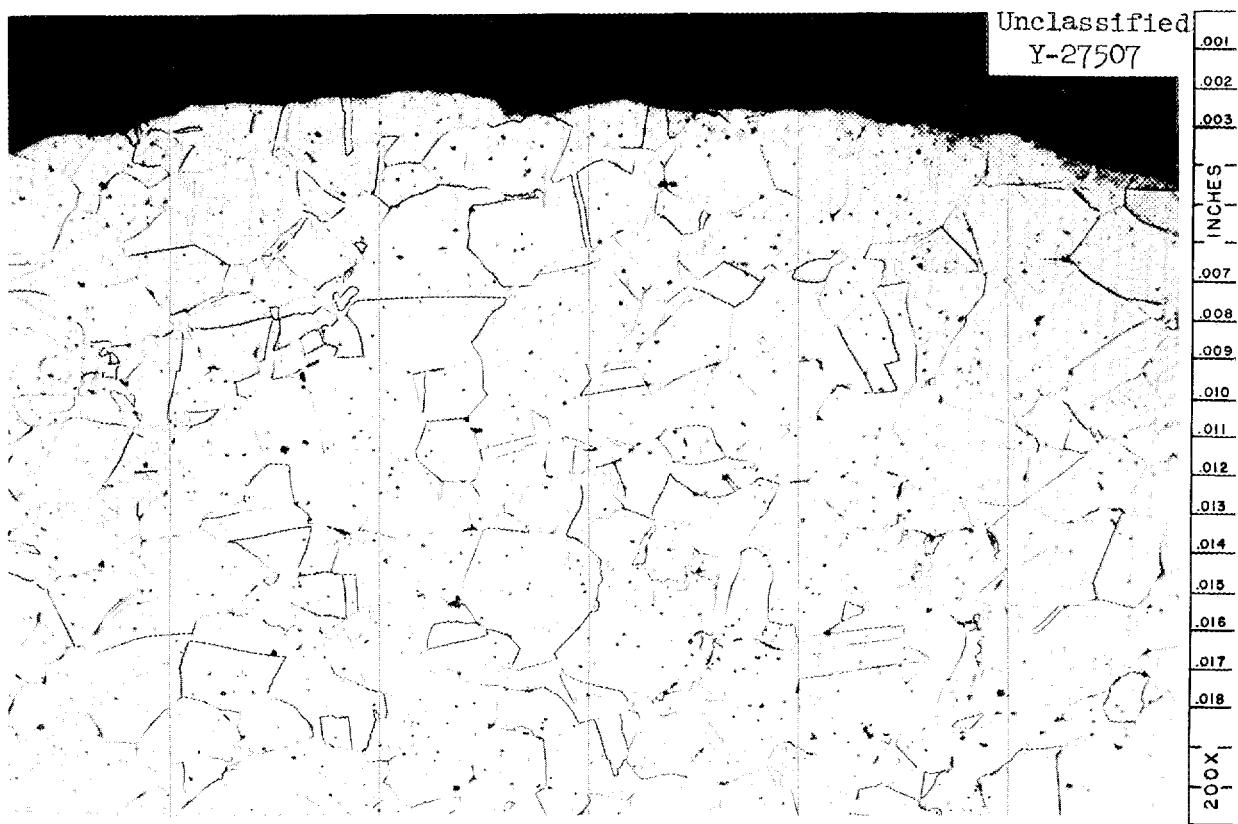
Fig. 61B. Portion of 61A. Typical Surface and Microstructure.  
Etchant: Concentrated HNO<sub>3</sub>. 200X.

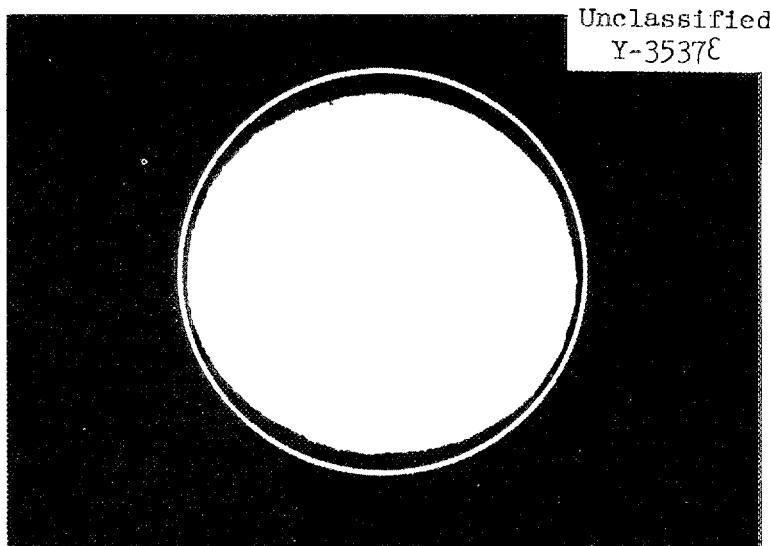
Fig. 62A. Cross Section of Interface Region Sample from INOR-2 Corrosion Specimen (Runs C-9-C-15:1). Interior circumference of white circle indicates original size. 85X.

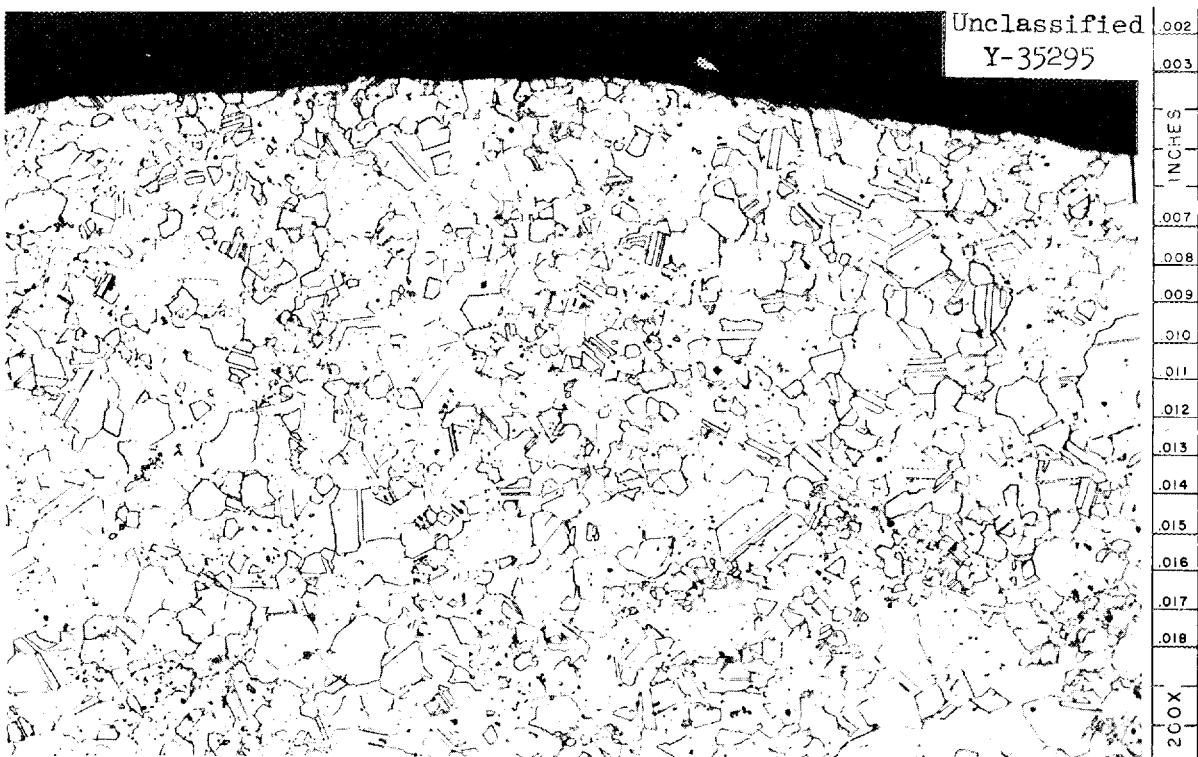
Fig. 62B. Portion of Fig. 62A. Typical Surface and Microstructure.  
Etchant: Chromium regia. 200X.
