ORNL-2832

CORROSION ASSOCIATED WITH FLUORINATION  
IN THE OAK RIDGE NATIONAL LABORATORY  
FLUORIDE VOLATILITY PROCESS

CORROSION ASSOCIATED WITH FLUORINATION IN THE  
OAK RIDGE NATIONAL LABORATORY FLUORIDE VOLATILITY PROCESS

A. P. Litman and A. E. Goldman

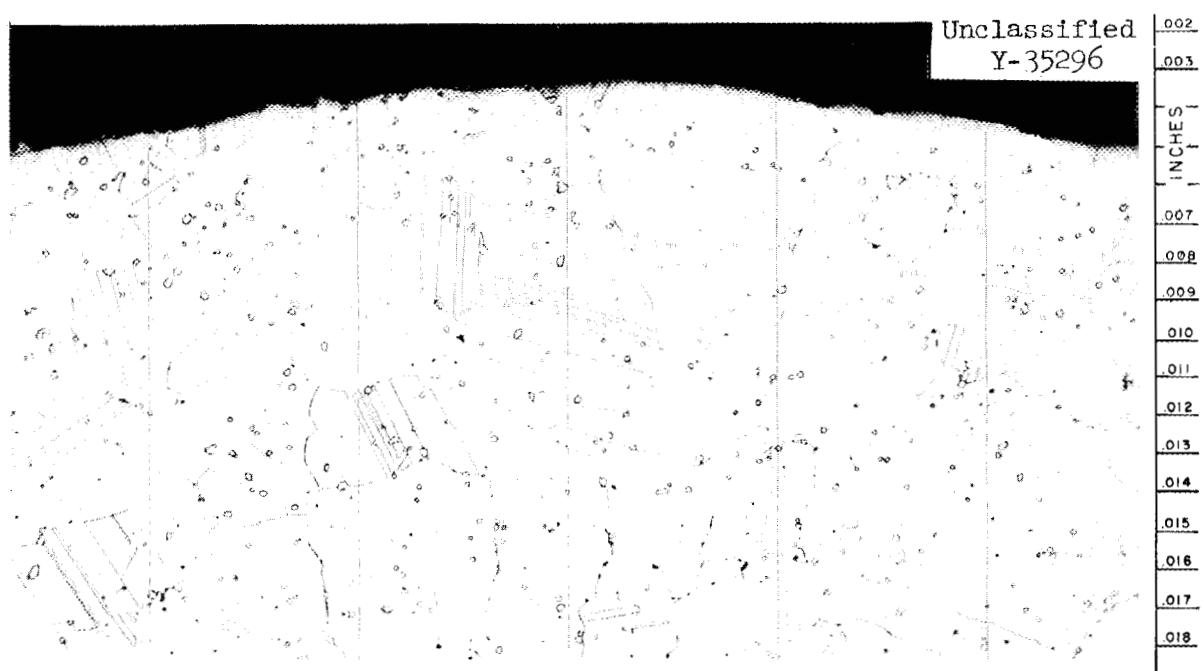
Fig. 63. Section of Vapor Region Sample from Hastelloy B Corrosion Specimen (Runs C-9-C-15:4) Showing Typical Surface and Microstructure. Etchant: Chromium regia. 200X.

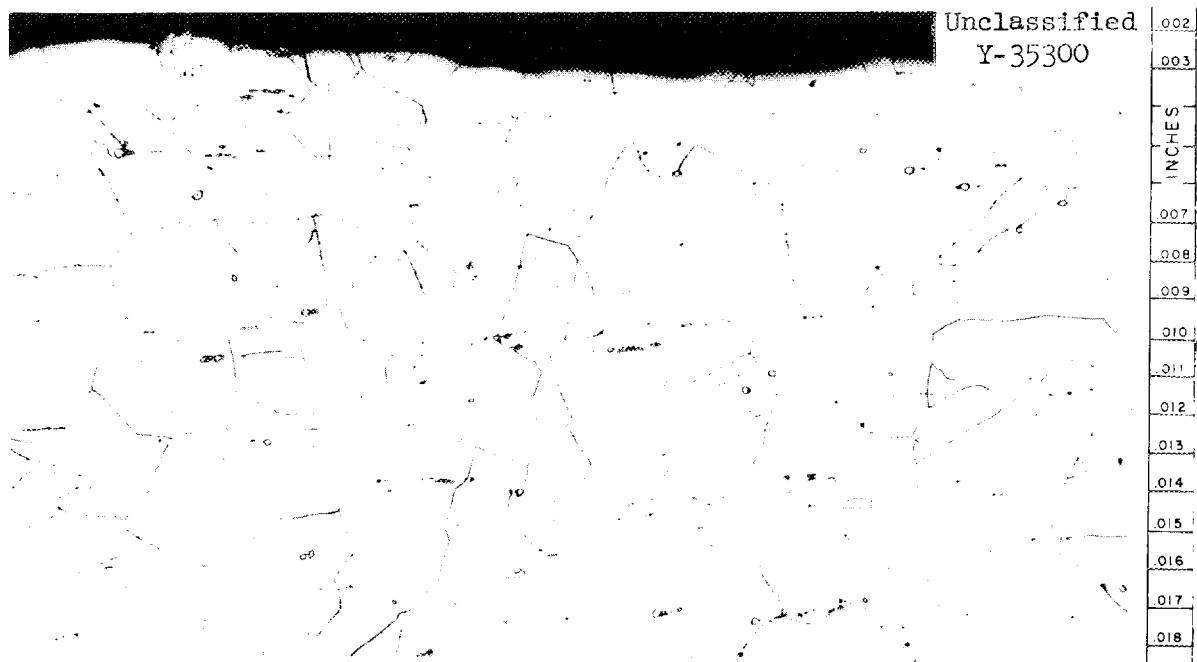
Fig. 64. Section of Vapor Region Sample from Inconel Corrosion Specimen (Runs E-3-E-6:2) Showing Typical Surface and Microstructure. Etchant: Modified aqua regia. 200X.

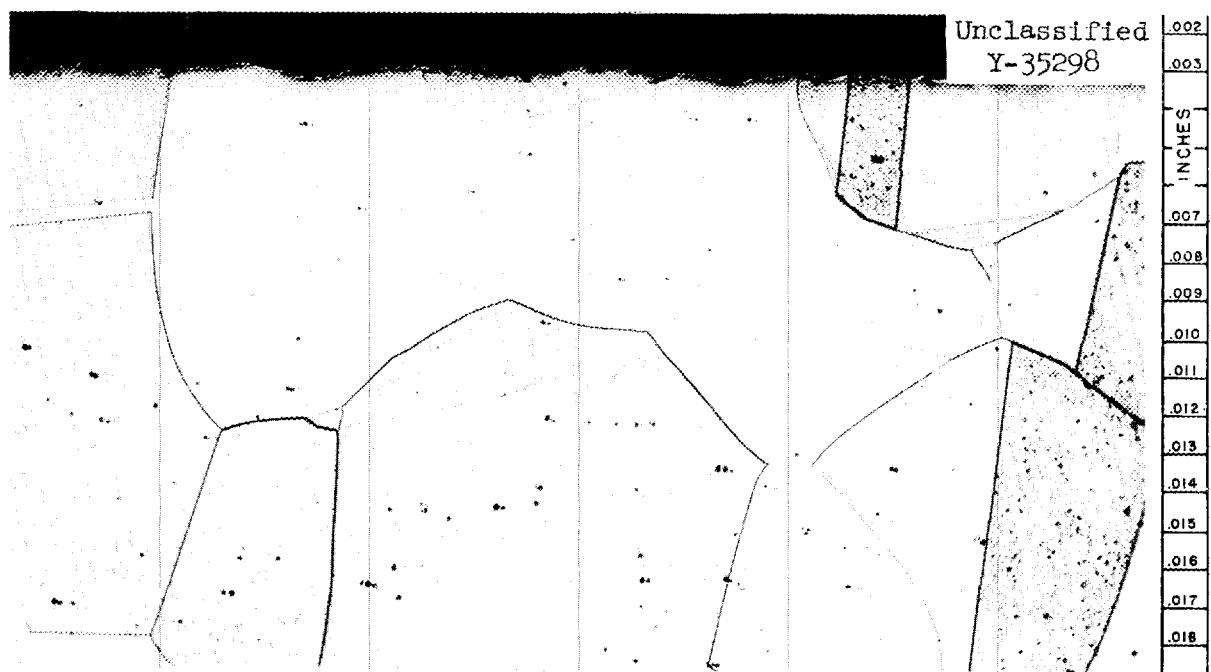
The nickel-rich copper specimen, Monel, provided poor resistance to the fluorination environment during a single test run. The specimen failed completely at the vapor-salt interface.

Fig. 65. Section of Vapor Region Sample from Monel Corrosion Specimen (Runs E-3-E-6:3) Showing Typical Surface and Microstructure.  
Etchant:  $\text{HC}_2\text{H}_3\text{O}_2:\text{HNO}_3:\text{HCl}$ . 200X.

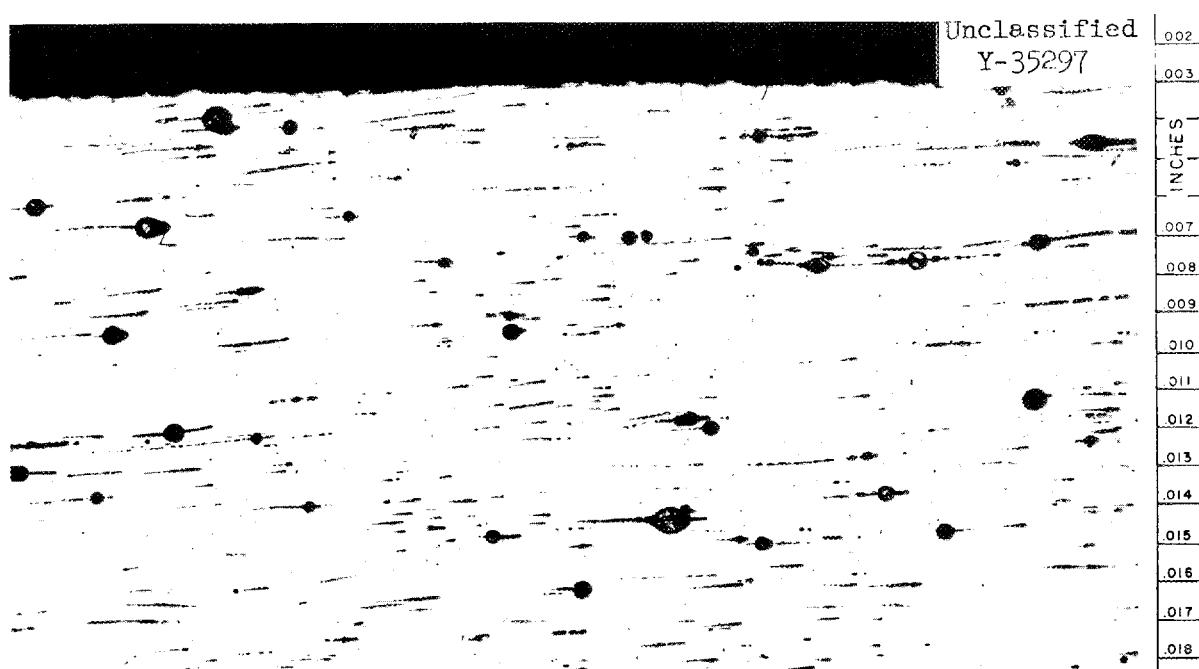
Fig. 66. Section of Vapor Region Sample from OFHC Copper Corrosion Specimen (Runs E-3-E-6:7) Showing Typical Surface and Microstructure.  
Etchant:  $\text{NH}_4\text{OH} \cdot \text{H}_2\text{O}_2$ . 200X.

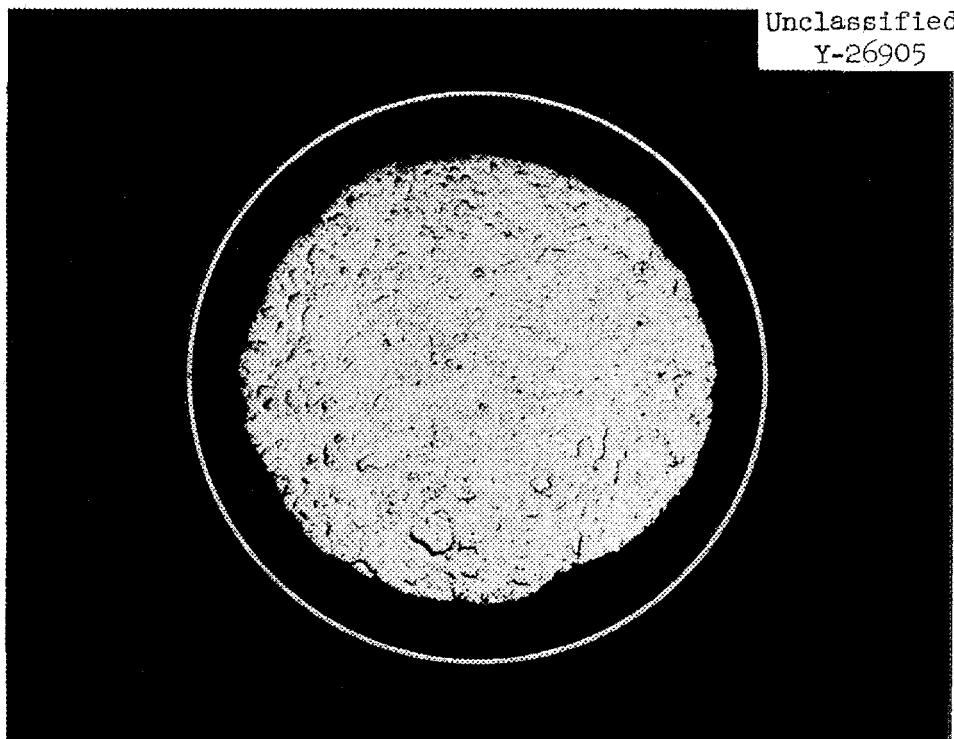
Fig. 67A. Cross Section of Interface Region Sample from 80 Ni-20 Co Corrosion Specimen (Runs E-3-E-6:4). Interior circumference of white circle indicates original size. Combination of grain size and etchant presents a relief appearance because of light. Etchant:  $\text{HNO}_3:\text{H}_2\text{SO}_4$ . 15X.

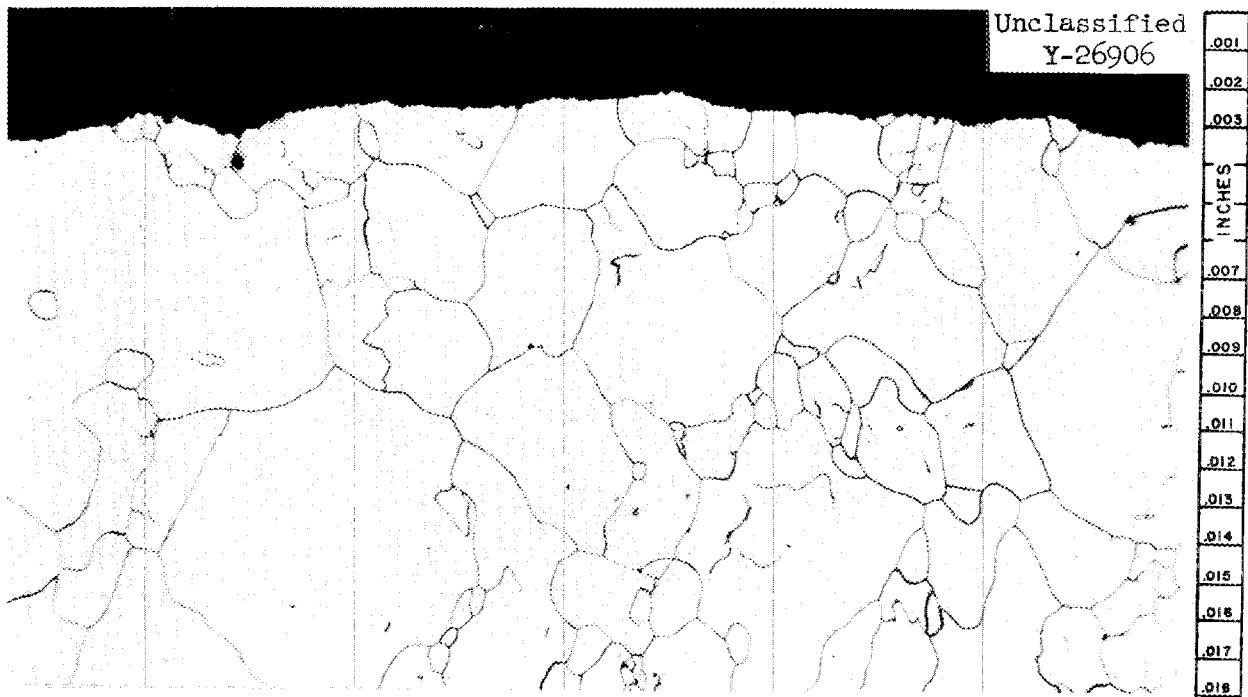
Fig. 67B. Portion of Fig. 67A. Typical Surface and Microstructure.  
Etchant: Concentrated  $\text{HNO}_3$ . 200X.

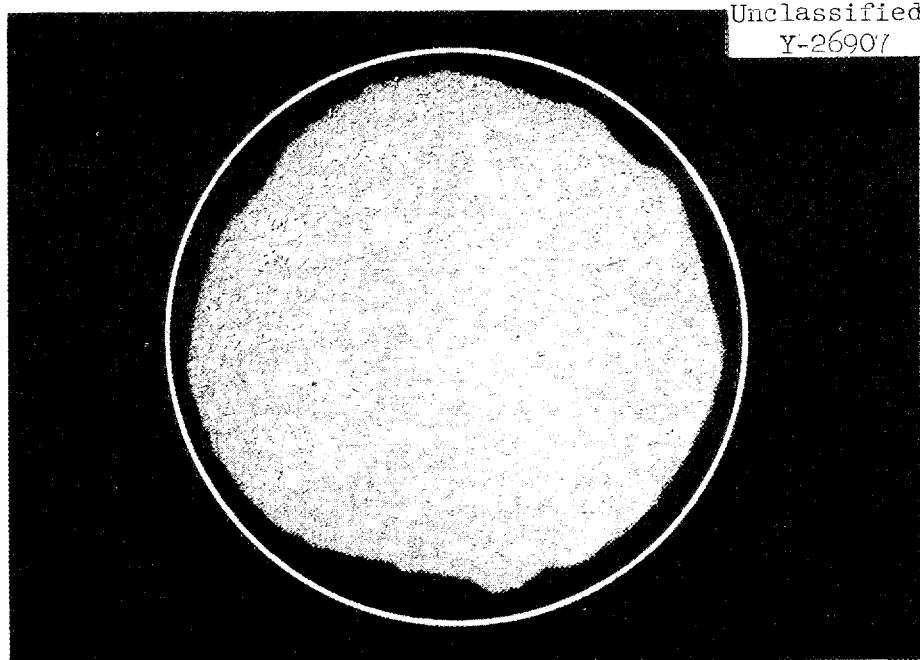
Fig. 68A. Cross Section from Interface Region Sample from 90 Ni-10 Co Corrosion Specimen (Runs E-3-E-6:6). Interior circumference of white circle indicates original size. Etchant:  $\text{HNO}_3:\text{H}_2\text{SO}_4$ .

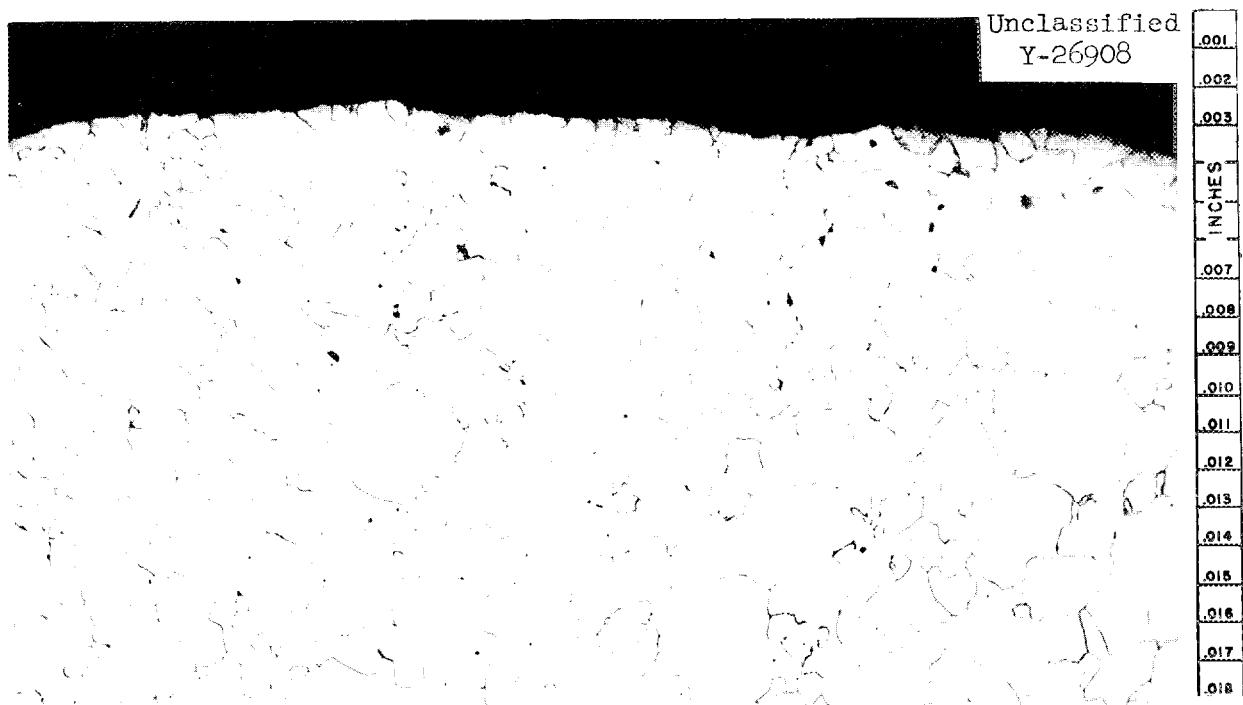
Fig. 68B. Portion of Fig. 68A. Typical Surface and Microstructure.  
Etchant: Dilute  $\text{HNO}_3$ . 200X.

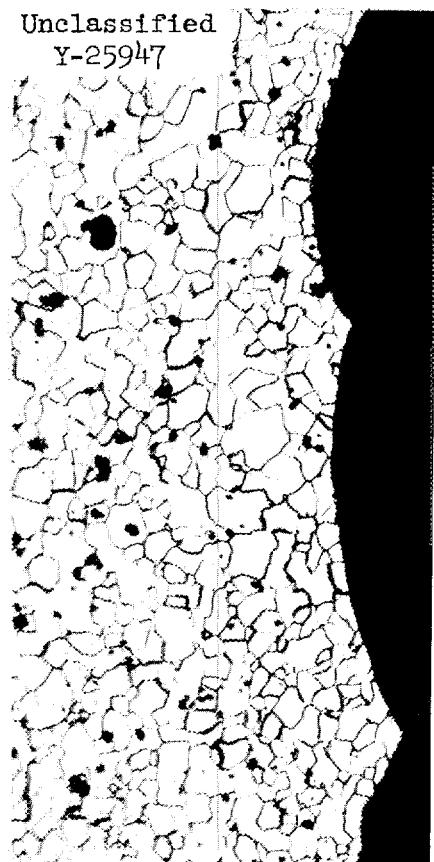
Fig. 69. Longitudinal Cross Section of Vapor Region Sample from Platinum Corrosion Specimen (Run E-6) Showing Typical Surface and Microstructure. Cathodic vacuum etch. 200X.

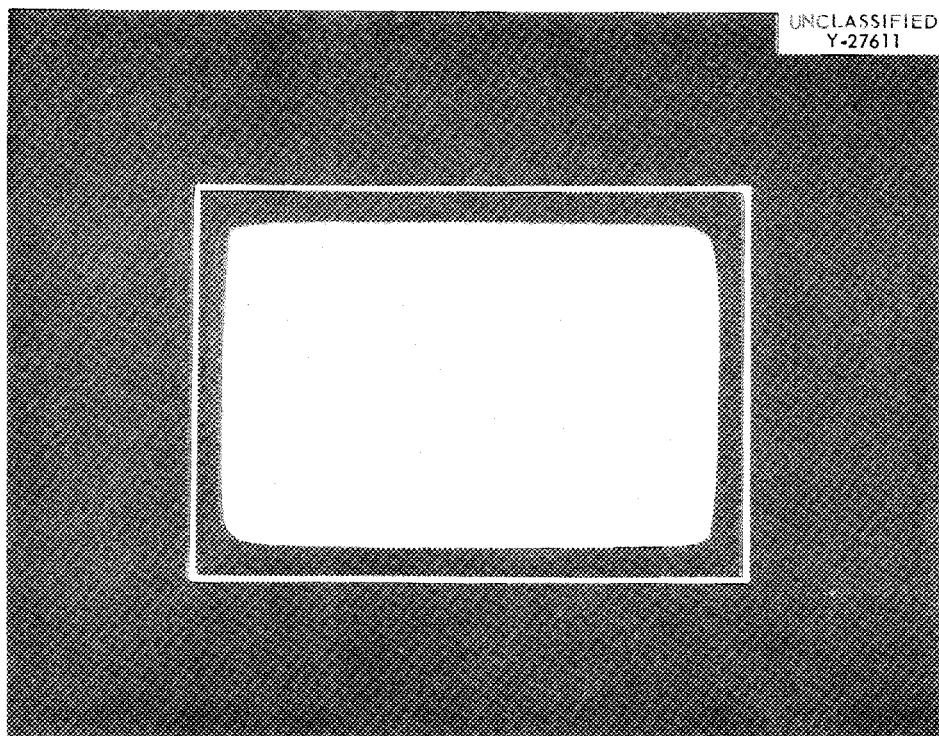
Fig. 70A. Cross Section of Interface Region Sample from D Nickel Corrosion Specimen (Runs L-5-L-9:1). Interior of white lines indicates original size. As-polished. 10X.

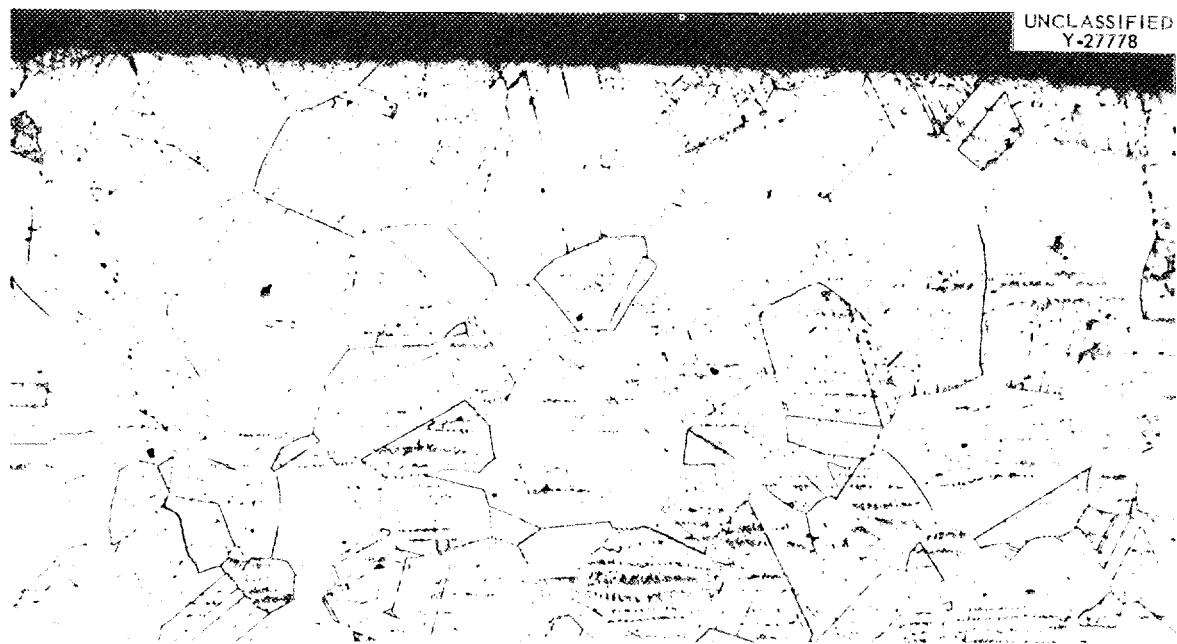
Fig. 70B. Portion of Fig. 70A. Typical Surface and Microstructure.  
Etchant:  $KCN-(NH_4)_2S_2O_8$ . 200X.

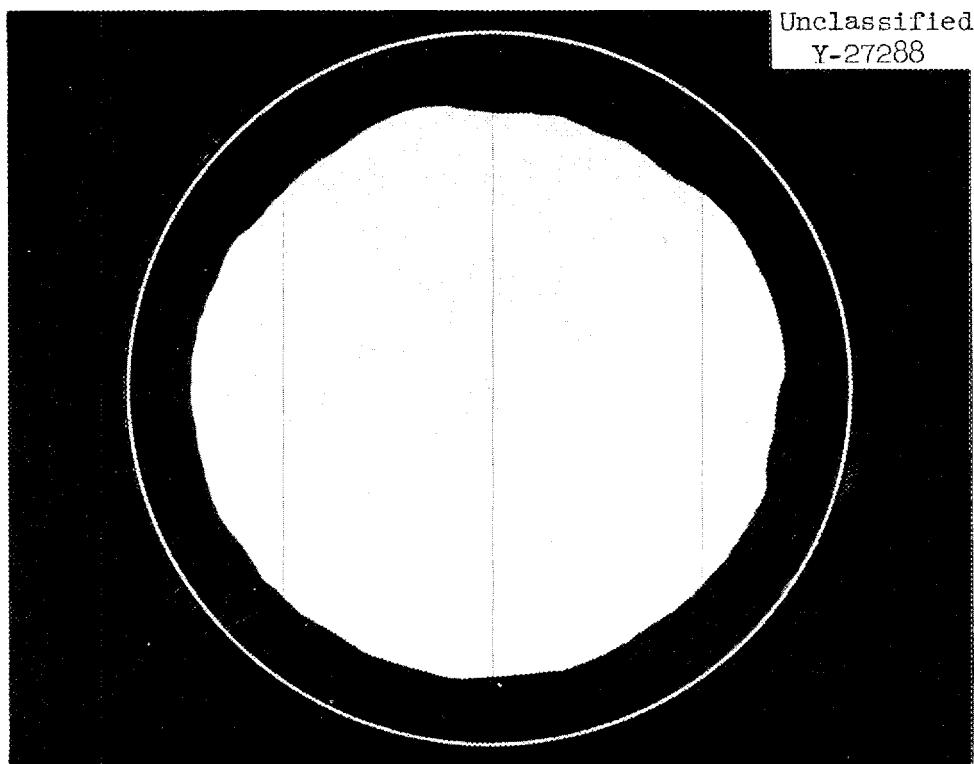
Fig. 71A. Cross Section of Salt Region Sample from INCO-700 Corrosion Specimen (Runs L-1-L-4:4). Interior circumference of white circle indicates original specimen size. As-polished. 5X.

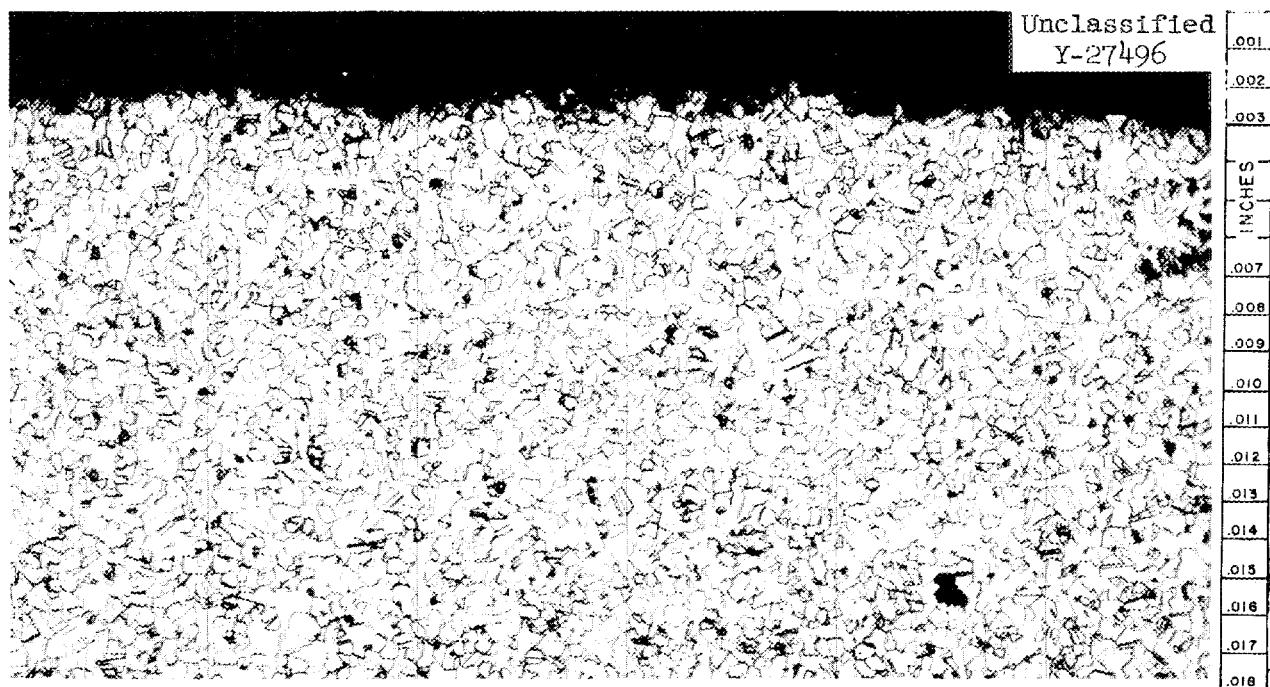
Fig. 71B. Portion of Fig. 71A. Typical Surface and Microstructure. Cathodic vacuum etch. 200X.

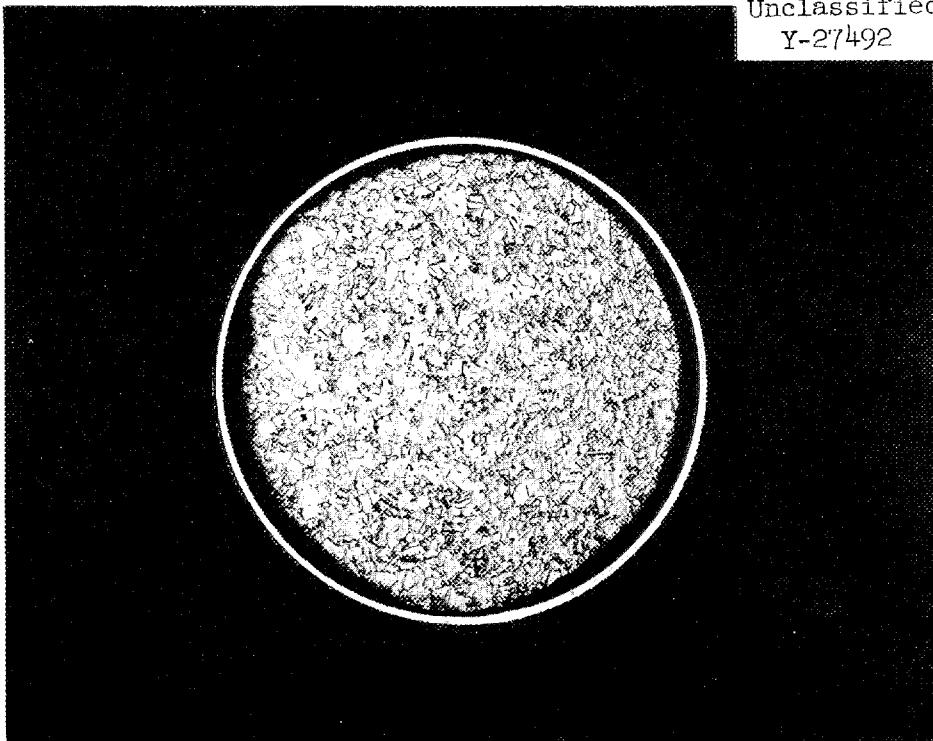
Fig. 72. Cross Section of Vapor Region Sample from Cobanic Corrosion Specimen (Runs L-1-L-4:5). Interior circumference of white circle indicates original size. Etchant: Concentrated  $\text{HNO}_3$ . 100X.

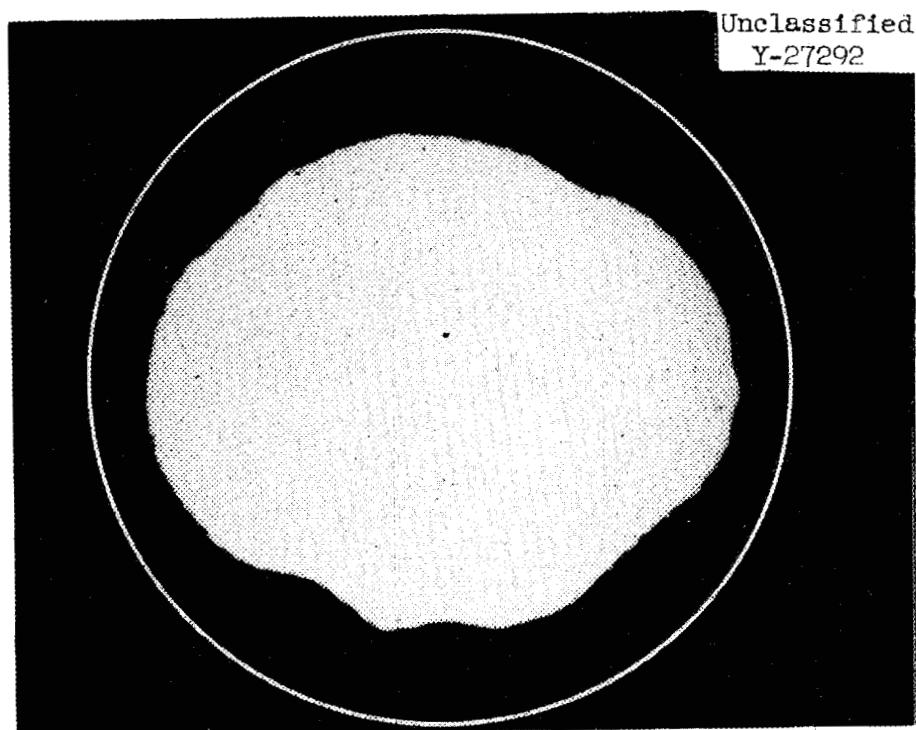
Fig. 73A. Cross Section of Salt Region Samples from INOR-8 Corrosion Specimen (Runs L-1-L-4:1). Interior circumference of white circle indicates original size. As-polished. 15X.

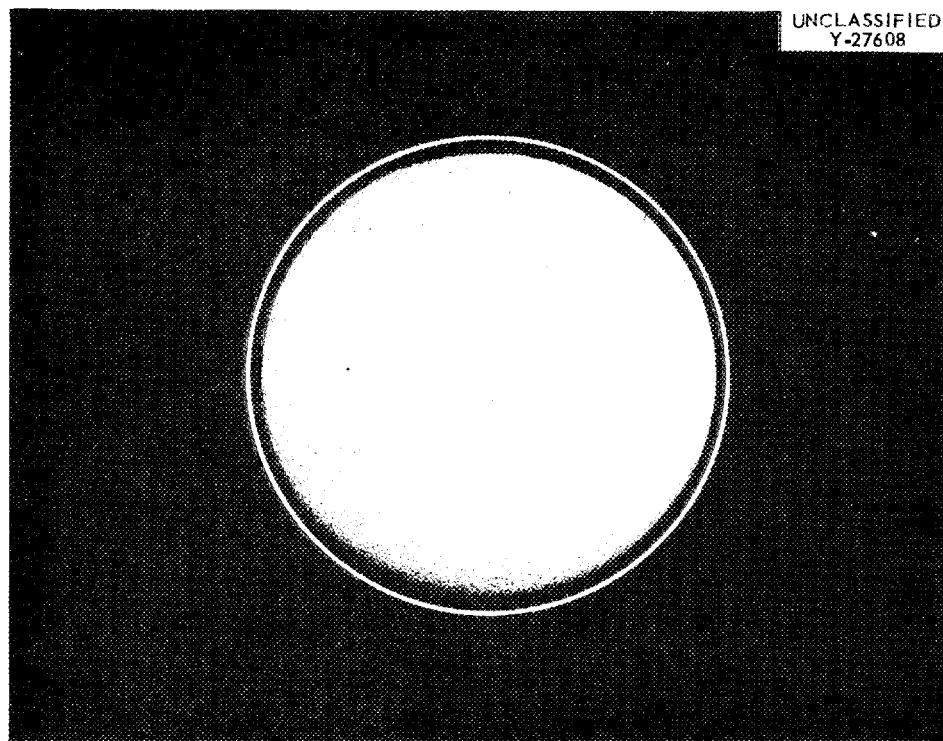
Fig. 74A. Cross Section of Interface Region Sample from Waspalloy Corrosion Specimen (Runs L-5-L-9: $\frac{1}{4}$ ). Interior circumference of white circle indicates original size. As-polished. 5X.

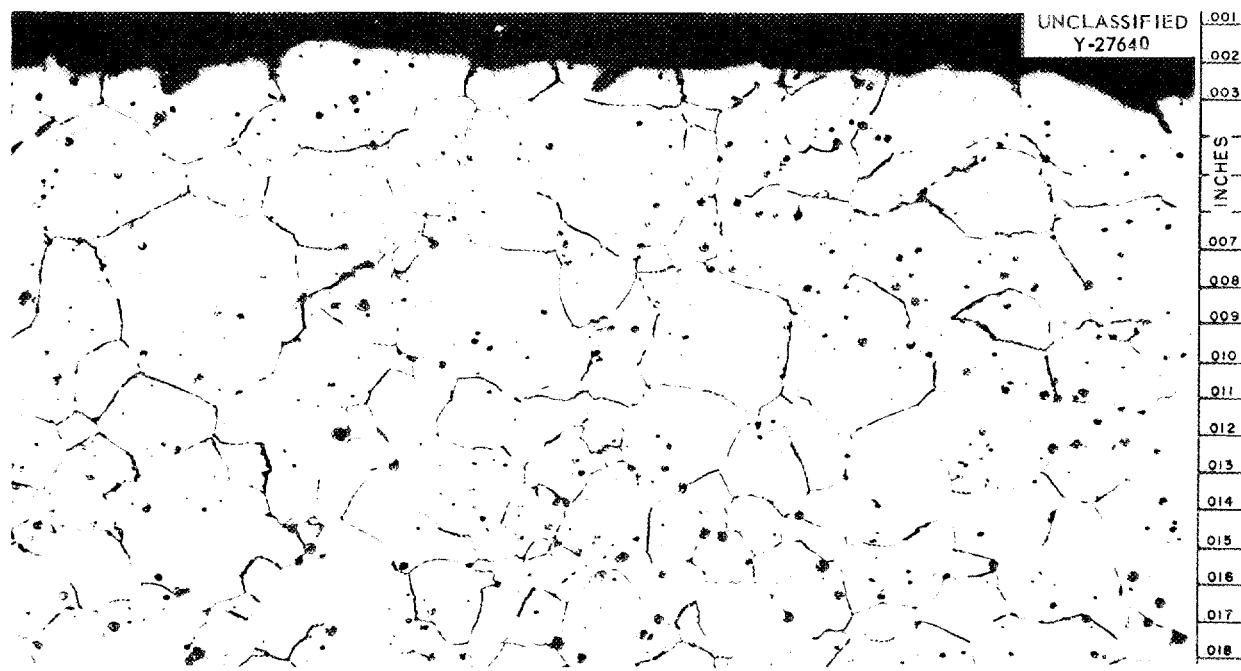
Fig. 74B. Portion of Fig. 74A. Typical Surface and Microstructure.  
Etchant: Aqua regia. 200X.

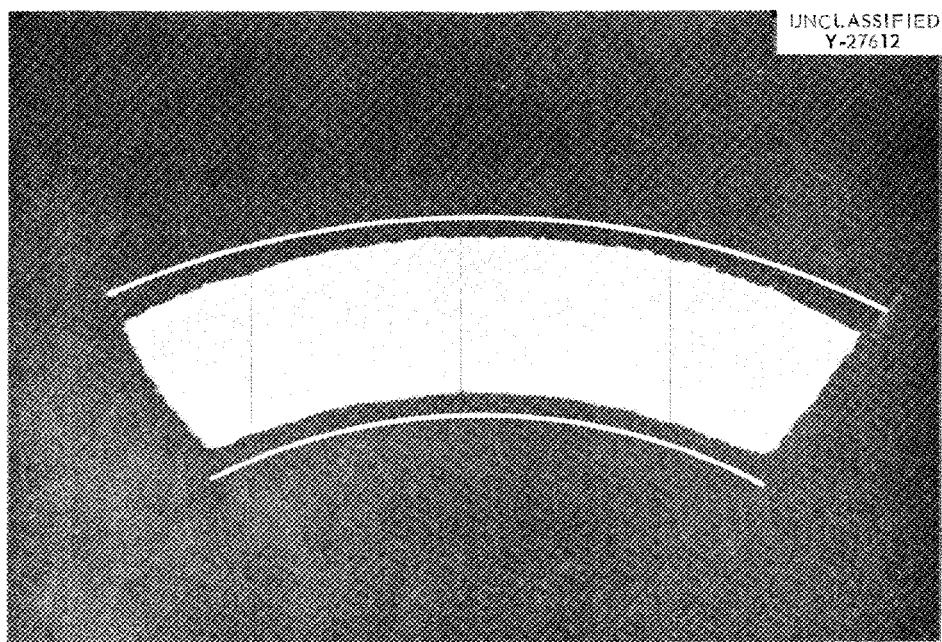
Fig. 75A. Cross Section of Interface Region Sample from Hastelloy X Corrosion Specimen (Runs L-5-L-9:5). Interior of white lines indicates original thickness. As-polished. 10X.

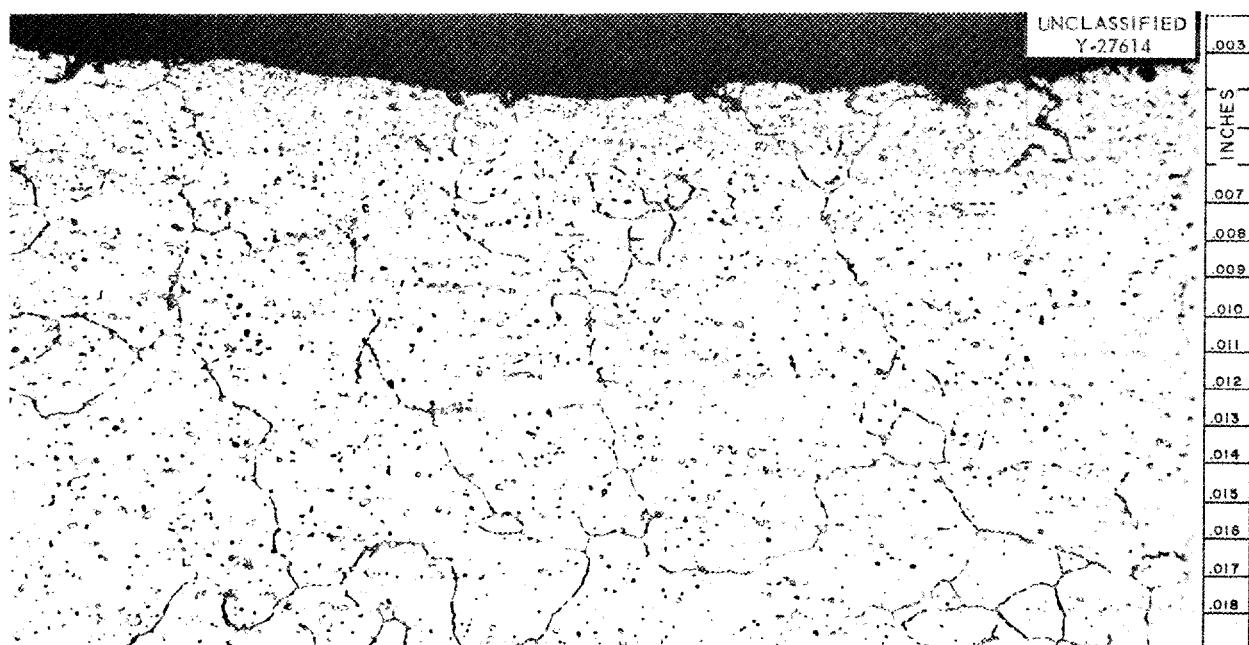
Fig. 75B. Portion of Fig. 75A. Typical Surface and Microstructure. Etchant: Chromium regia. 200X.

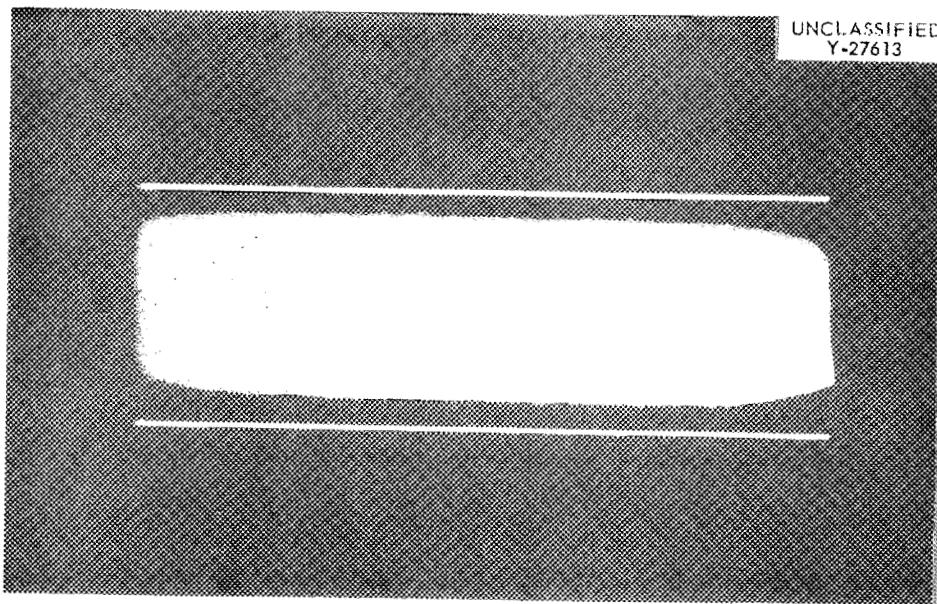
Fig. 76A. Cross Section of Interface Region Sample from Hastelloy W Corrosion Specimen (Runs L-5-L-9;6). Interior of white lines indicates original thickness. As-polished. 10X.

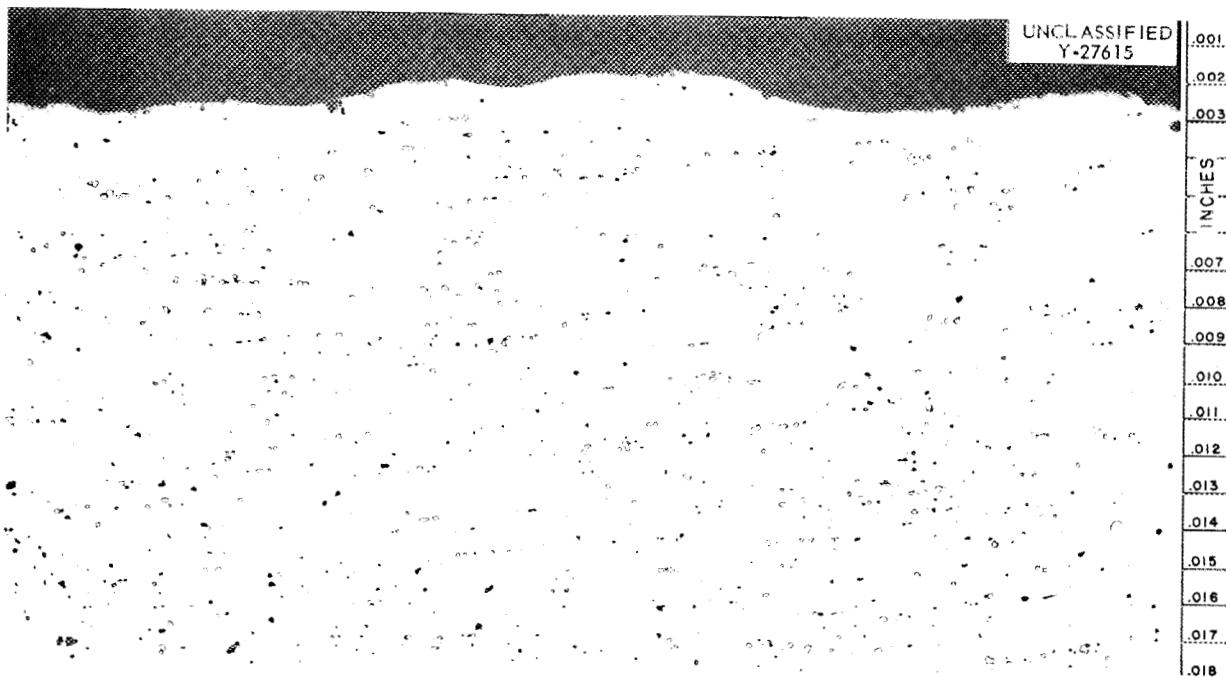
Fig. 76B. Portion of Fig. 76A. Typical Surface and Microstructure.  
Etchant: Chromium regia. 200X.

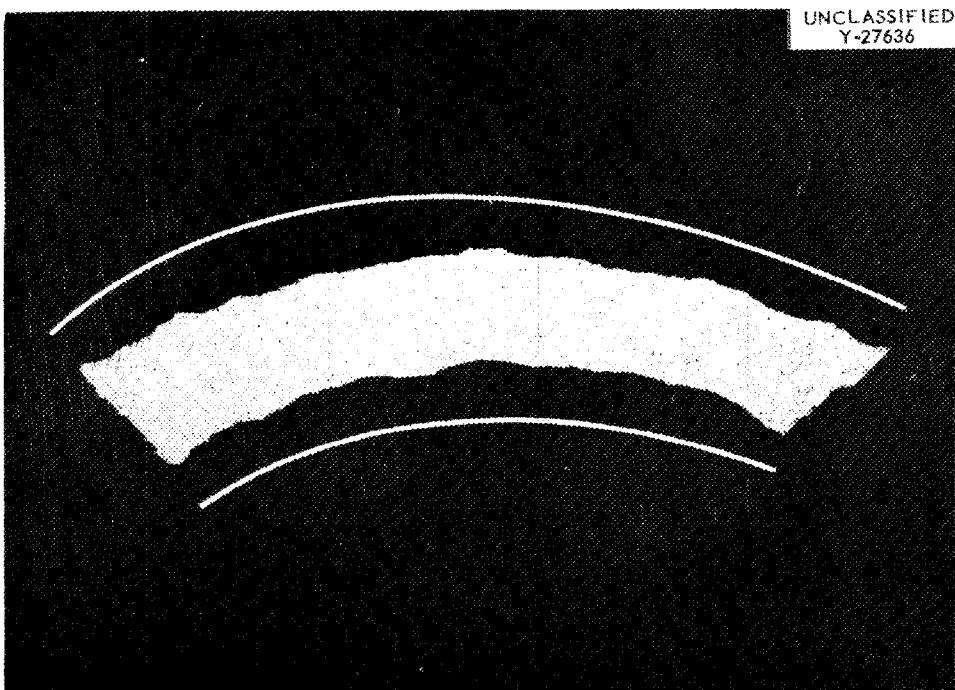
Fig. 77A. Cross Section of Salt Region Sample from Nimonic 80 Corrosion Specimen (Runs L-5-L-9:7). Interior of white lines indicates original thickness. As-polished. 10X.

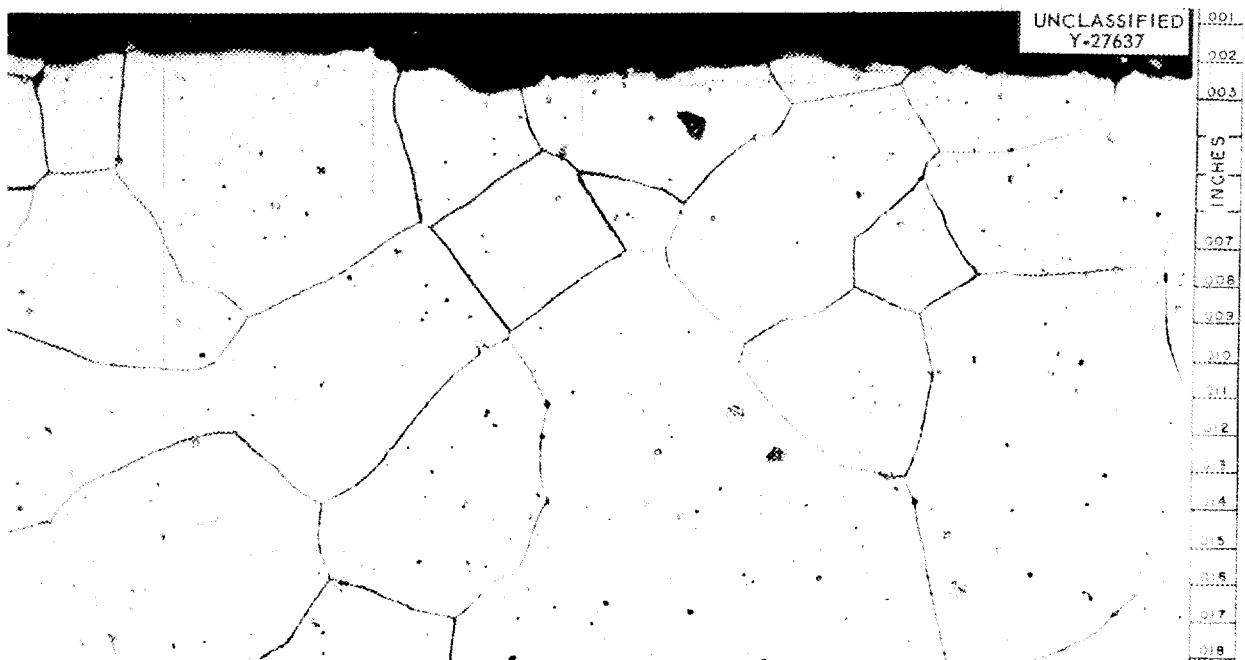
Fig. 77B. Portion of Fig. 77A. Typical Surface and Microstructure. Etchant: Aqua regia. 200X.

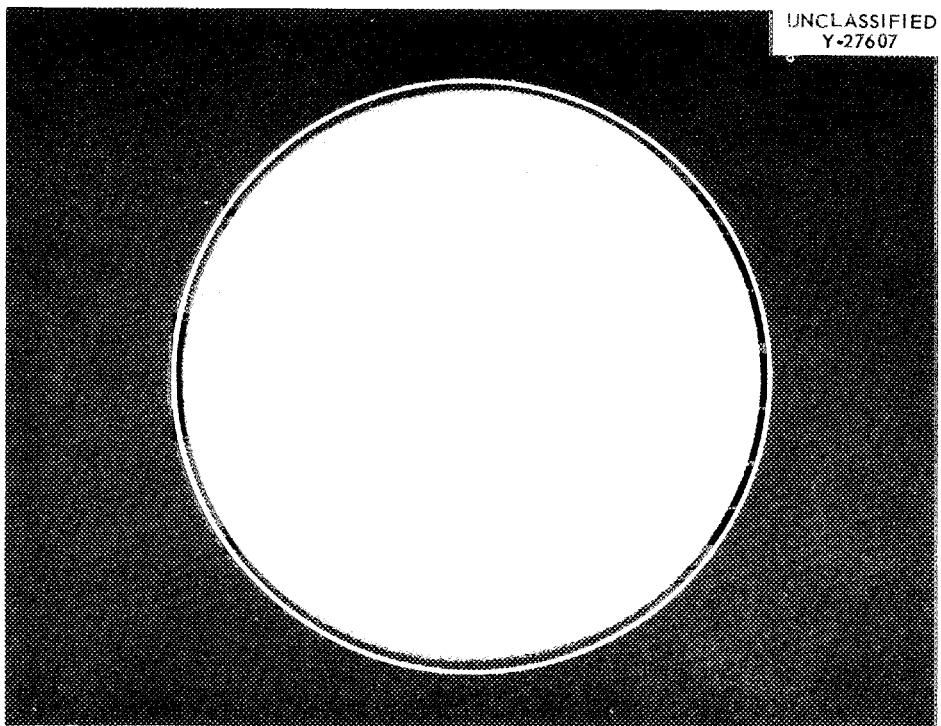
Fig. 78A. Cross Section from Interface Region Sample from Hymu 80 Corrosion Specimen (Runs L-5-L-9:8). Interior circumference of white circle indicates original size. As-polished. 5X.

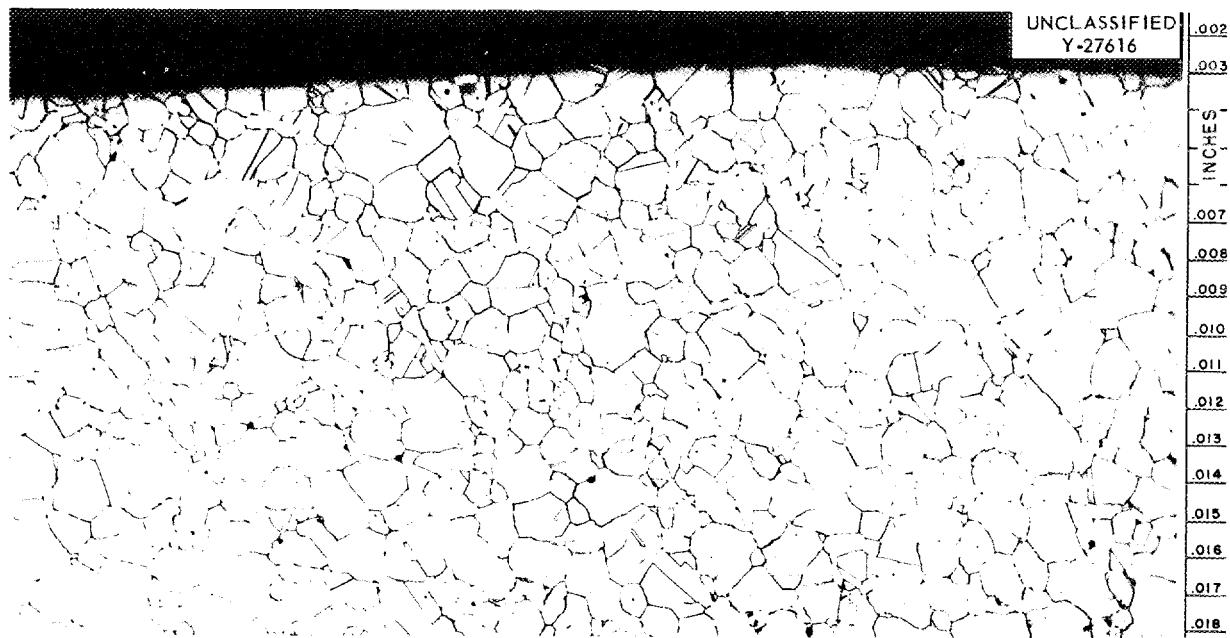
Fig. 78B. Portion of Fig. 78A. Typical Surface and Microstructure.  
Etchant: Aqua regia. 200X.

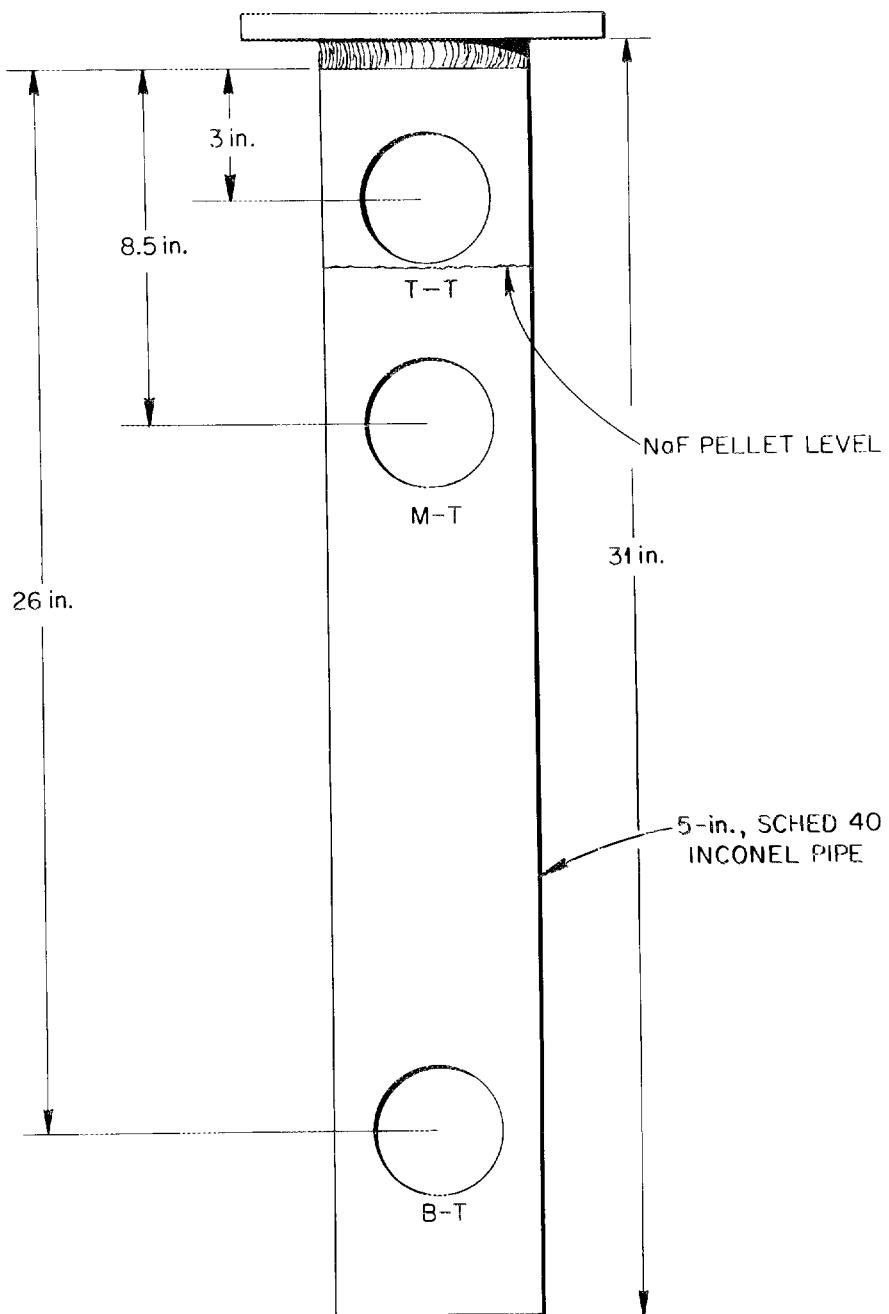
Fig. 80. Location of Specimens Trepanned from the Inconel CRP Trap.

Macroscopic examination of the samples at 20X revealed outlining of the Inconel grains and an etched surface with increased attack noted at Section B-T.

Dimensional analyses were performed on the sections as well as a microscopic examination. A summary of the corrosion losses found by BMI personnel is presented in Table XXI. Included in the table is a column converting the maximum total losses to a mils per hour rate based on fluorine exposure time at operating temperature for the vessel. A maximum total corrosion attack rate of 0.46 mils/hr occurred in the lower section of the trap which sustained the higher operating temperatures.

Optical microscopic examination of sections removed from the trap revealed intergranular attack on both the interior and exterior surfaces of the vessel in the lower regions. The upper region showed intergranular attack only on the vessel's interior wall. A typical cross section of the interior wall of the CRP trap is shown in Fig. 81.

No appropriate reason can be advanced to explain the variations cited in corrosive behavior for the CRP trap and the Inconel bench-scale fluorinator. However, the results present additional evidence that Inconel should be used with caution as the construction material for certain fluoride volatility process components.

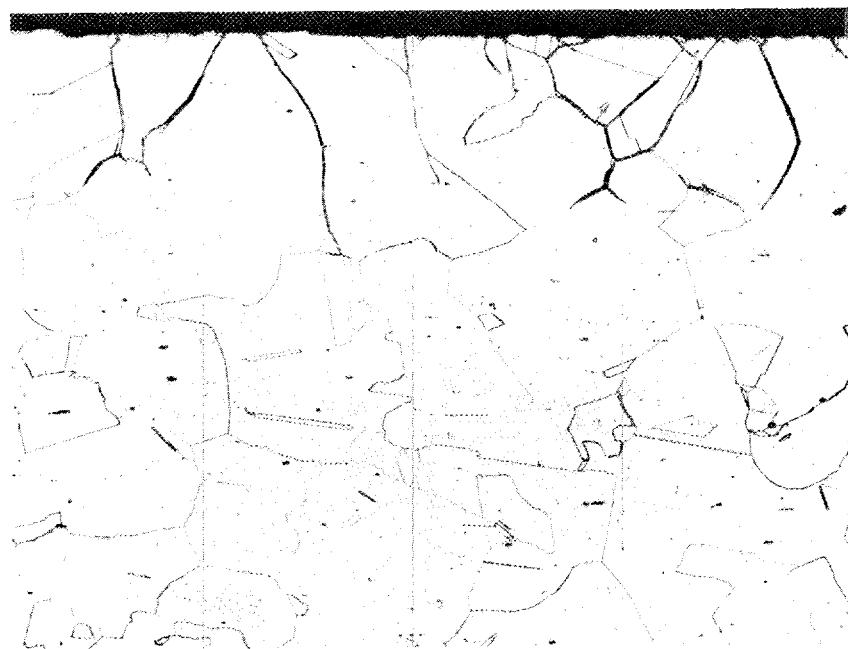
Comparison of the corrosive attack on the Inconel CRP trap and the Inconel bench-scale fluorinator described in Section III indicated maximum rate losses for the trap to be approximately twice that for the bench-scale fluorination vessel. The most similar areas with respect to operating environments were the lower vapor region of the fluorinator and the lower region of the CRP trap. At those locations, similar temperatures (approx 500°C) and process gases ( $F_2$ ,  $UF_6$ ) were present. In addition, however, sodium fluoride pellets were in contact with the wall of the CRP trap. The maximum bulk metal losses in the two regions were in a ratio of 3:1 (Trap:Fluorinator) while the maximum interior intergranular penetration ratio was > 5:1. These differences are difficult to reconcile in view of the 2:1 ratio for fluorine contact time at elevated temperatures for the two vessels.

Fig. 81. Typical Microstructure of Sample B-T from the Interior Wall of the Inconel CRP Trap Showing Intergranular Attack. Etchant: Hydrochloric-nitric acid. 100X.
