ORNL-2832

CORROSION ASSOCIATED WITH FLUORINATION  
IN THE OAK RIDGE NATIONAL LABORATORY  
FLUORIDE VOLATILITY PROCESS

CORROSION ASSOCIATED WITH FLUORINATION IN THE  
OAK RIDGE NATIONAL LABORATORY FLUORIDE VOLATILITY PROCESS

A. P. Litman and A. E. Goldman

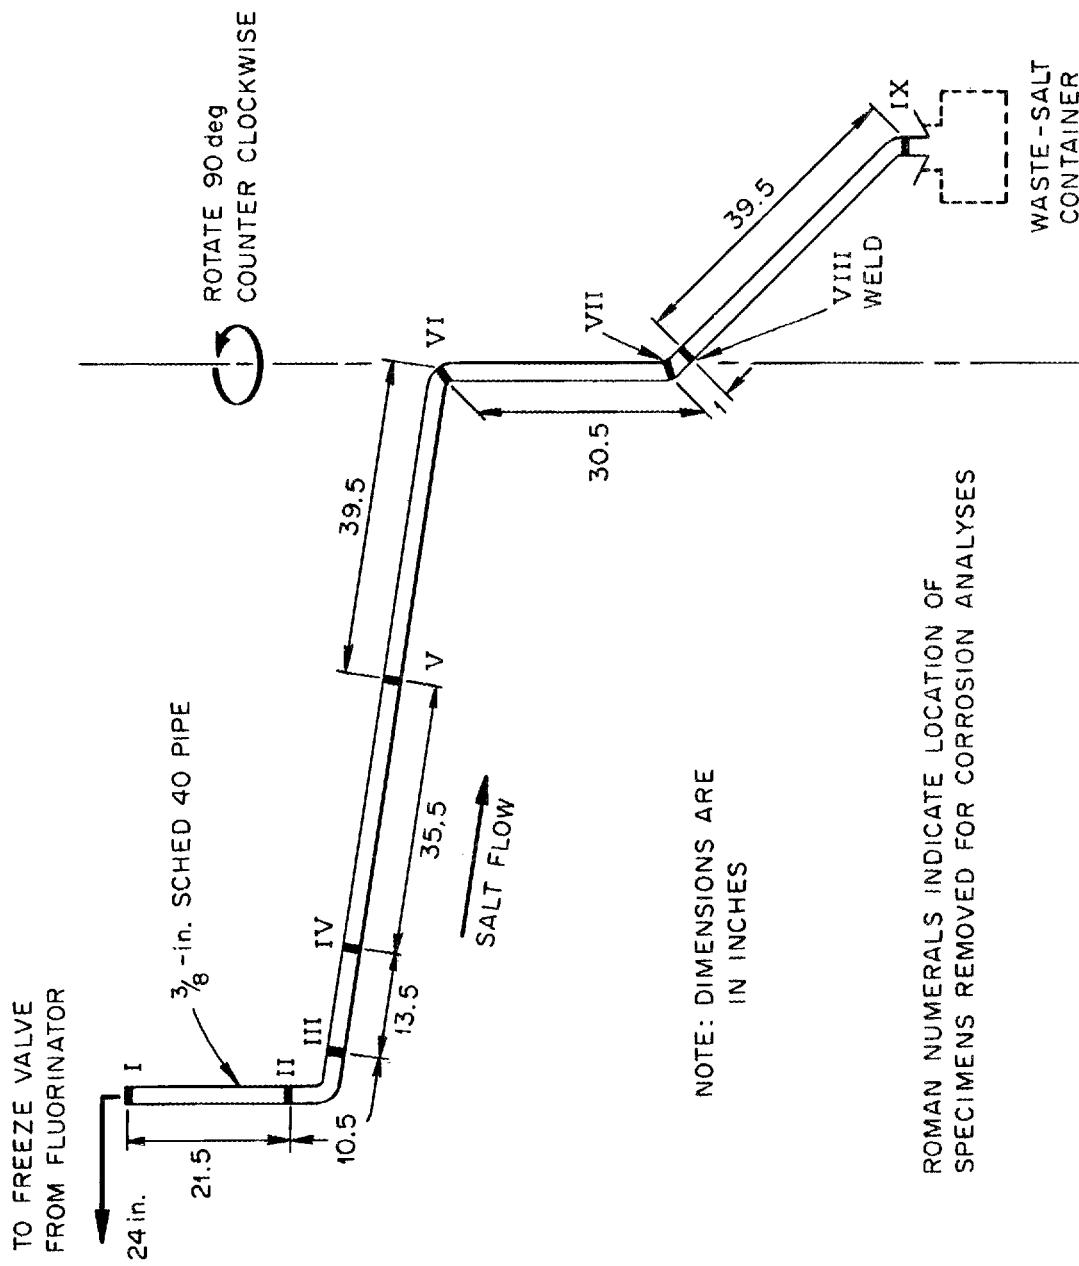
Fig. 82. Schematic Drawing of Inconel Waste-Salt Line from VPP Fluorinator.  
Roman numerals indicate location of specimens removed from line for corrosion analyses.

After Run M-64, the piping was removed from the pilot plant, sectioned in nine places and specimens sent to BMI for corrosion analyses. Figure 82 shows a schematic drawing of the waste line and the location of the specimens. Table XXII lists the corrosion data established at BMI by micrometer measurements and metallographic examinations. Maximum wall-thickness losses of 21 mils were found in specimen IX which was at the exit end of the waste-salt line.

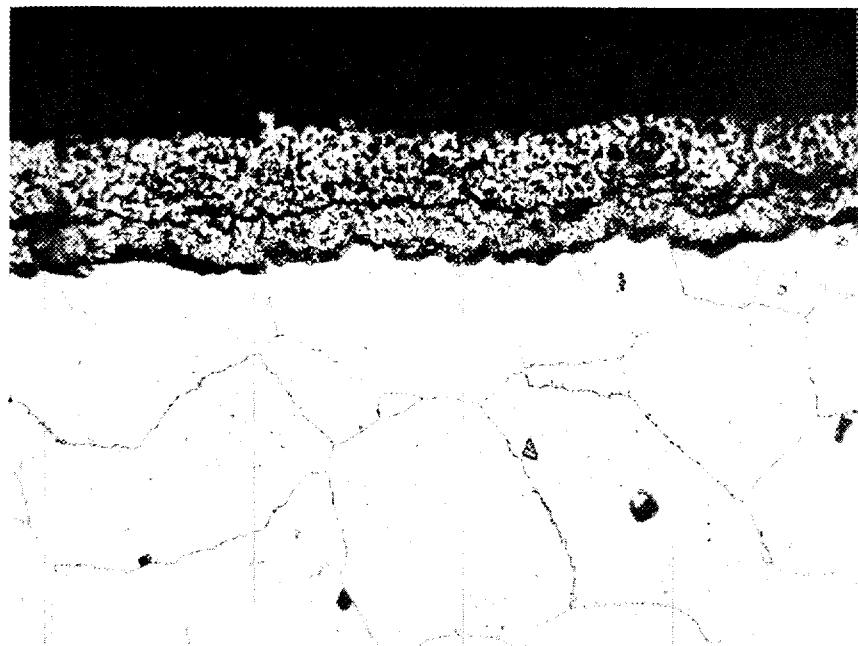
Figure 83 shows the corrosion product layer and the subsurface structure. The product layer was spongy in character and similar in appearance to surface layers found on sections removed from early test Inconel freeze valves which had been in contact with NaF, ZrF<sub>4</sub>, UF<sub>4</sub> (50-46-4 mole %) at 650°C. (ref 53)

Fig. 83. Microstructure of Sample IX from the Interior Wall of Inconel Waste Salt Showing Corrosion Product Layer.

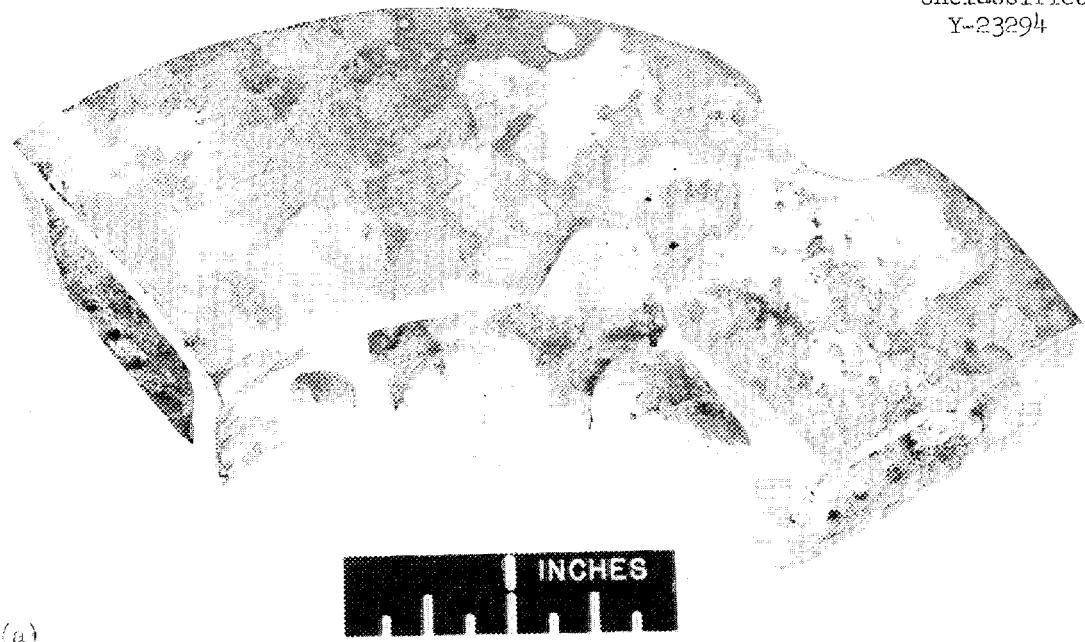
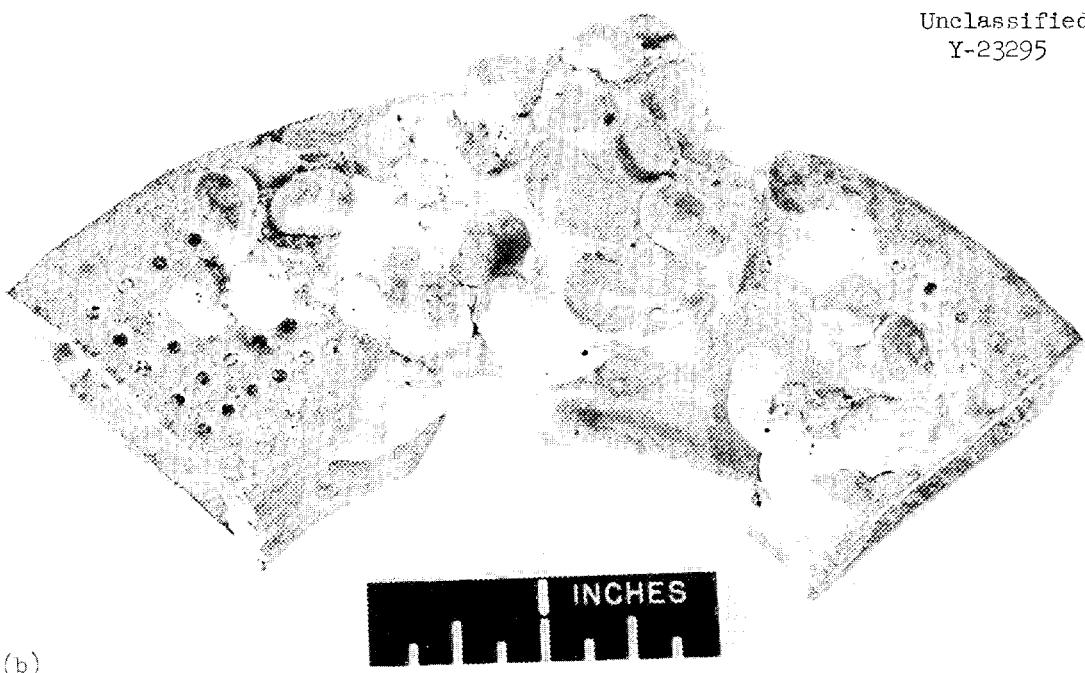
A schematic view of the absorber and the gas-distribution ring is shown in Fig. 84. As shown on the photographs, Fig. 85-a and -b, approx 3 in.<sup>3</sup> of Inconel was melted in an area roughly 180 deg from the junction of the distribution ring and the inlet pipe. The melted area was about 5 in. long and the distribution ring was nearly severed by this action.

Fig. 85. Photographs of Failed Region from the Inconel Gas-Distribution Ring of Absorber, (a) Top View (b) Bottom View, Showing Molten and Recast Nodules and Adhering Salt.

present in this area of the absorber were NaF pellets, F<sub>2</sub> and UF<sub>6</sub>. Table XXIII shows the prior history of the ring up to the time of failure. Three unusual plant operating procedures were a part of this prior history:<sup>57</sup> (1) substitution of hydrogen fluoride for low temperature fluorine conditioning, (2) allowing fluorine to enter the absorber at approx 600°C rather than 375°C as specified in the standard operating procedures (the higher temperature was used to minimize hydrogen fluoride from the NaF and to reduce the sodium fluosilicate content of the NaF), (3) use of an accelerated cooling rate after desorption.

Only (2) is felt to be pertinent toward causing the failure described.

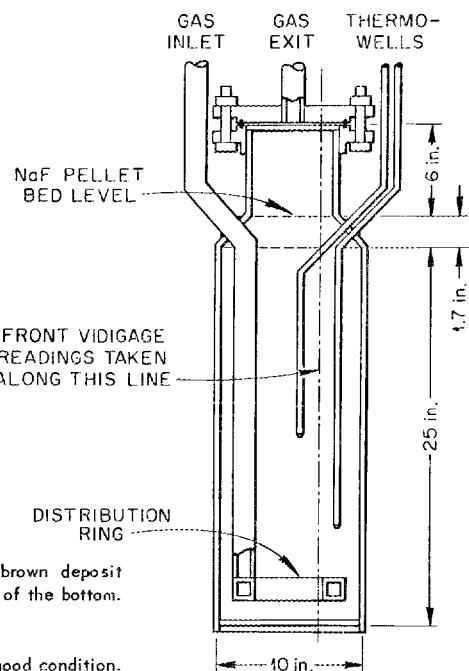
Inspection of Absorbers. Following fluorination Run L-9, the absorbers were visually inspected and thickness measurements taken with a "Vidigage." The ultrasonic device was operated by members of the Nondestructive Testing Group of the Metallurgy Division. Results of those examinations are cited in Figs. 86 and 87. The maximum detectable losses found were approx 30 mils in the upper regions of the vessel, a rate of approx 0.06 mils/hr, based upon fluorine residence time.

Fig. 87. Results of Visual and Vidigate Inspection on VPP Second Absorber.

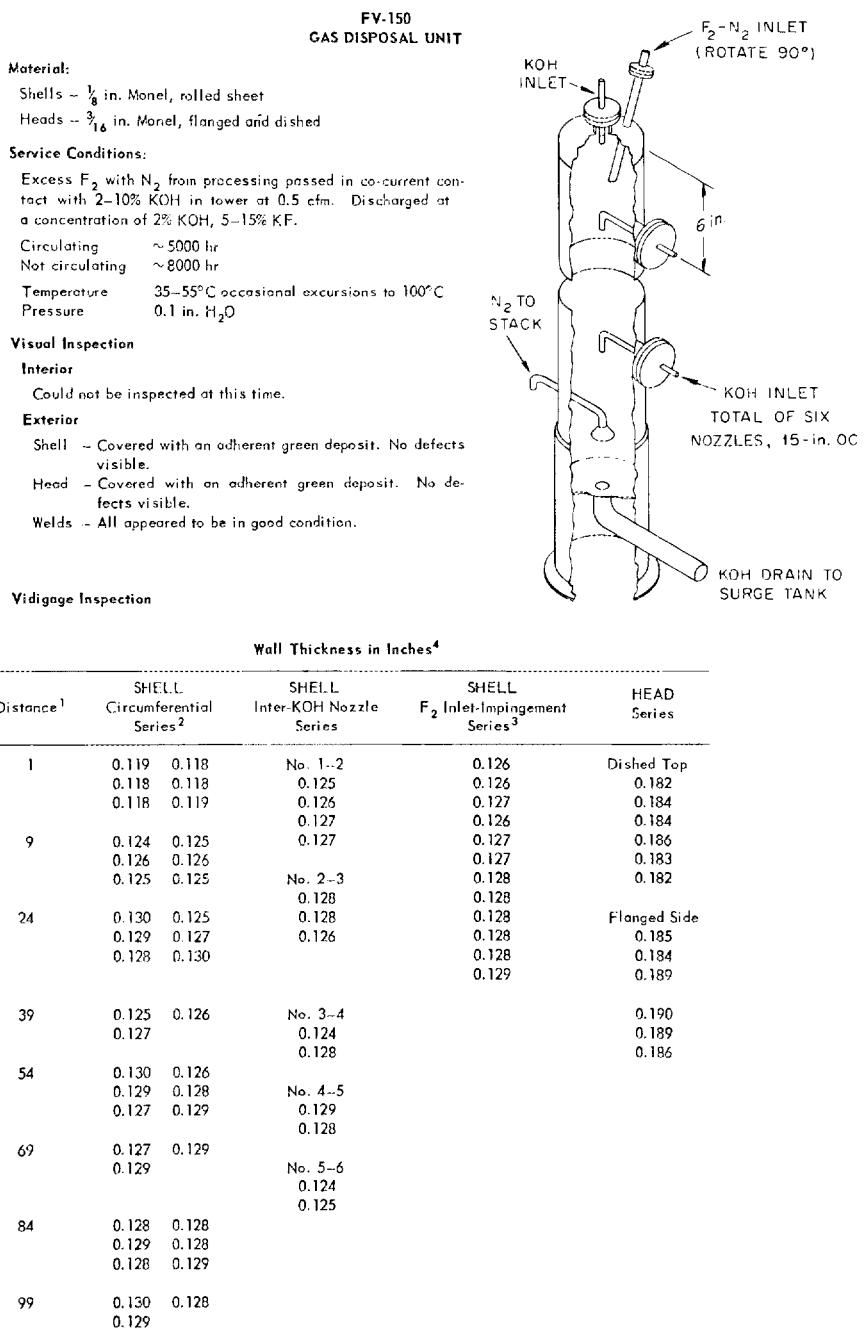
Fig. 91. Results of Visual and Vidigage Inspection on VPP Gas Disposal Unit.

After VPP Run L-9, visual and ultrasonic thickness measurements were taken on the gas-disposal unit and the surge tank to ascertain their suitability for additional VPP service. The respective service conditions for the two vessels and the results of those inspections are presented in Figs. 91 and 92. A maximum wall-thickness loss of 5 mils was found near the top head of the gas-disposal unit while no detectable metal losses were found in the surge tank.

Previous studies have indicated that heavy corrosive attack can occur on the process gas inlet pipe inside the gas-disposal unit.<sup>58</sup> Therefore, an inlet pipe fabricated from 1-in. sched-40 Monel pipe in service for approx 4900 hr was removed from the disposal unit and subjected to visual and metallographic examination. Figure 91 shows the location of the gas inlet pipe.
